# RECALL CAMPAIGN BULLETIN

## VOLUNTARY RECALL CAMPAIGN 2018 - 2019 NV200 AND 2019 NV200 TAXI; AV CONTROL UNIT (INFOTAINMENT) SOFTWARE UPDATE

**CAMPAIGN ID #:** R1911  
**NHTSA #:** 19V-654  
**APPLIED VEHICLES:** 2018 – 2019 NV200 (M20)  
2019 NV200 Taxi (M20T)

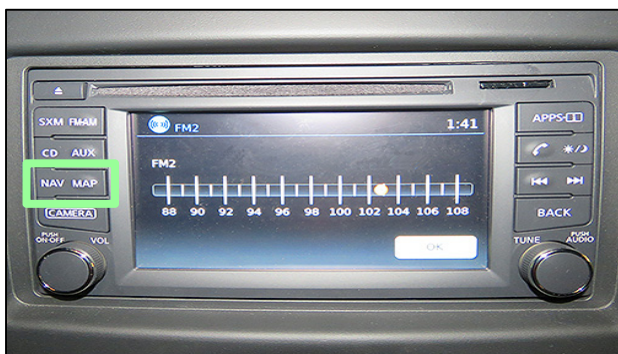
1. Confirm which audio system is present in the vehicle (see Figure 1 and Figure 2 below).
  - If the vehicle is equipped with navigation as shown in Figure 1, below, continue to step 2 below.
  - If the vehicle is **NOT** equipped with navigation, as shown in Figure 2, below, skip to step 19 on page 8.

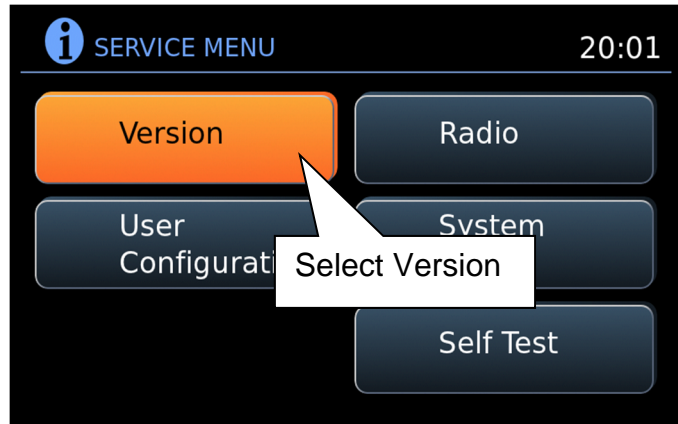
Figure 3

9. Select **Version**.

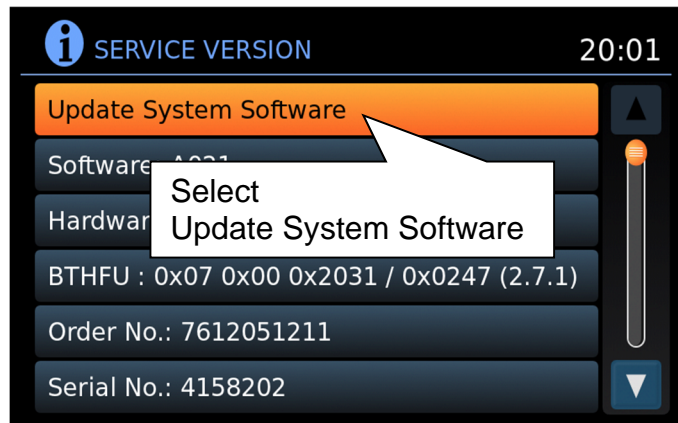
Figure 4

10. Select **Update System Software**.

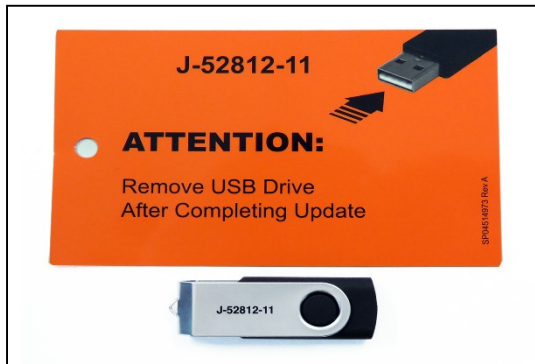
Figure 5

11. Insert the special tool USB drive J-52812-11 into the USB media port and select **OK**.

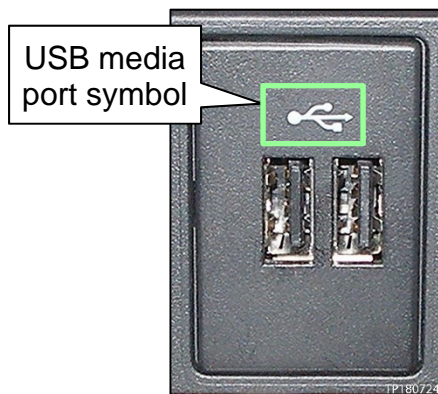
Figure 7

**HINT:** Charging ports are marked in the vehicle with a “lightning bolt” symbol.

**NOTICE** Do not insert the USB drive into a charging port. If used, the update software and/or USB drive may become damaged. Only insert the USB drive in a USB media port.

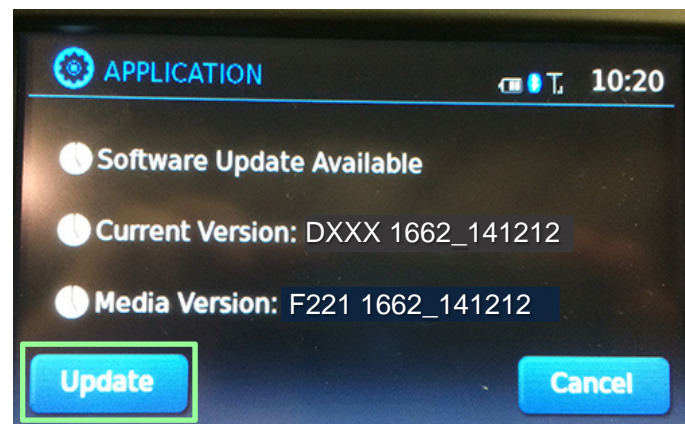
Figure 9

12. Wait for the **APPLICATION** screen to appear (Figure 9).

13. Select **Update**.

**HINT:** After selecting **Update**, the screen will go black for up to 1 minute. This is a normal part of the update.

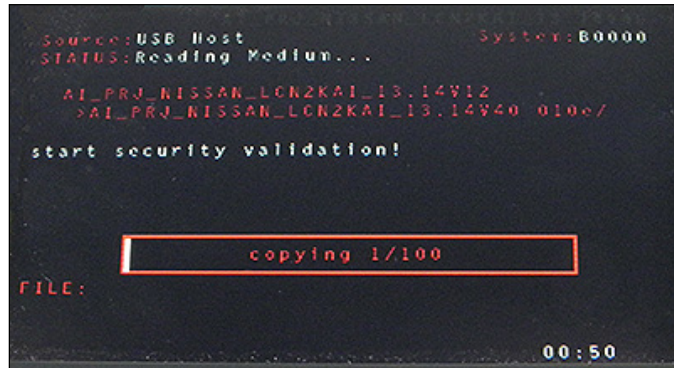
- The screen in Figure 10 will be displayed during the update.
- Figure 11 may display before the update begins. DO NOT remove the USB drive during the update.

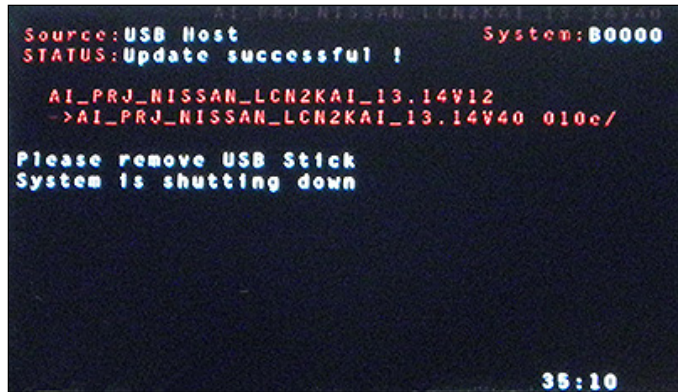
15. When Figure 12 is displayed, remove the USB drive to complete the update.

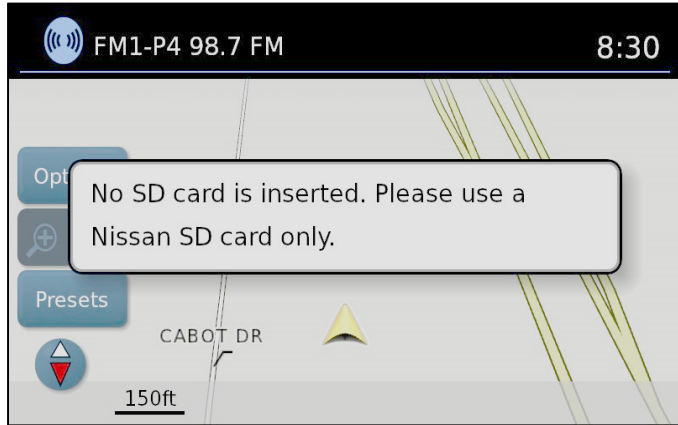
Figure 13

- This will cause the system to restart and may take up to 1 minute.
- If the message “No SD card is inserted. Please use a Nissan SD card only” is displayed (Figure 13) proceed to step 16.
- If the APPLICATION screen is displayed (Figure 14), skip to step 17.
- If neither screen is displayed, the update is complete. Skip to step 32 on page 11.

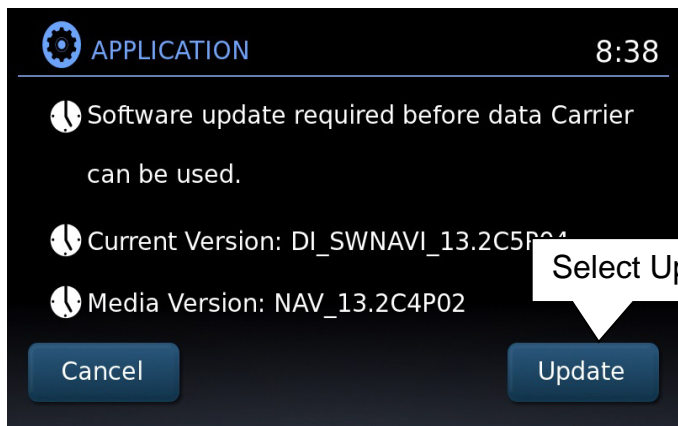
Figure 14

16. Remove and reinsert the map SD card from the card slot.
  - After the map SD card is reinserted, the “APPLICATION” screen will display (Figure 14).

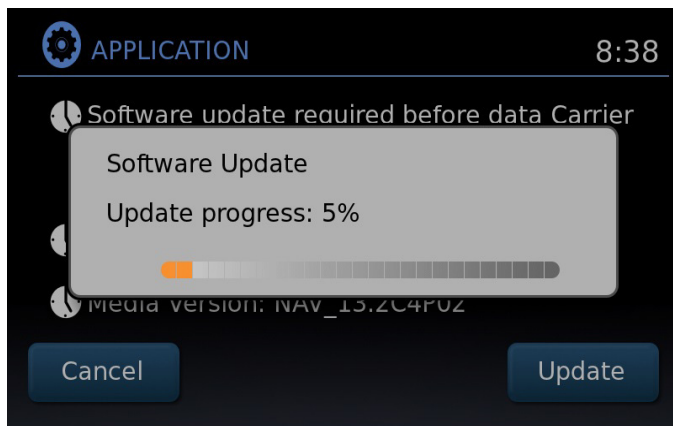
Figure 15

- The update will take about 1 minute to complete and will display as shown in Figure 15.

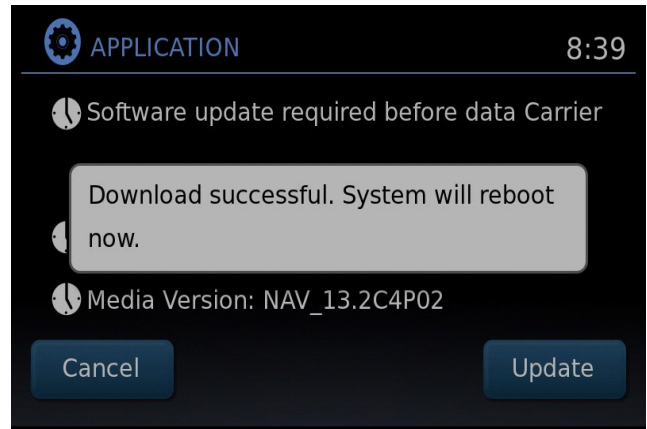
Figure 16

- The message “Download successful. System will reboot now” will display and the audio unit will reboot (Figure 16). After the system reboots, the update is complete.

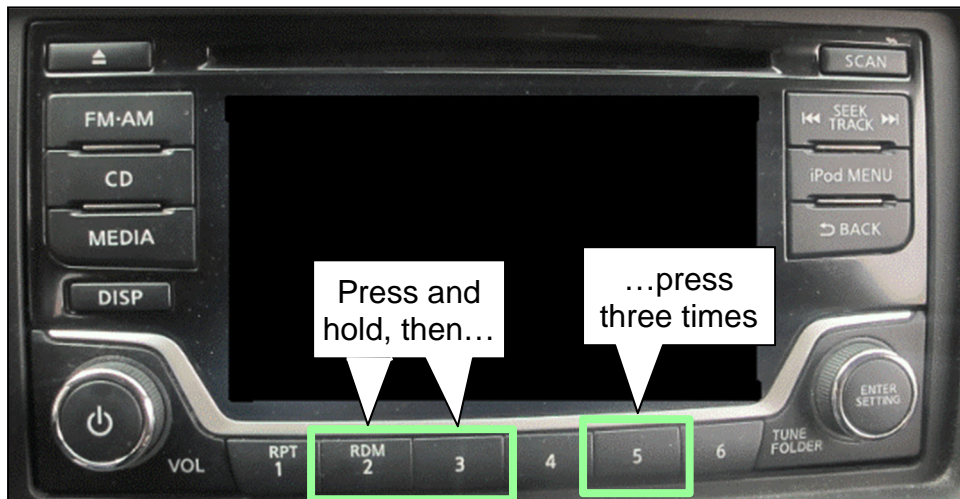
Figure 17

19. Turn the ignition ON.
20. Turn the audio OFF.
21. Open the System Diagnosis Menu on the audio unit:
  - a. Press and hold the preset buttons “2” and “3”.
  - b. Press the preset button “5” three times to open the System Diagnosis Menu.

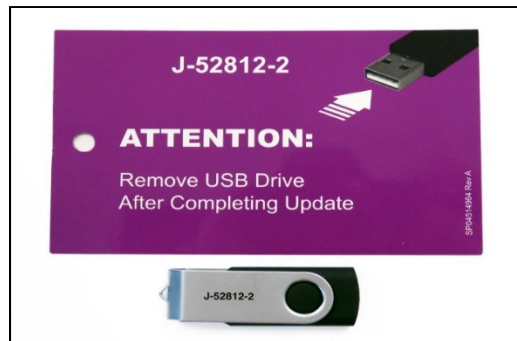
Figure 19

29. Turn the audio OFF.
30. Insert the special tool USB drive J-52812-2 into the USB media port.

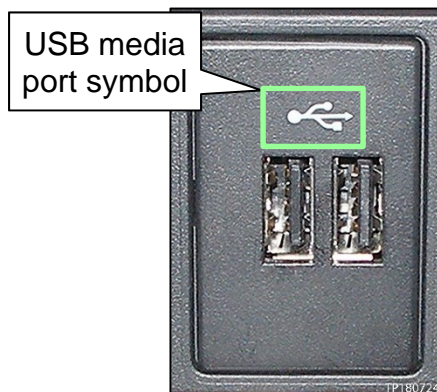
Figure 20

**HINT:** Charging ports are marked in the vehicle with a “lightning bolt” symbol.

**NOTICE** Do not insert the USB drive into a charging port. If used, the update software and/or USB drive may become damaged. Only insert the USB drive in a USB media port.
