# RECALL CAMPAIGN BULLETIN

## VOLUNTARY RECALL CAMPAIGN 2018 GT-R; AV CONTROL UNIT (INFOTAINMENT) SOFTWARE UPDATE

**CAMPAIGN ID #:** R1911  
**NHTSA #:** 19V-654  
**APPLIED VEHICLE:** 2018 GT-R (R35)

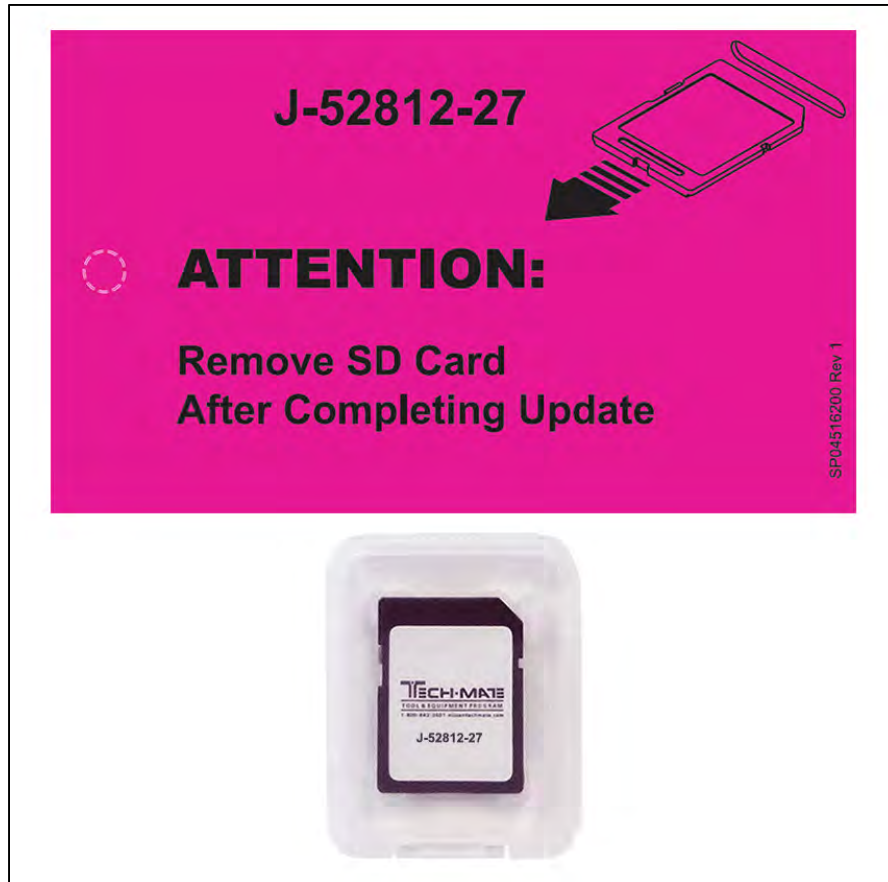
Figure 1

- Special tool SD Card J-52812-27 has been shipped to each dealer (see Figure 1).
- Additional SD cards are available from Tech•Mate: [nissantechmate.com](http://nissantechmate.com) or 1-800-662-2001.

It is highly recommended that the provided campaign SD card, J-52812-27, be used.

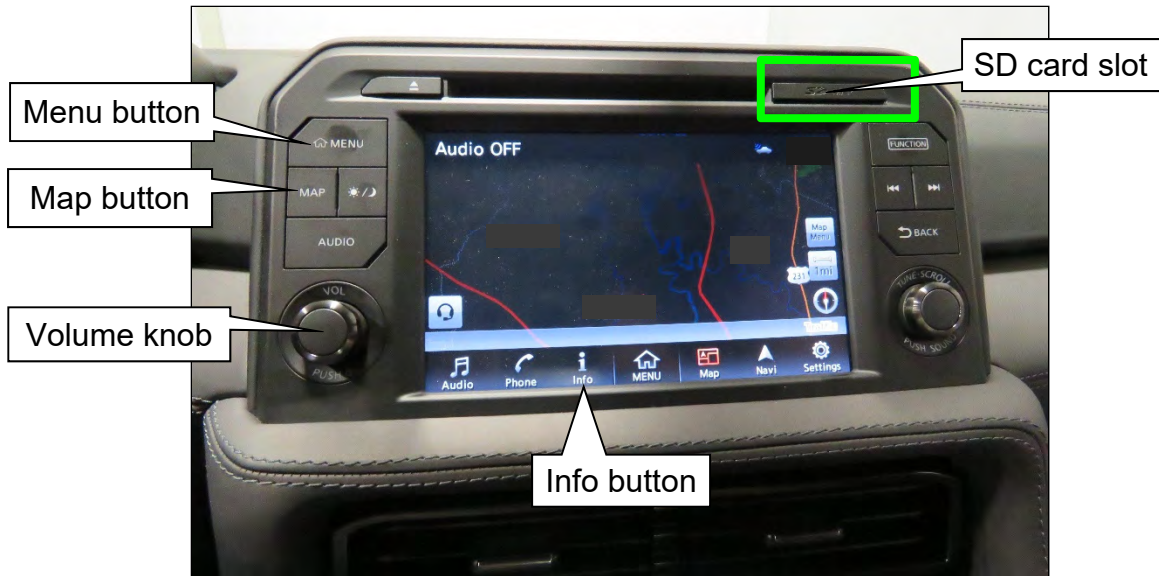
**NOTE:** Refer to Figure 2 below for location of controls and SD card slot.

1. Make sure the MAP SD card (not the software update card) is inserted in the SD card slot before starting the software update procedure.
2. Turn the ignition to ON/ACC.
3. Turn the hazard warning lamps ON to prevent the BCM from entering battery saver mode.
4. Ensure the map is displayed on the screen by pressing the MAP button.
5. Ensure the audio system is OFF (Audio OFF should be displayed in the top left corner of the MAP screen as shown in Figure 2).

- Refer to Figure 2 on page 3 for the SD card location.
- The SD card slot has a small cover. To access the MAP SD card, open the cover with a suitable tool.
- Push on the MAP SD card, and then it will eject.

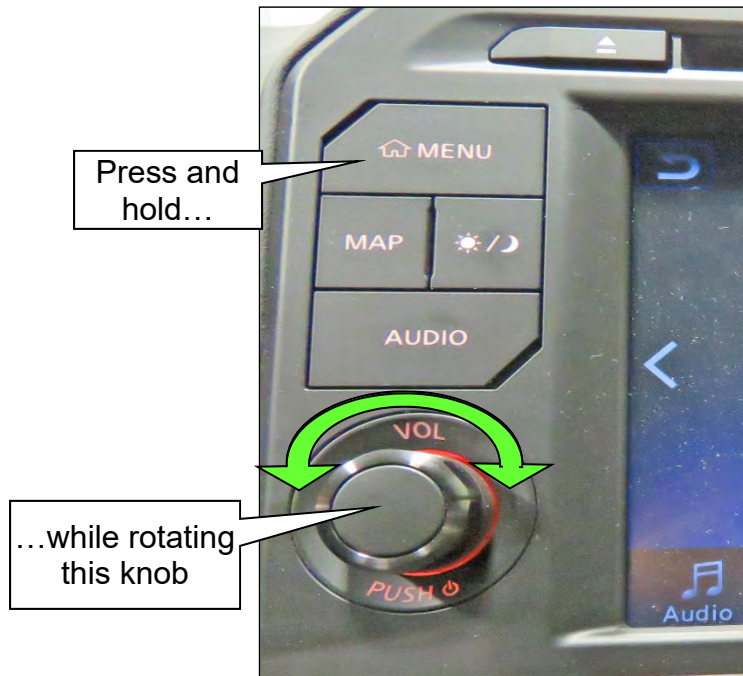
Figure 3

- Press and hold down the MENU button and at the same time rotate the volume knob (Figure 3) more than three clicks in each direction (back and forth) until **System Diagnostic Menu** displays (Figure 4).

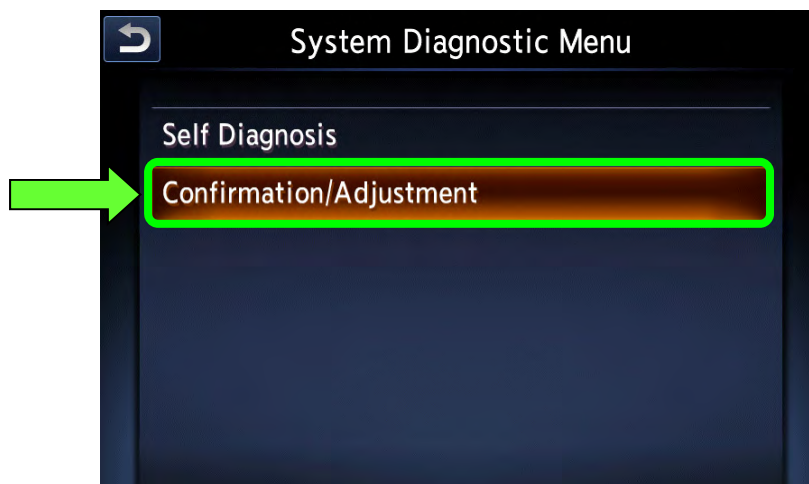
Figure 4

7. Select **Confirmation/Adjustment** (Figure 4).

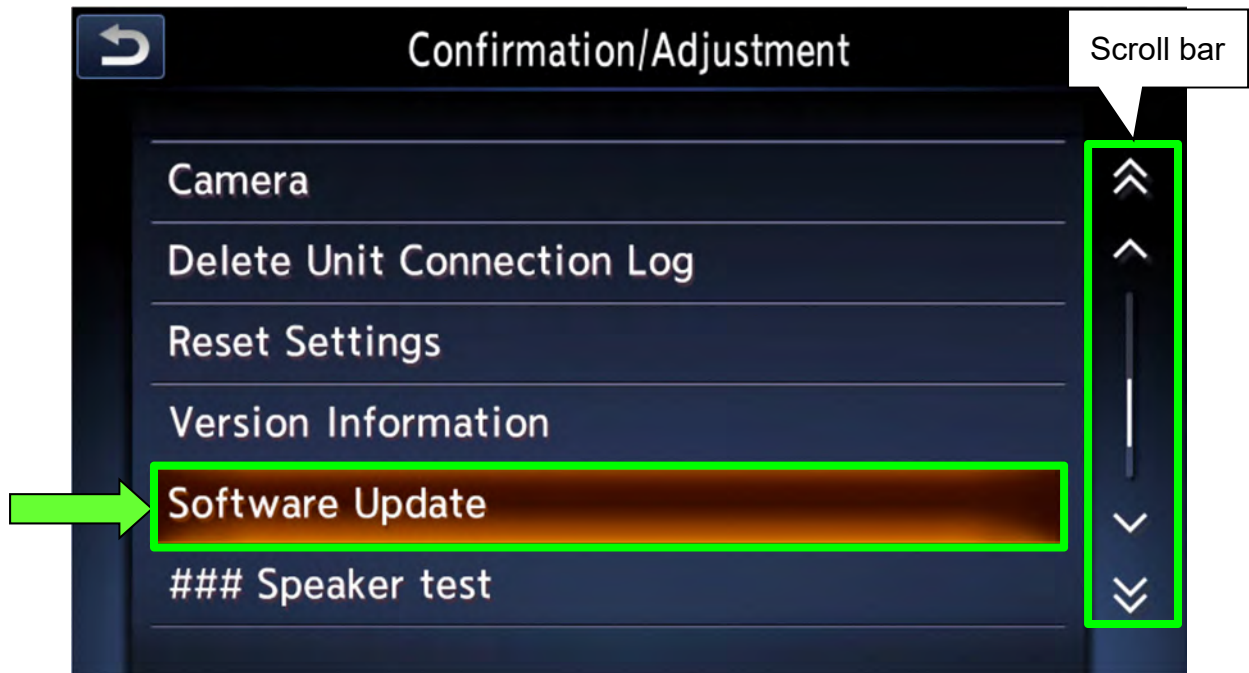
Figure 5

8. Use the scroll bar to scroll down, and then select **Software Update** (Figure 5).

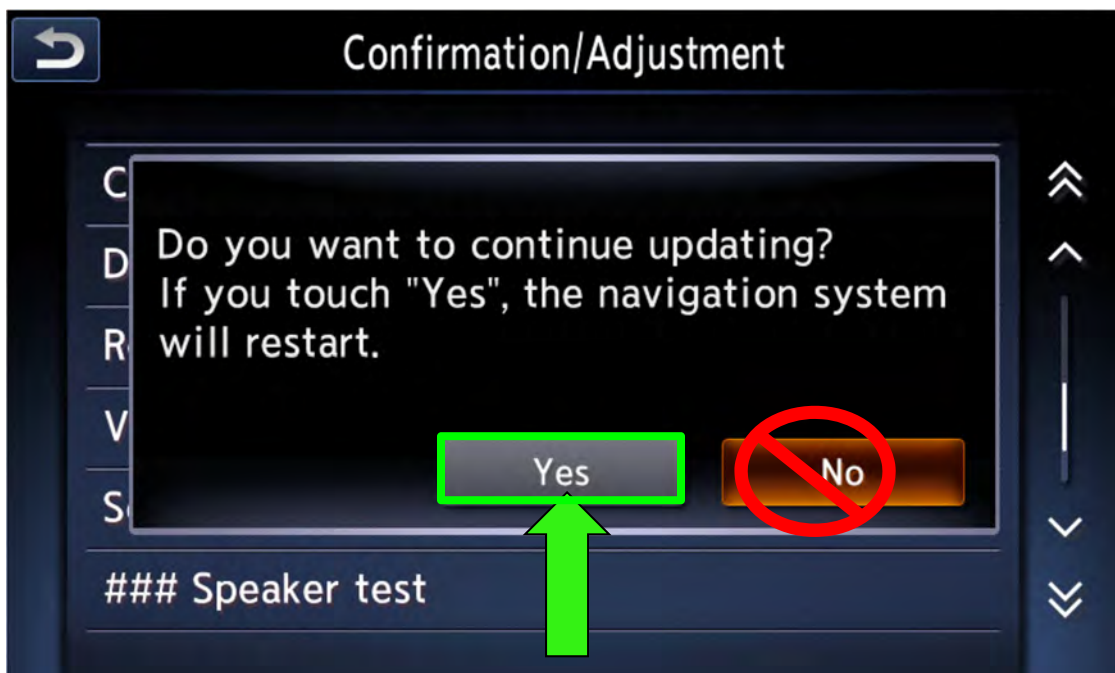
Figure 6

9. Select **YES** (Figure 6).
- The system will reboot automatically.

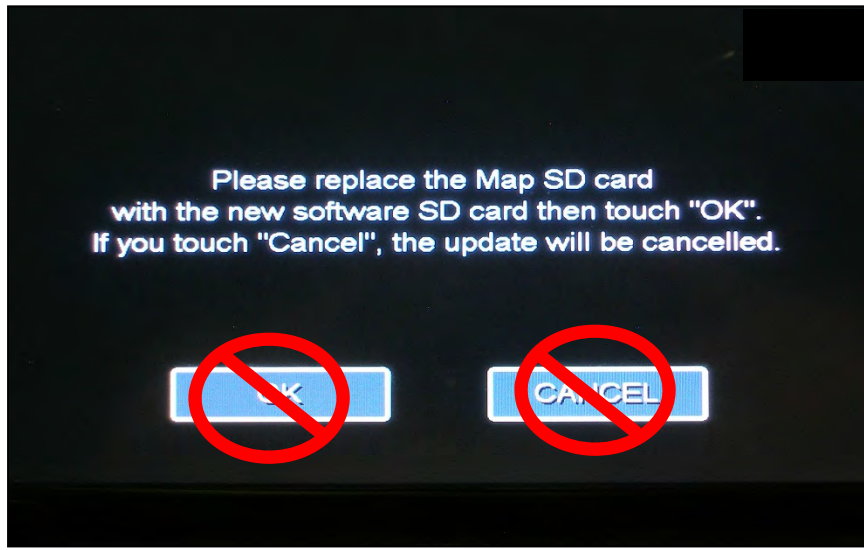
- The reboot is complete when the message in Figure 7 displays. **DO NOT select "OK" or "CANCEL" at this time.**

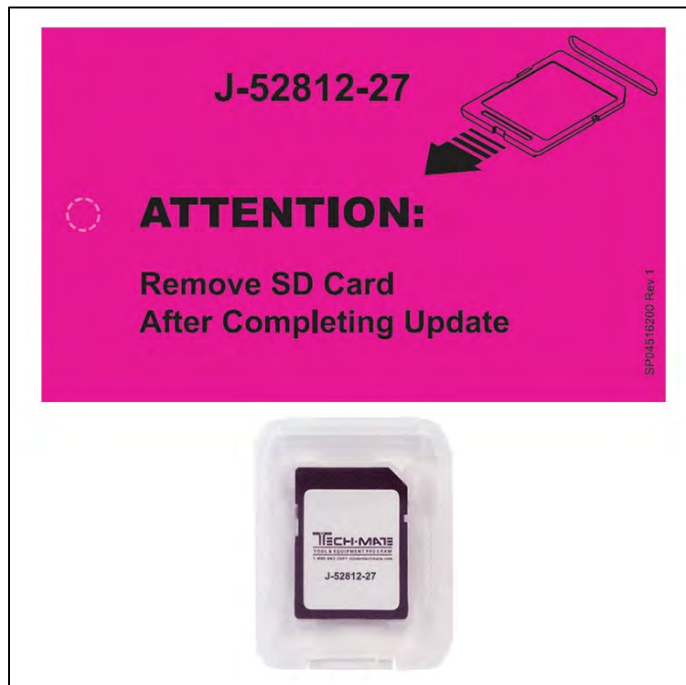
Figure 8

11. Install special tool J-52812-27 (provided; Figure 8) into the SD card slot.

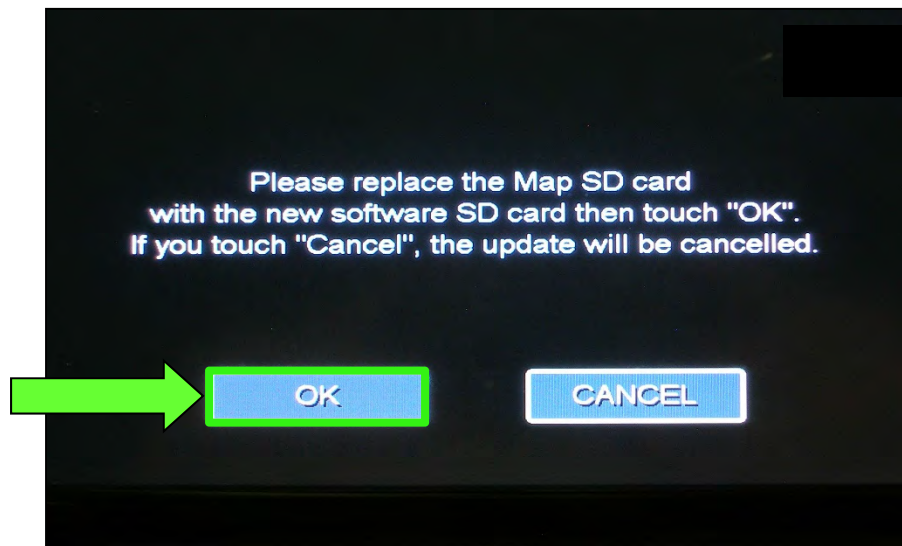
Figure 9

12. Select **OK** (Figure 9).

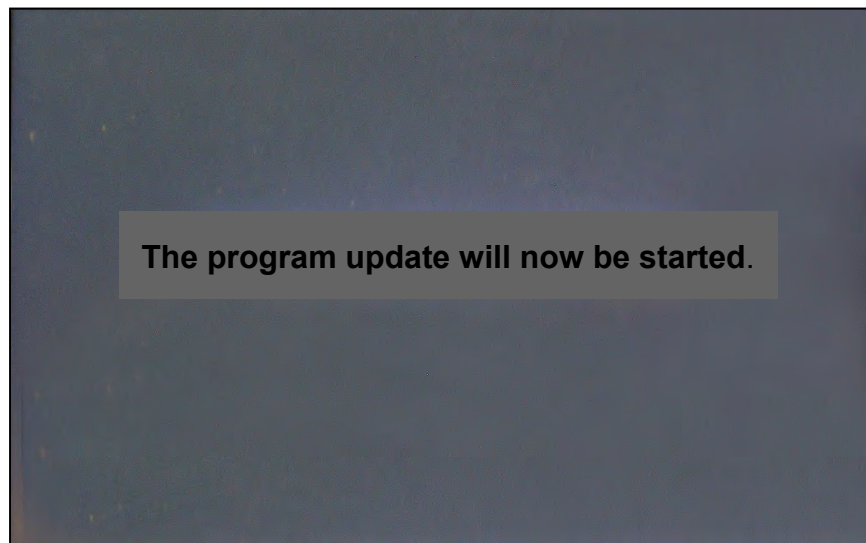
- Once OK has been selected, the message in Figure 10 should appear.

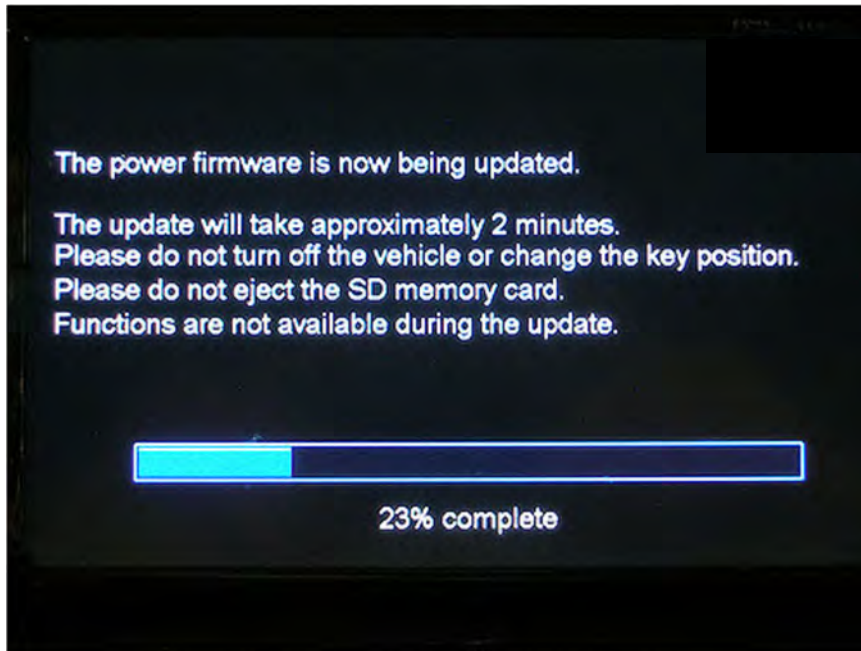
Figure 11

- An update status progress bar will appear (Figure 11).
- The software update will take approximately 5-7 minutes.

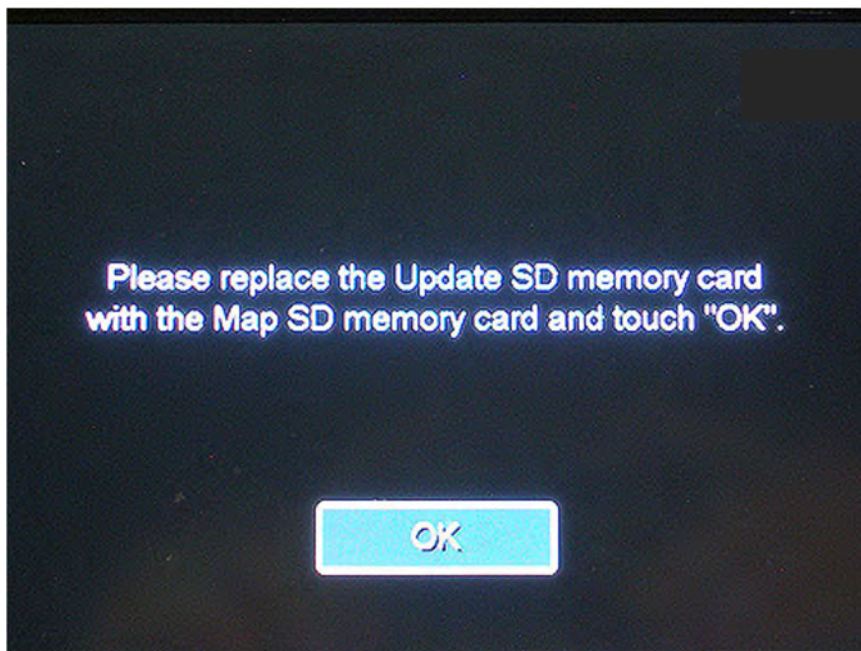
- After the update has completed, the screen in Figure 12 should display.

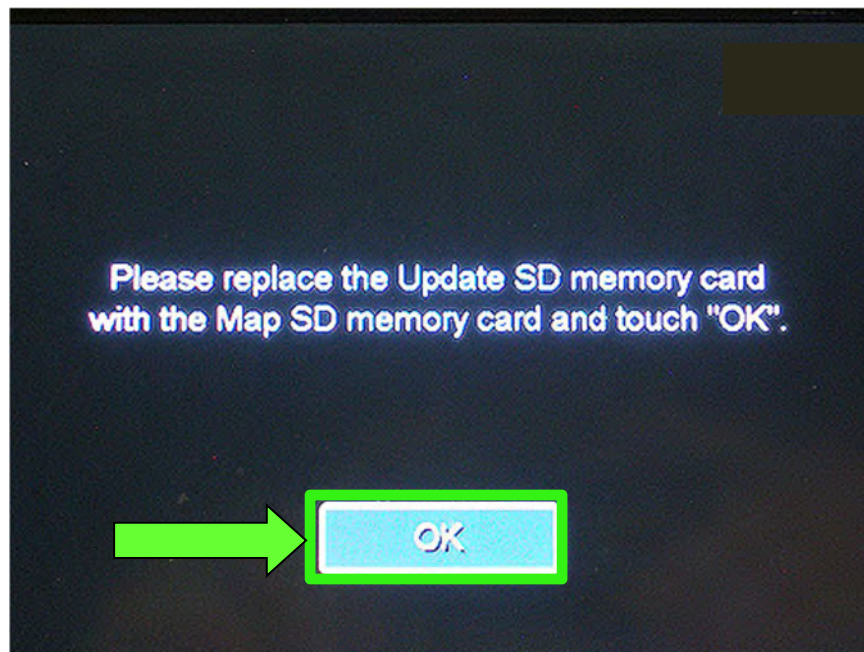
Figure 13

13. Remove J-52812-27 from the SD card slot.
14. Insert the MAP SD card.
15. Select **OK** (Figure 13).

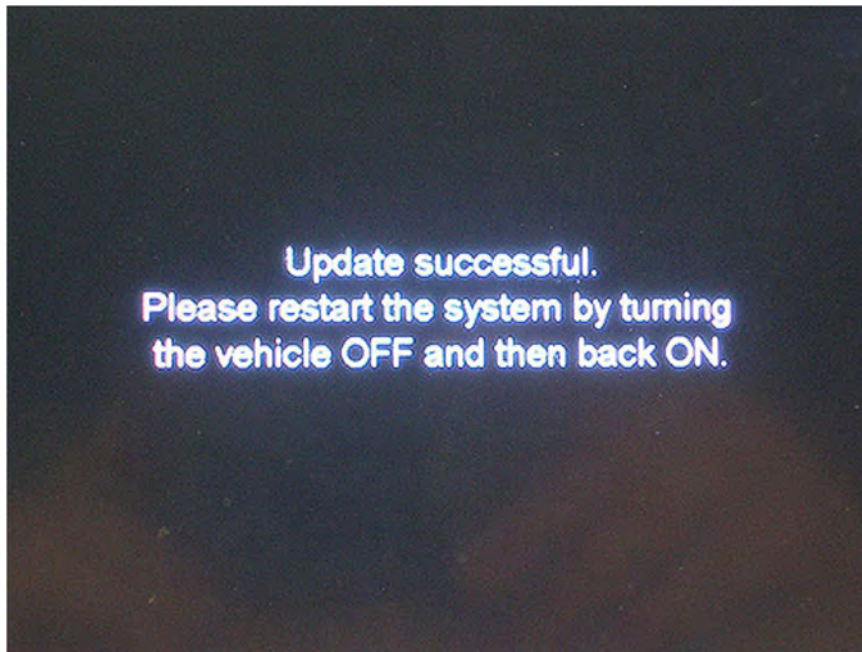
- After selecting **OK**, the screen in Figure 14 should display after 1-2 minutes.
