TECHNICAL INSTRUCTIONS

Safety (Noncompliance) Recall 19TA19 Certain 2020 Model Year Supra Vehicles Back Up Camera Display - Brightness and Contrast Settings

V. OVERVIEW OF REMEDY PROCEDURE (REPROGRAMMING USING ISTA)

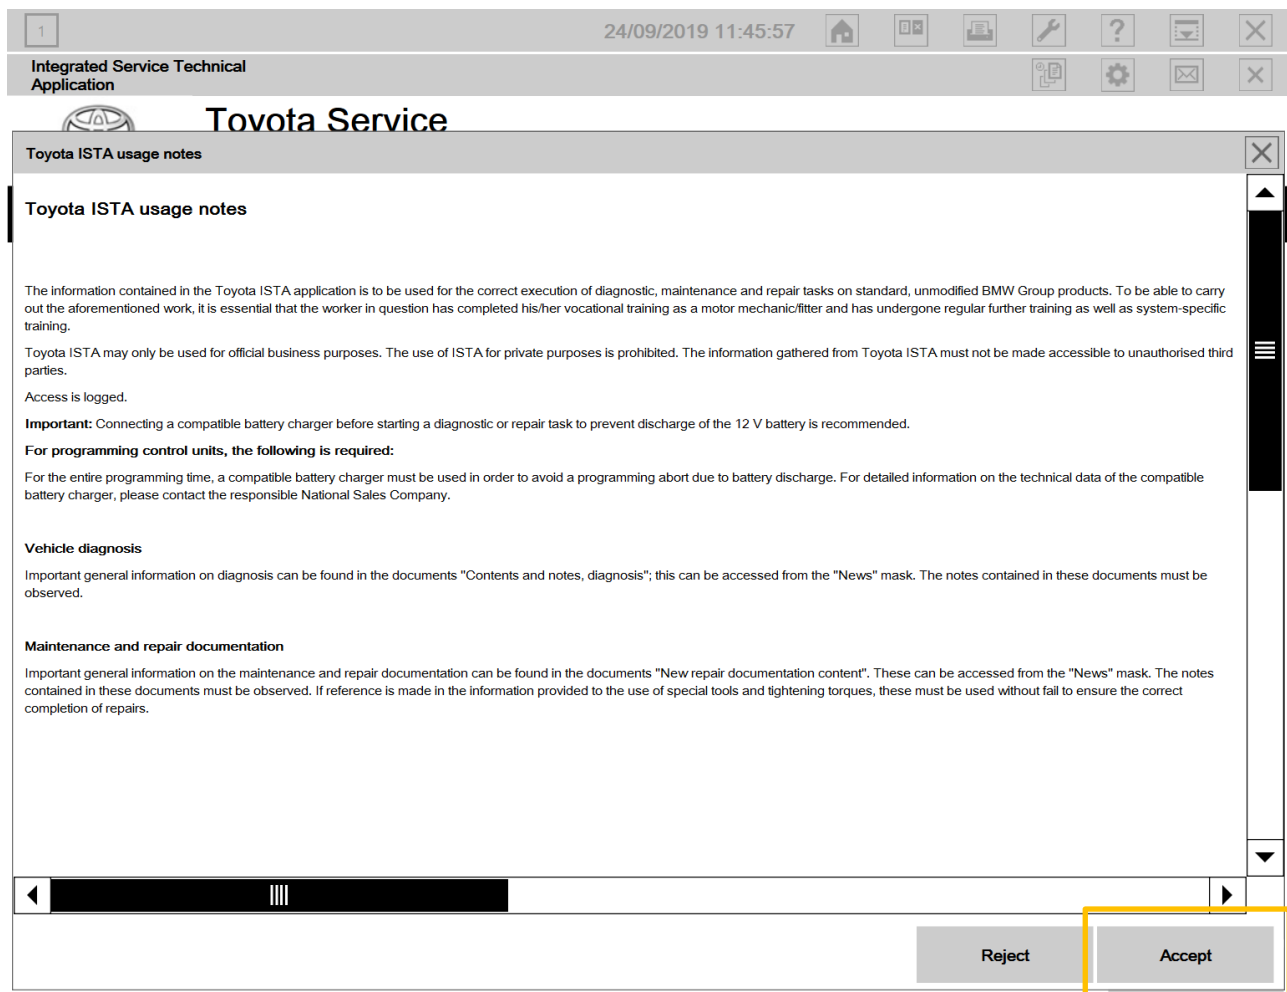
3. The following screen appears. Click “accept”.

A screenshot of the Toyota Service application interface. At the top, there is a status bar with the date and time '24/09/2019 11:45:57' and several icons. Below this is a title bar for 'Integrated Service Technical Application'. The main window title is 'Toyota Service'. A dialog box titled 'Toyota ISTA usage notes' is open, displaying the following text:

At the bottom of the dialog box, there are two buttons: 'Reject' and 'Accept'. The 'Accept' button is highlighted with a yellow border.

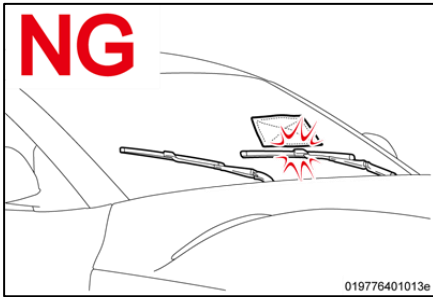
3. **DO NOT** place anything on the windshield so that the wiper can work normally, because the wiper may move automatically during reprogramming for initialization.

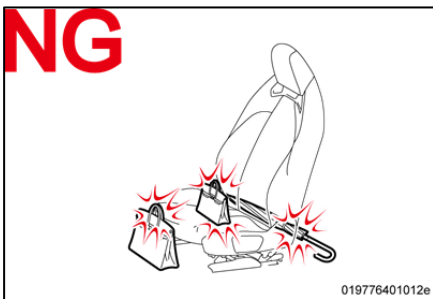
5. **DO NOT** place any on, in front of, or behind the front seats because the front seats move automatically during reprogramming for initialization.

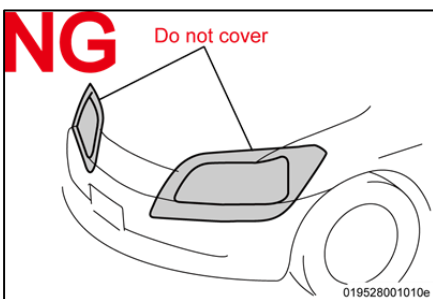
6. **DO NOT** cover the headlights with protective covers because temperature may rise and the headlights may be deformed or damaged.

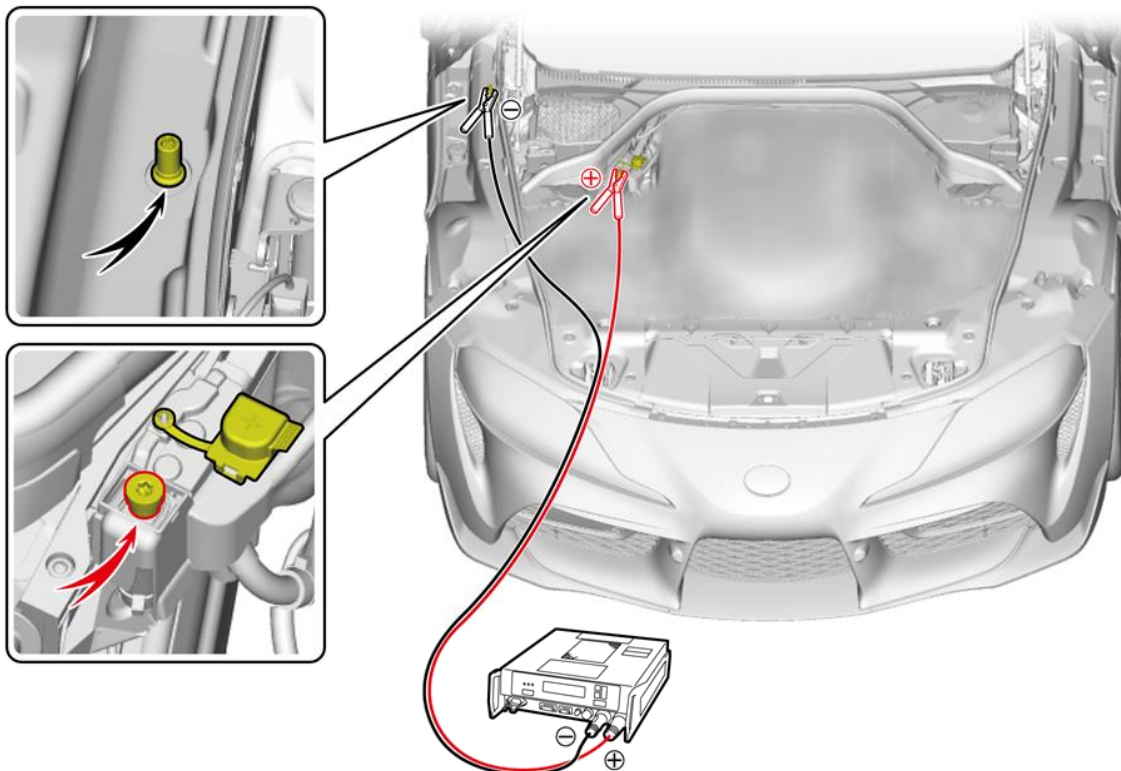
Connect Battery Charger

- Always connect the power supply of the battery charger to an outlet directly. If a power strip or other device is used, and multiple electrical components are connected, the battery charger may detect a power supply error due to insufficient current, and it may not be possible to charge the battery.
- Make sure that the battery charger is off before connecting it.
- Make sure you respect the correct polarity when connecting the battery charger cables like displayed in the illustration below.
- **DO NOT** disconnect the battery charger during reprogramming work.

Before starting the reprogramming procedure, please make sure you have connected the DCA-8000 battery charger. The usage of a charger during the ECU Software update process is mandatory.

During this reprogramming the headlights will turn on, and the seats and other electrical components will function. To prevent damage to the ECU's, due to flat battery or voltage drop, ALWAYS connect the specified battery charger.

Unlike other Toyota vehicles, the new Toyota Supra is capable of drawing high amperage (a peak of 70 Amps flows at maximum) during diagnosis and repair. The Toyota Supra is equipped with an AGM type battery, discharges will affect the life span of the battery. AGM batteries must not have a charging voltage that exceeds 14.6 volts.

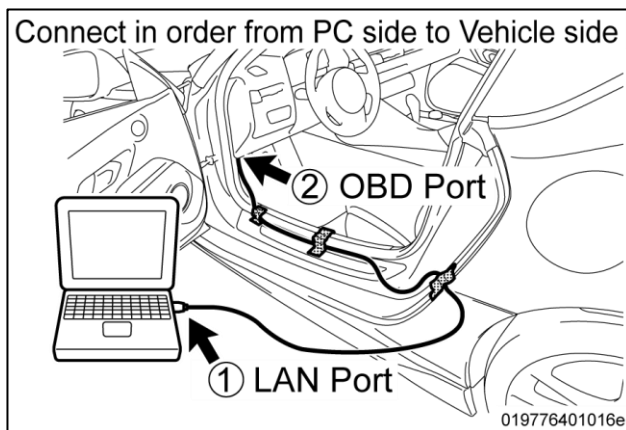
1. Connect the Cable (connection sequence):

Always connect the SUPRA diagnostic cable **first** to your **PC LAN port (1)** and only after that to the **OBD port of the vehicle (2)**.

If this order of operations is not respected, possible vehicle communication issues may occur when using Toyota ISTA software.

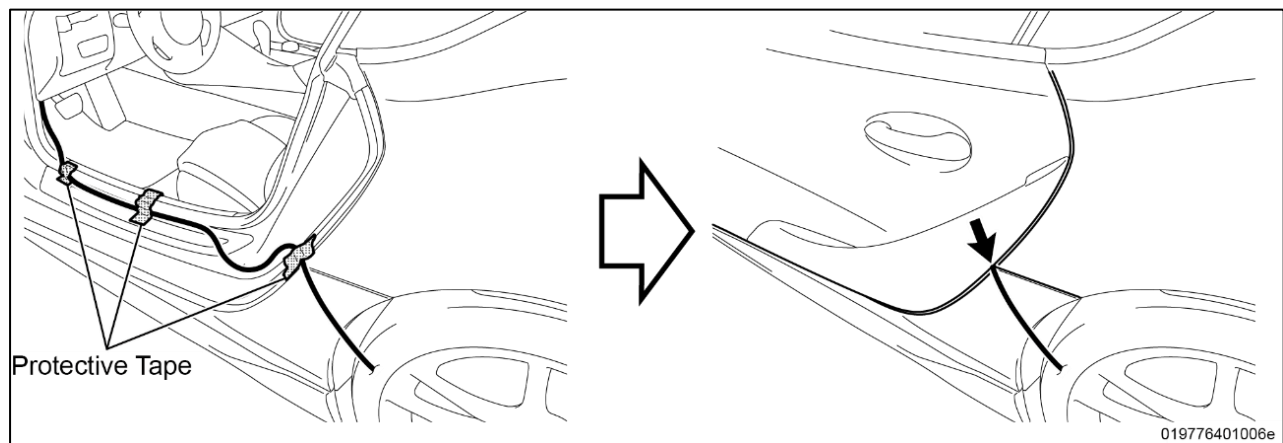
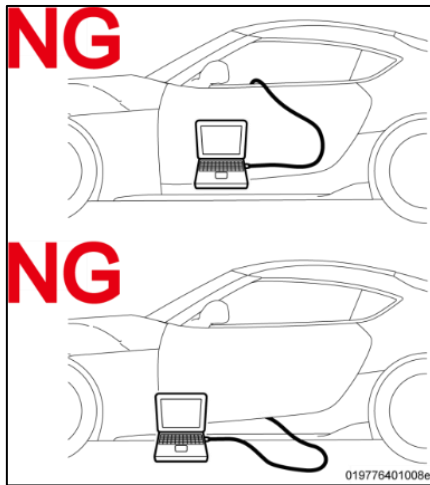
The Toyota Supra Diagnostic cable should always be passed through the position shown in the figure below. If it passes through any other position it is possible that the cable will be damaged.

Using the gap between the rear fender and the side garnish, pull the Supra Diagnostic cable to the outside of the vehicle. Please use protective tape for fixation and protection of the cable.

Do not attempt to pass the Supra Diagnostic cable through the window opening. The window glass may move during reprogramming or initialization.

Ensure the cable is out of the path of the front Driver's seat. During initialization the driver's seat moves and could damage cable or disconnect the OBDII connector during movement.

Position the SUPRA diagnostic cable out of the vehicle as shown in the illustration. Otherwise the **SUPRA diagnostic cable may be pinched, communication disconnected, and ECU's permanently damaged.**

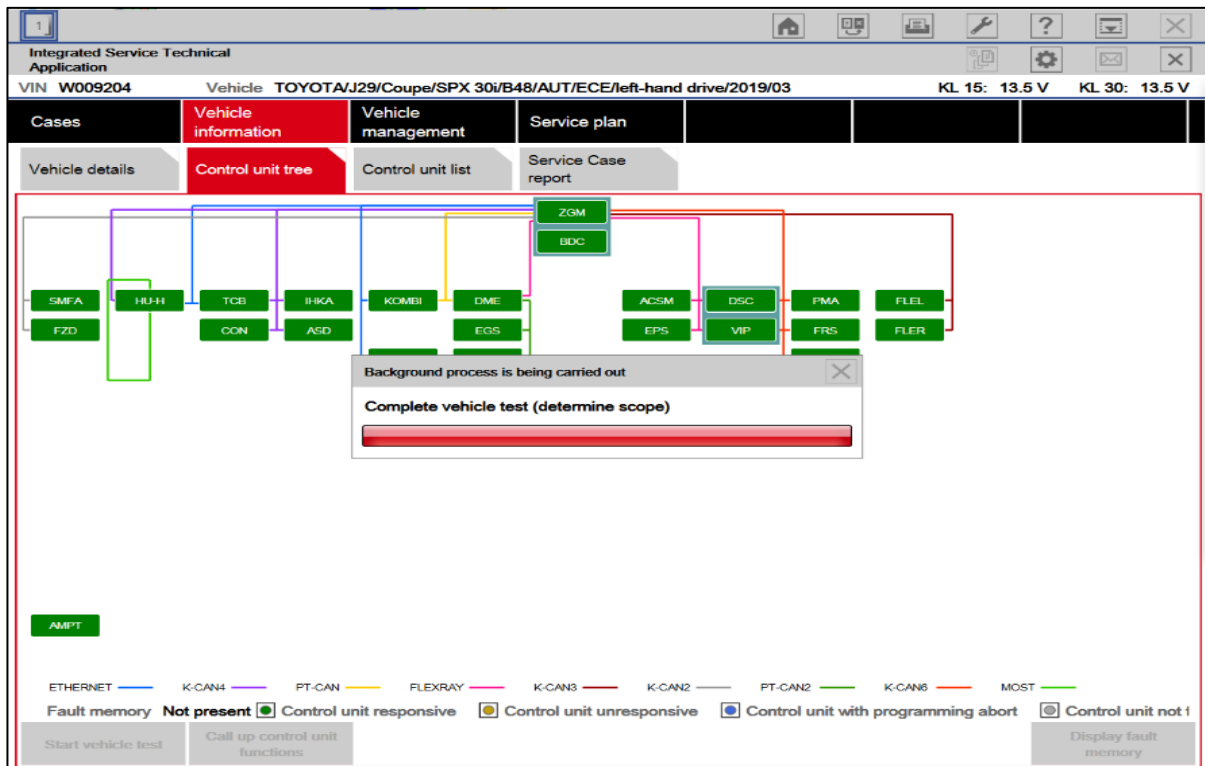
8. The identification of all ECU's will start as shown below.

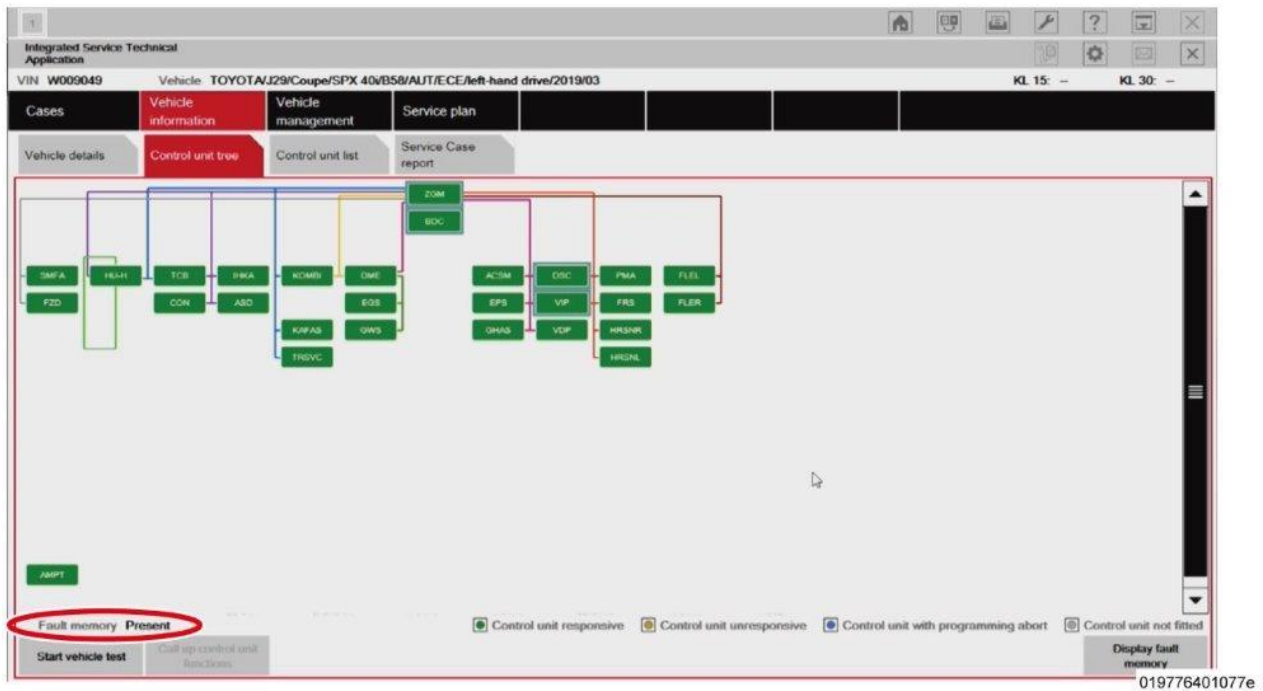
9. The control unit screen will appear after the identification has ended.

NOTICE: When Fault memory “Present” or “Existing” is displayed at the bottom left of the screen, check for DTCs. Note that this campaign does not cover the diagnostic fees and/or repairs for any DTC’s/

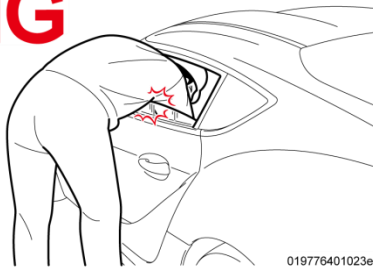
NG

1. **DO NOT** put your head or hand in the window of the vehicle you are reprogramming. Since the window may close automatically at the time of initialization, there is the risk of being pinched and injured.

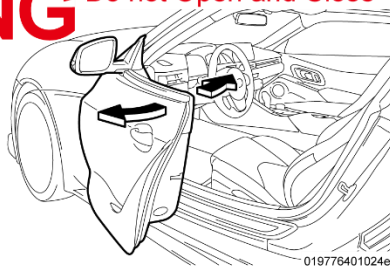
NG Do not Open and Close

2. **DO NOT** open or close the driver's door and other door during the programming routine.

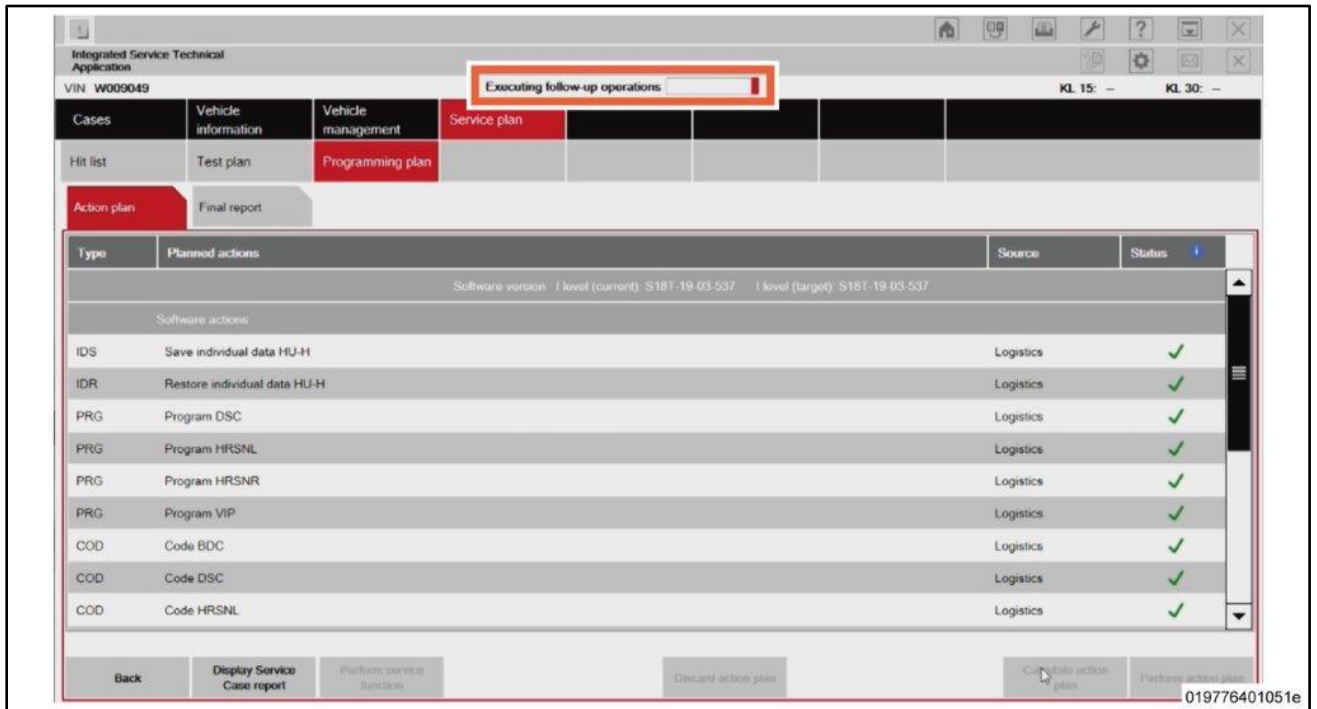
8. Executing follow-up operations is displayed in the center of the screen.

Integrated Service Technical Application
VIN W009049
Executing follow-up operations
KL 15: - KL 30: -

Type	Planned actions	Source	Status
Software version: I level (current): S18T-19-03-537 I level (target): S18T-19-03-537			
Software actions			
IDS	Save individual data HU-H	Logistics	✓
IDR	Restore individual data HU-H	Logistics	✓
PRG	Program DSC	Logistics	✓
PRG	Program HRSNL	Logistics	✓
PRG	Program HRSNR	Logistics	✓
PRG	Program VIP	Logistics	✓
COD	Code BDC	Logistics	✓
COD	Code DSC	Logistics	✓
COD	Code HRSNL	Logistics	✓

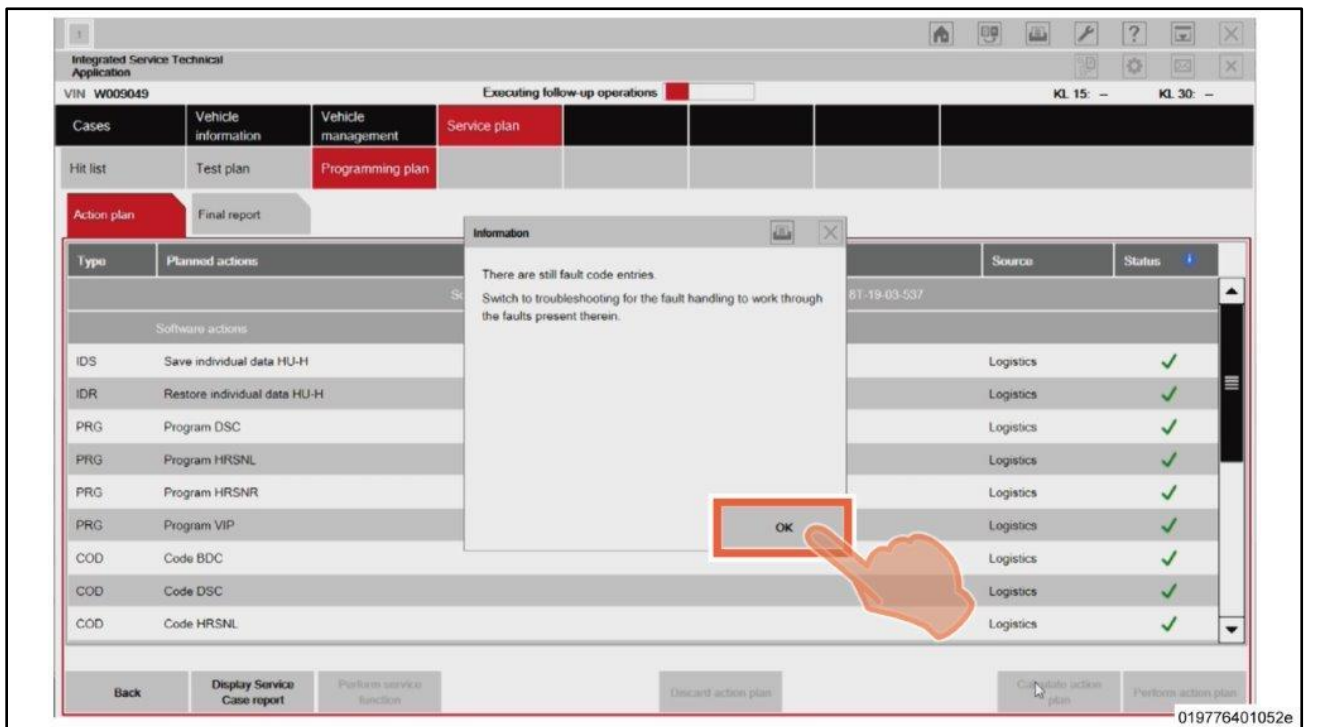
Notice: If the following “Information” dialog box is displayed during “Executing follow-up operation”, click “OK” to continue the follow-up operation. After reprogramming is complete, follow the on-screen instructions and carry out initialization and other work.

Integrated Service Technical Application
VIN W009049
Executing follow-up operations
KL 15: - KL 30: -
