2007-2012 CX-7, 2007-2015 CX-9, 2009-2013 MAZDA6 - PASSENGER AIR BAG SAFETY RECALL 1317F

B. REPAIR PROCEDURE

Passenger-Side Air Bag Inflator Replacement Procedure:

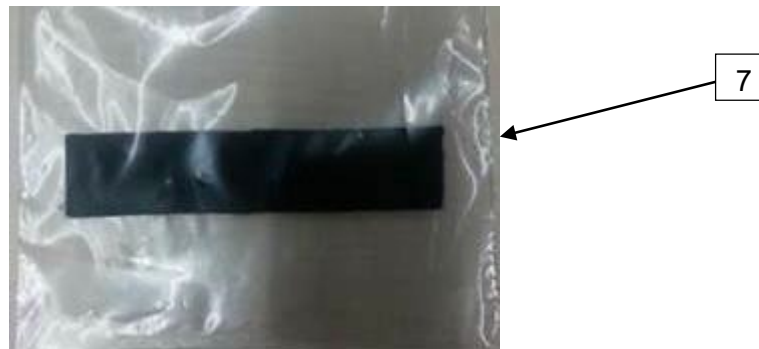
Felt Tape as needed for repairs as outlined in red in the repair instructions.

The Felt Tape will come in a plastic bag, (2) pcs of felt onto (1) liner. Each Piece is 20mm x 50mm. The center of the liner is kiss-cut so it bends so that each piece of felt can easily peel off. The bag is 5" x 7".

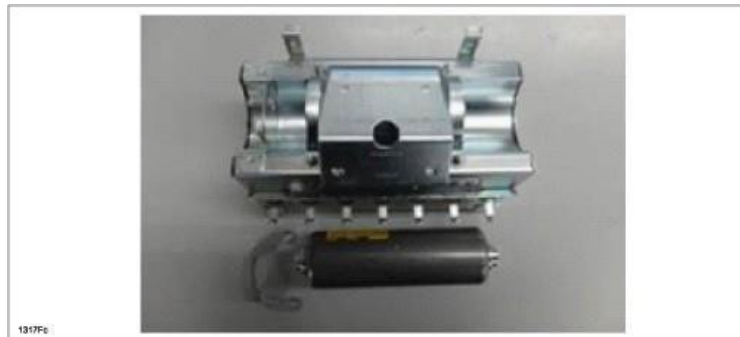
2. Remove the stopper plate and inflator.

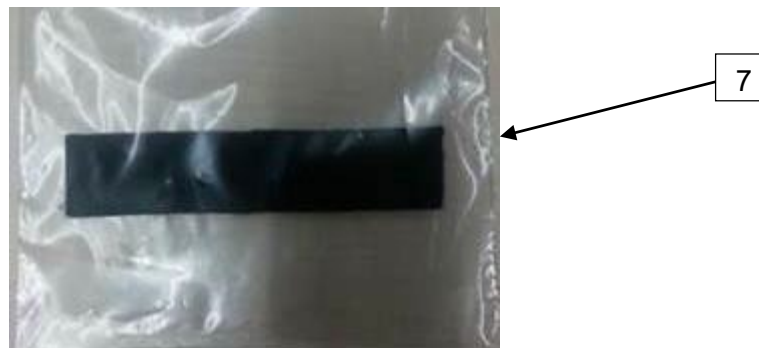
Felt Tape as needed for repairs as outlined in red in the repair instructions

The Felt Tape will come in a plastic bag, (2) pcs of felt onto (1) liner. Each Piece is 20mm x 50mm. The center of the liner is kiss-cut so it bends so that each piece of felt can easily peel off. The bag is 5" x 7".

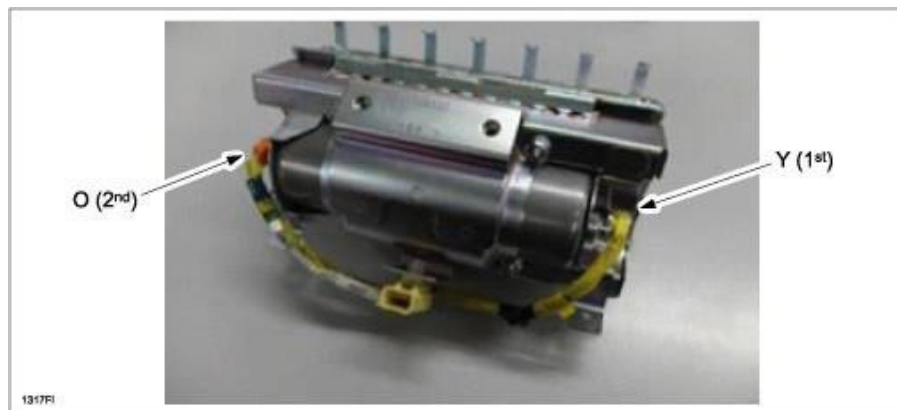
NOTE: To show the air bag module more clearly, the instrument panel trim was removed.

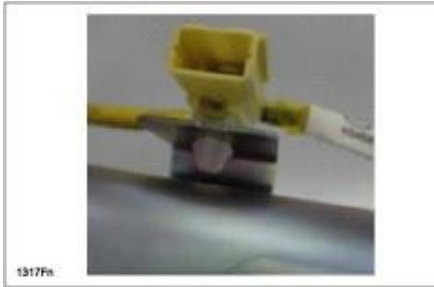
- b. Remove the clip from the coupler.

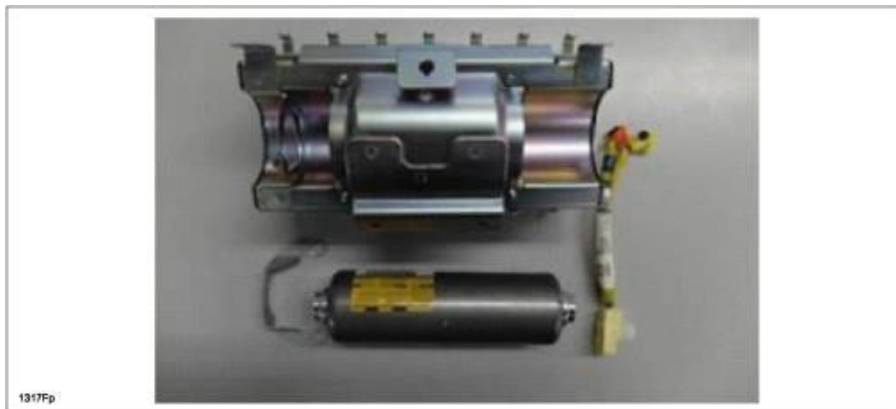
- 3. Remove the stopper plate and inflator.

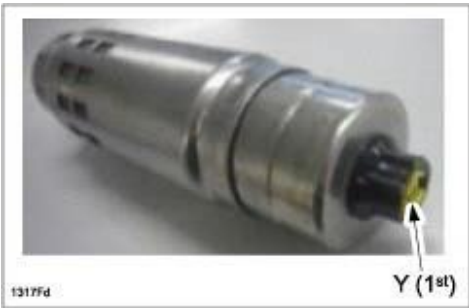
<p>1317Fd Y (1st)</p>

NOTE: Make sure to orientate the 1st and 2nd stage direction before inserting it into the retainer.

1st stage (Yellow connector)	2nd stage (Orange connector)

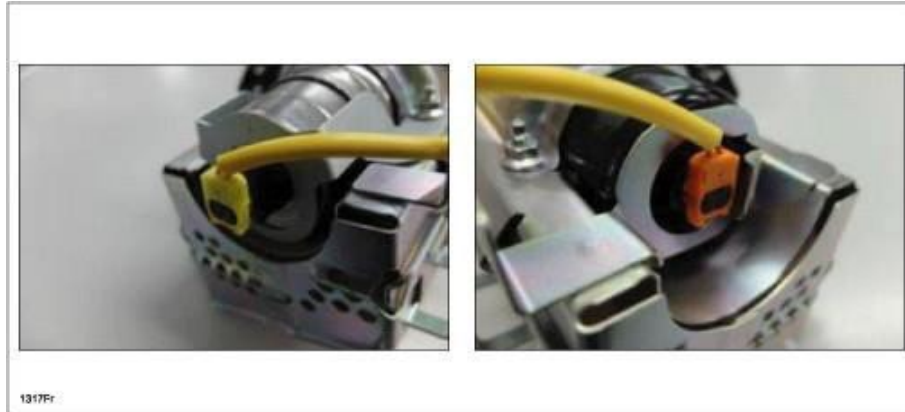
9. Connect the replacement wire harness at 2 locations.
 - a. Make sure the connectors are fitted properly.

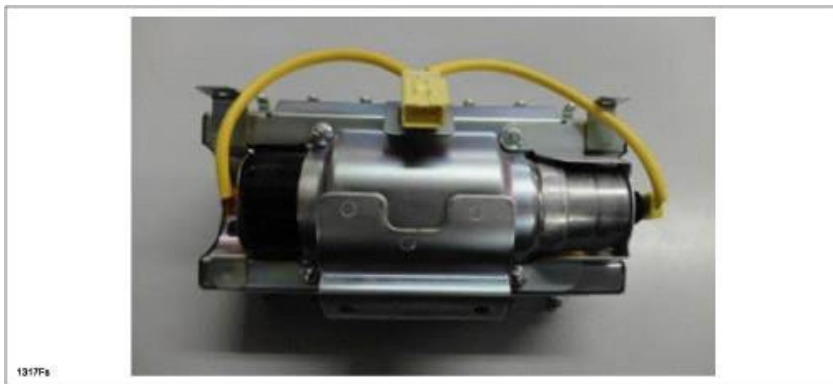
- b. The connectors direction is perpendicular to the bottom of the retainer.

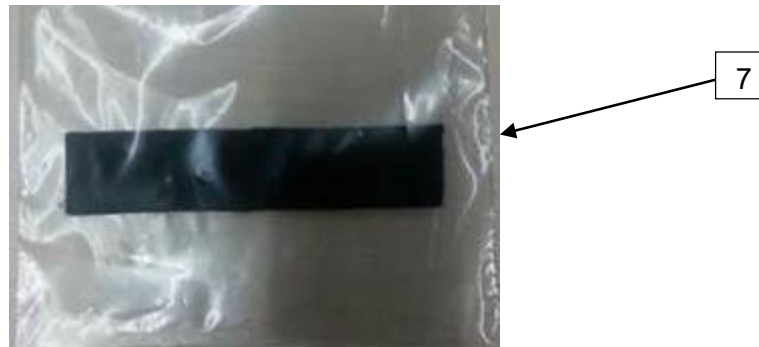
Felt Tape as needed for repairs as outlined in red in the repair instructions

The Felt Tape will come in a plastic bag, (2) pcs of felt onto (1) liner. Each Piece is 20mm x 50mm. The center of the liner is kiss-cut so it bends so that each piece of felt can easily peel off. The bag is 5” x 7”.

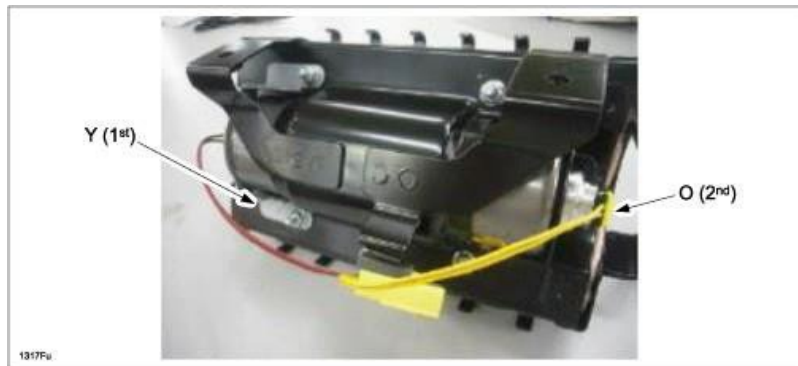
1. **To prevent the inflator from exploding by mistake during its removal, short-circuit the harnesses.**

NOTE: The harness will not be reused after shorting it.

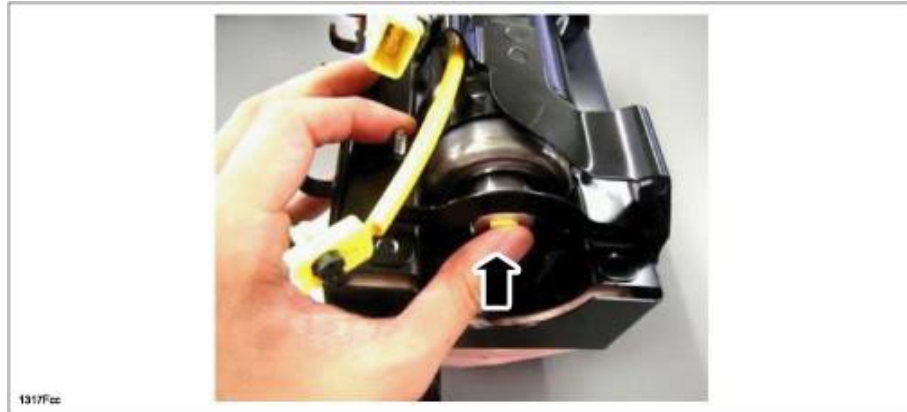
4. Push the inflator end with fingers, then remove it by sliding it in the direction shown.

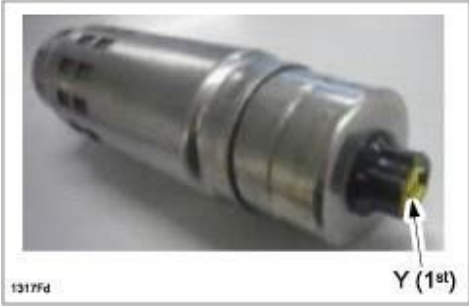
NOTE: Make sure to orientate the 1st and 2nd stage direction before inserting it into the retainer.

1st stage (Yellow connector)	2nd stage (Orange connector)

<p>A photograph of a cylindrical metal inflator. The front end has a yellow connector. An arrow points to the yellow connector with the label 'Y (1st)'. A small code '1317Fd' is in the bottom left corner.</p>

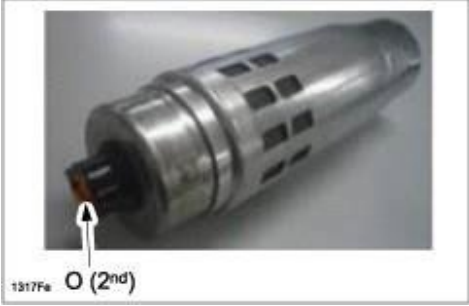
<p>A photograph of a cylindrical metal inflator. The front end has an orange connector. An arrow points to the orange connector with the label 'O (2nd)'. A small code '1317Fe' is in the bottom left corner.</p>

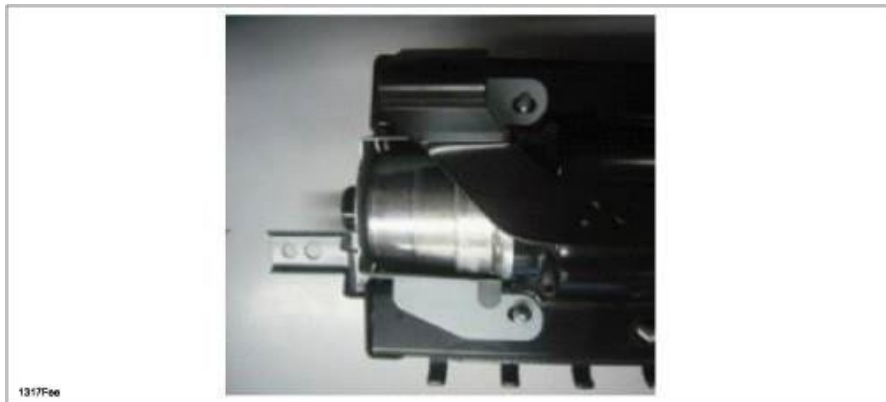
8. Install the new stopper to the retainer.

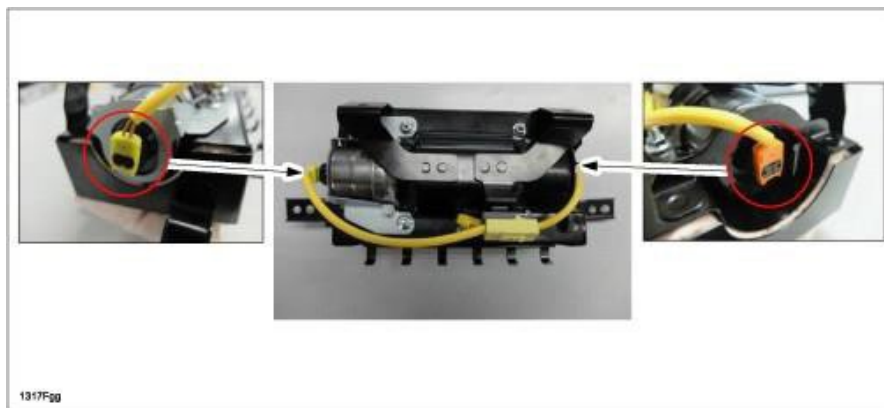
10. Connect the replacement wire harness at 2 locations.

NOTE: Make sure the connectors are fitted properly.
