## VOLUNTARY SAFETY RECALL CAMPAIGN FLEET AND NEW INVENTORY 2017-2019 QX60; ABS ACTUATOR

**CAMPAIGN ID #:** R1921  
**APPLIED VEHICLES:** 2017-2019 QX60 (L50)

Infiniti is conducting this voluntary safety recall campaign on certain specific model year 2017-2019 QX60 vehicles that are in fleet or new inventory to replace the ABS Actuator and Electric Unit (ABS control unit). This service will be performed at no charge to the customer for parts or labor.

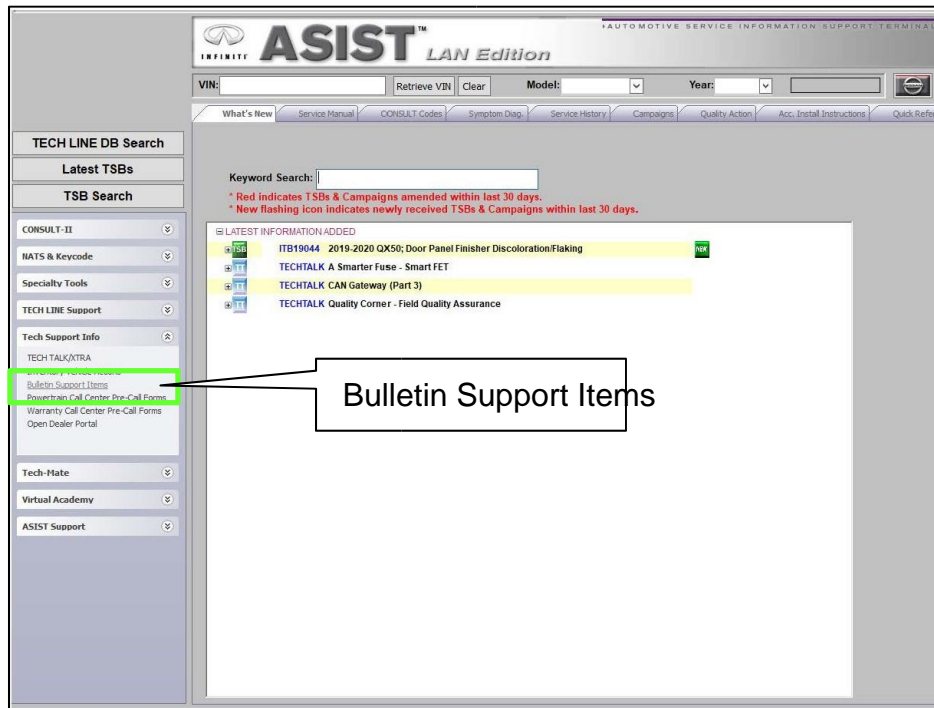
Figure 1

- a. Select **Bulletin Support Items**.

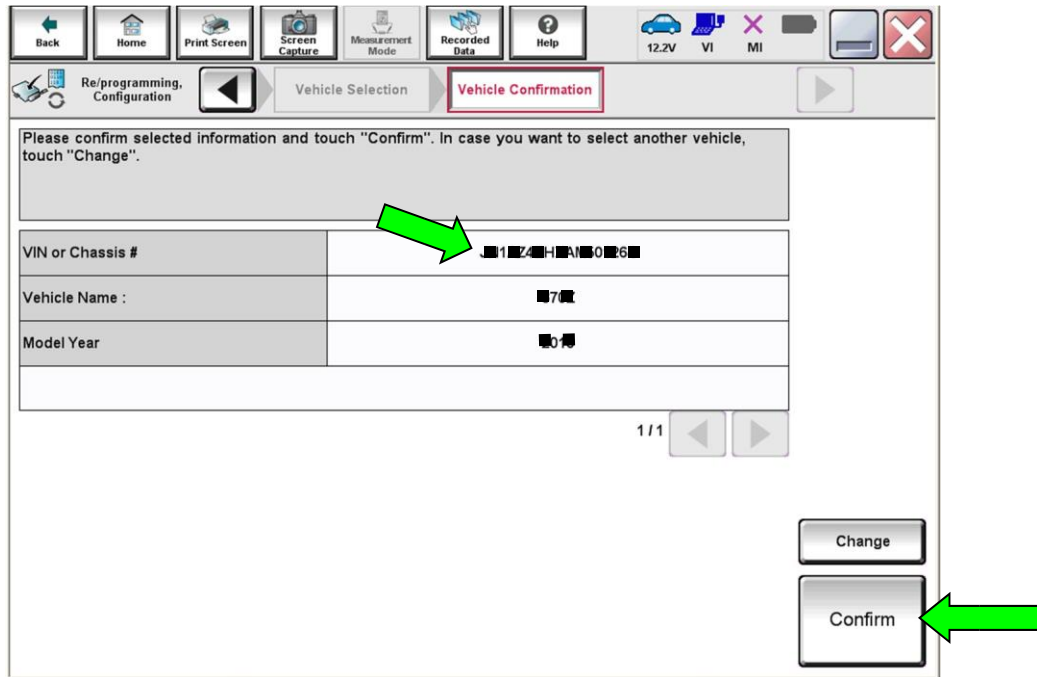
Figure 7

12. Make sure **VIN or Chassis #** matches the vehicle's VIN.

13. Select **Confirm**.

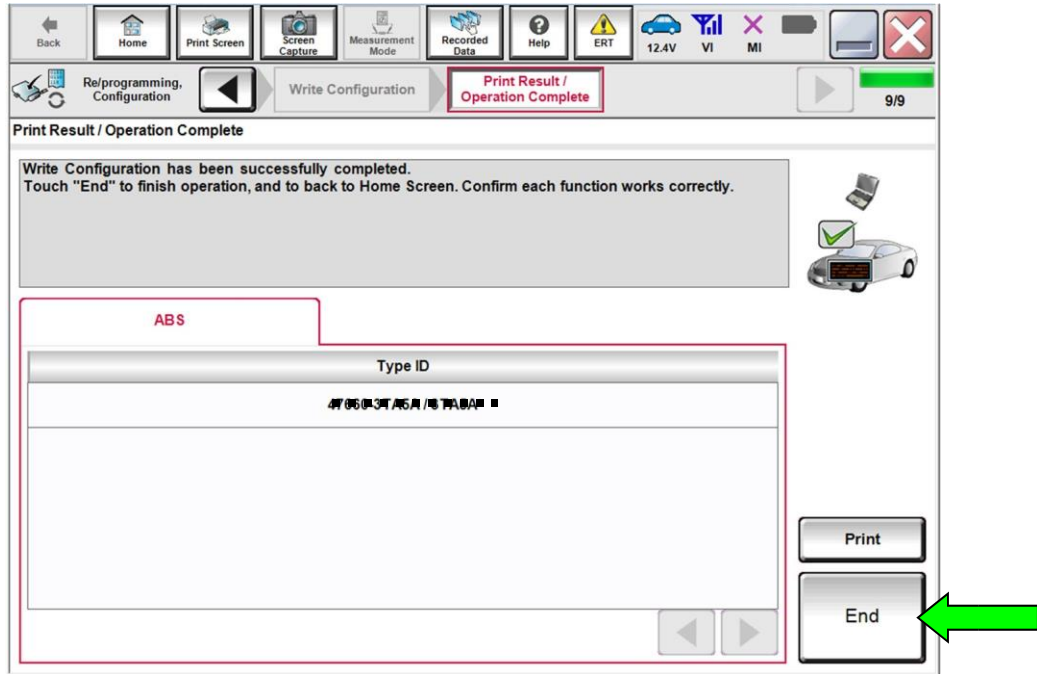
Figure 13

21. Configuration is complete, select **End**.
