RECALL CAMPAIGN BULLETIN

VOLUNTARY SAFETY RECALL CAMPAIGN FLEET AND NEW INVENTORY 2016-2018 MAXIMA, 2015-2018 MURANO AND 2017-2019 PATHFINDER; ABS ACTUATOR

CAMPAIGN ID #: R1920
APPLIED VEHICLES: 2016-2018 Maxima (A36)
2015-2018 Murano (Z52)
2017-2019 Pathfinder (R52)

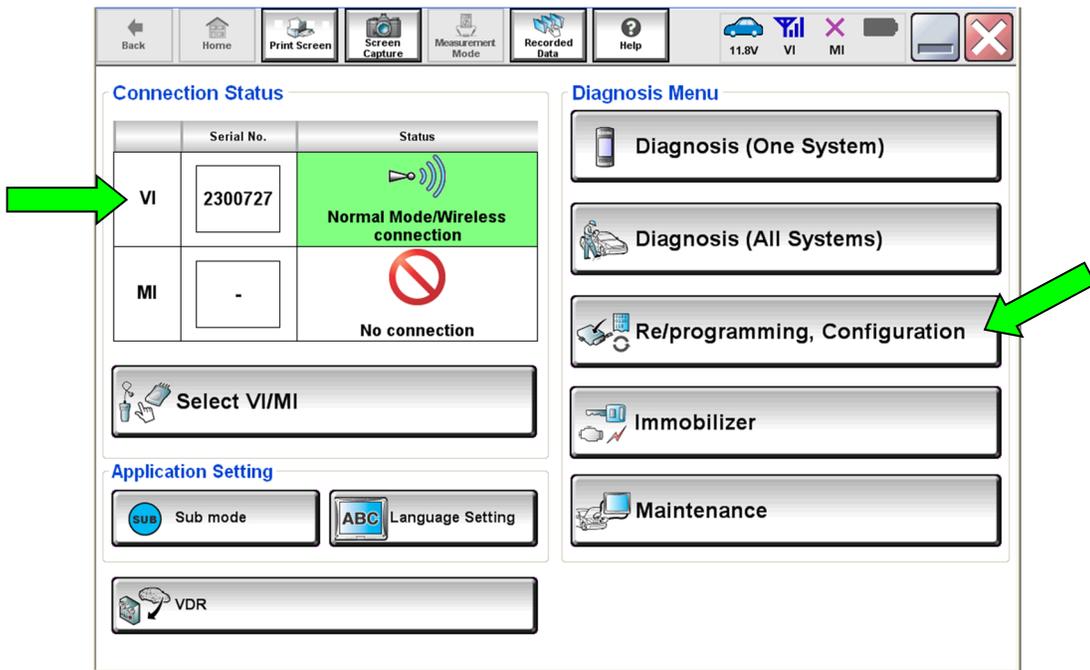
Figure 1

6. Select **Re/programming, Configuration**.

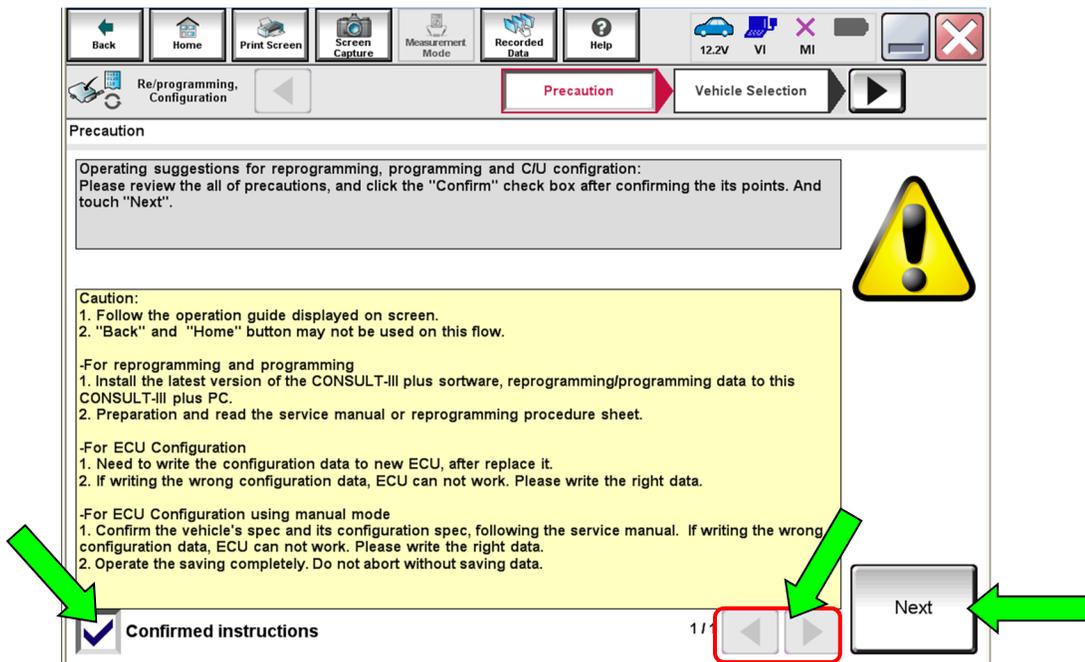
Figure 2

7. Use arrows (if needed) to view and read all precautions.
8. Check the box confirming the precautions have been read.
9. Select **Next**.

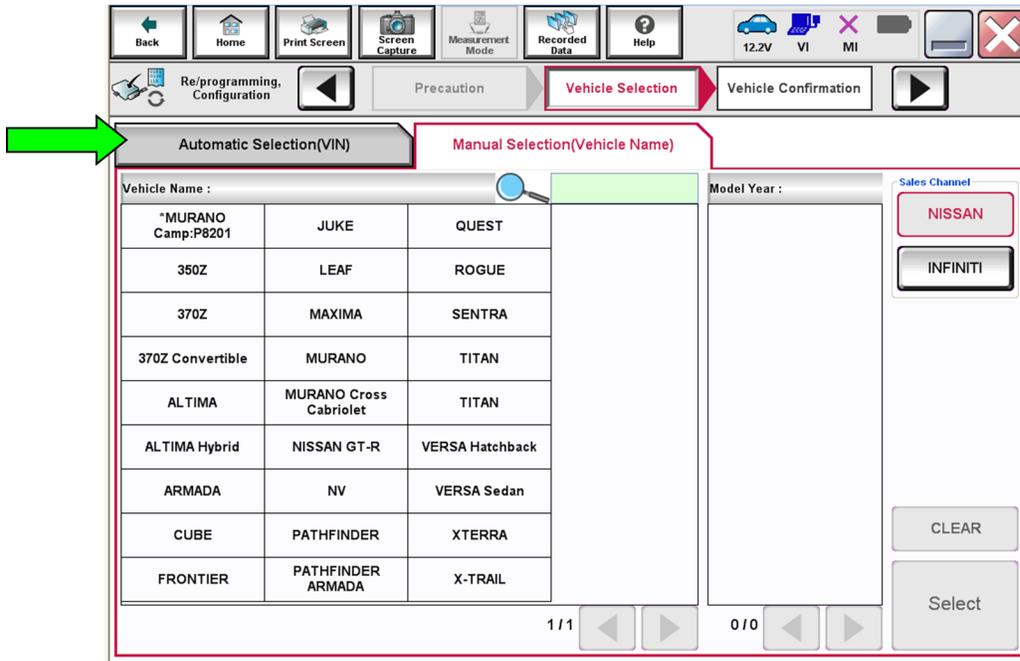
10. If the screen in Figure 3 displays, select **Automatic Selection(VIN)**.
 - If the screen in Figure 3 does not display, skip to step 11.

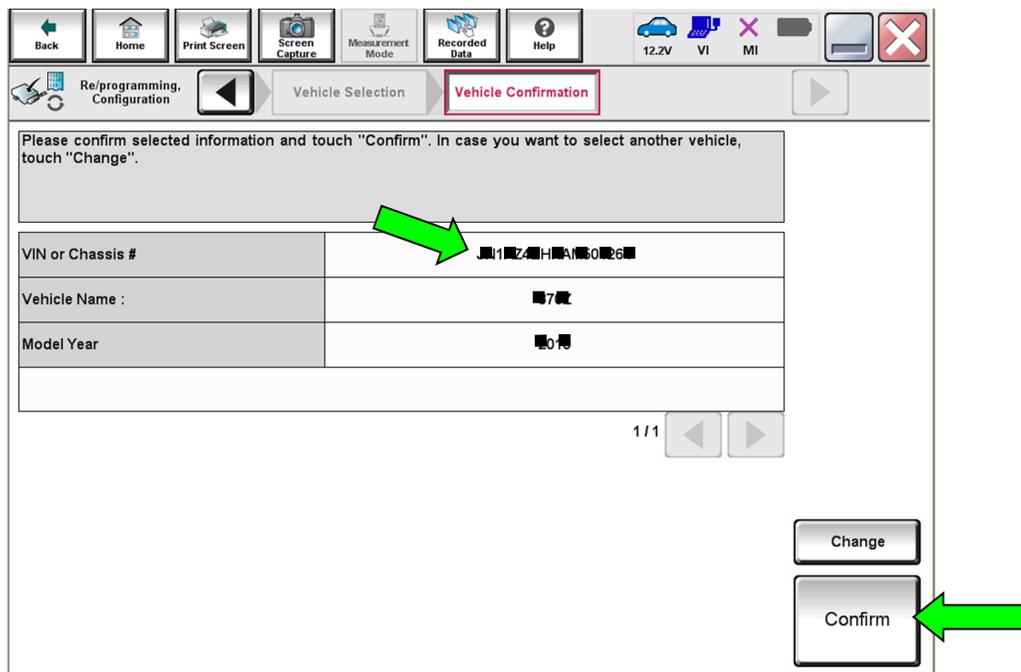
Figure 4

11. Make sure **VIN or Chassis #** matches the vehicle's VIN.
12. Select **Confirm**.

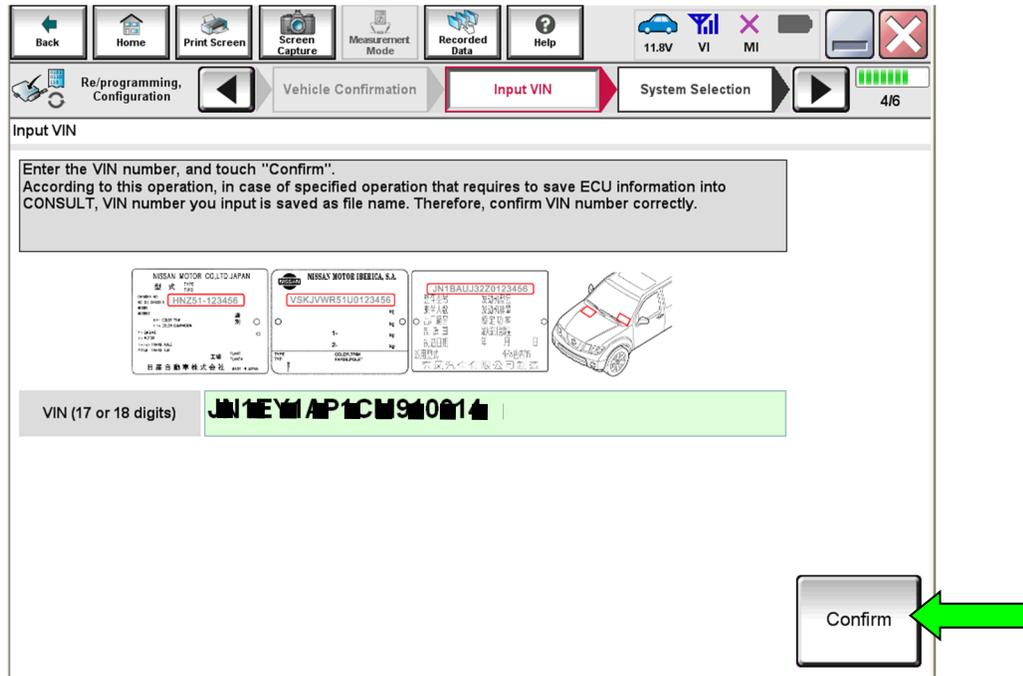
Figure 5

13. Select **Confirm**.

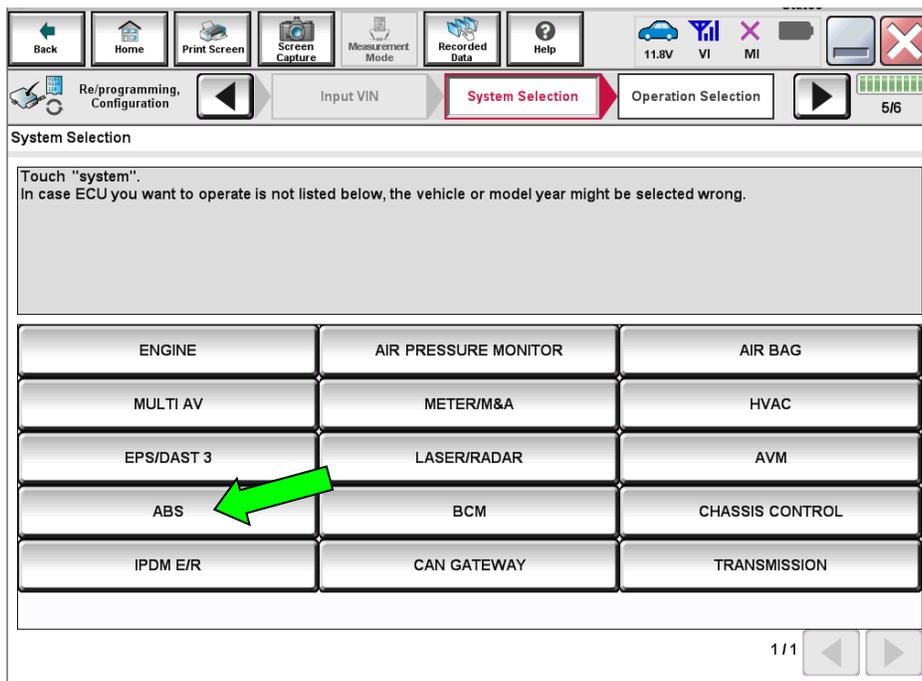
Figure 6

14. Select **ABS**.

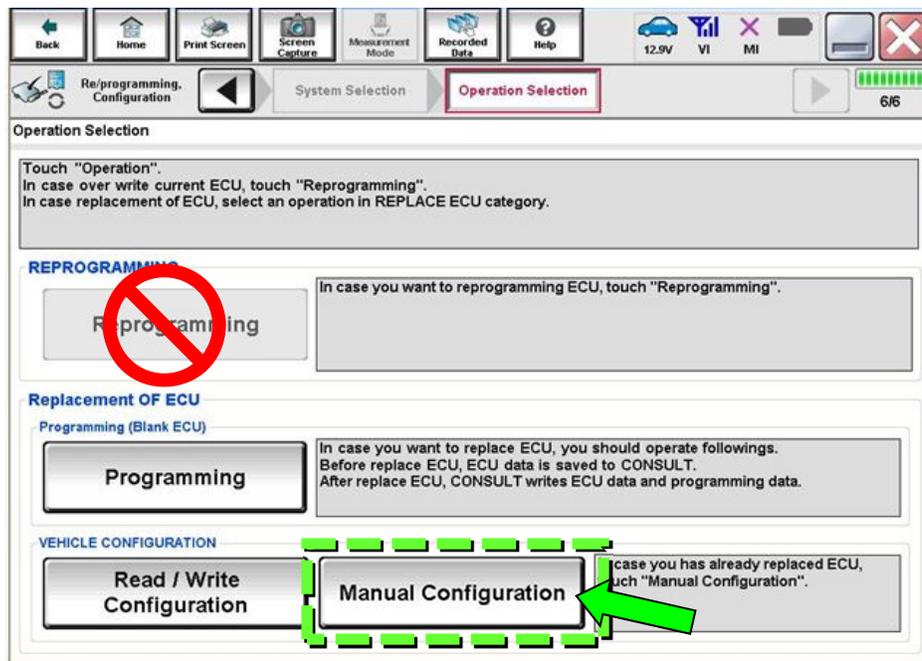
Figure 7

15. Select **Manual Configuration**.
 - **DO NOT** select Reprogramming.

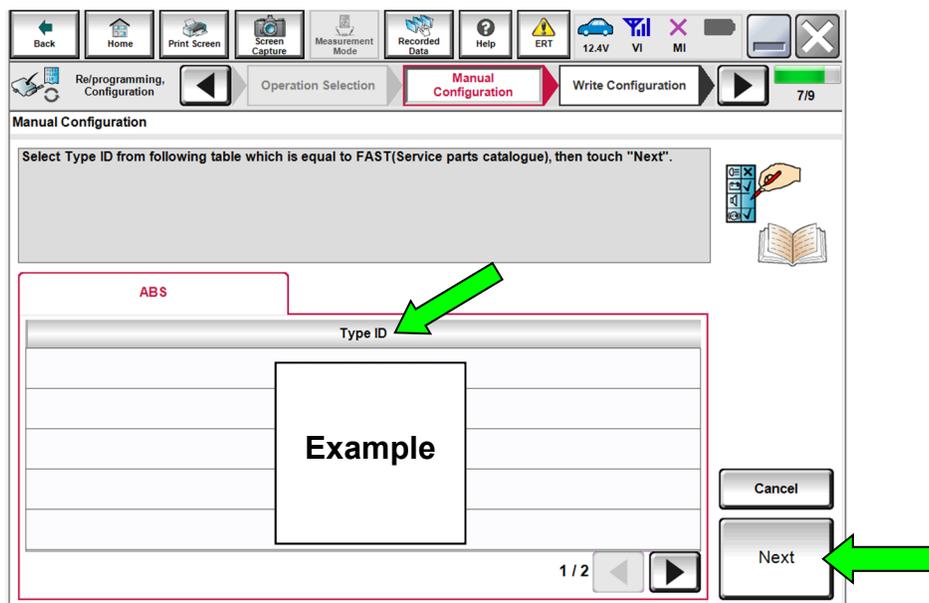
Figure 8

16. Select the correct **Type ID** number.
 - Refer to **Table A** (see page 7) for the correct **Type ID** number for the vehicle you are working on.
 - If needed, use scroll arrows to find the correct number.

NOTE: When a vehicle has only one configuration available, a list will not be displayed. Select **Next** (step 17), and C-III plus will select the correct configuration.

17. Select **Next**.

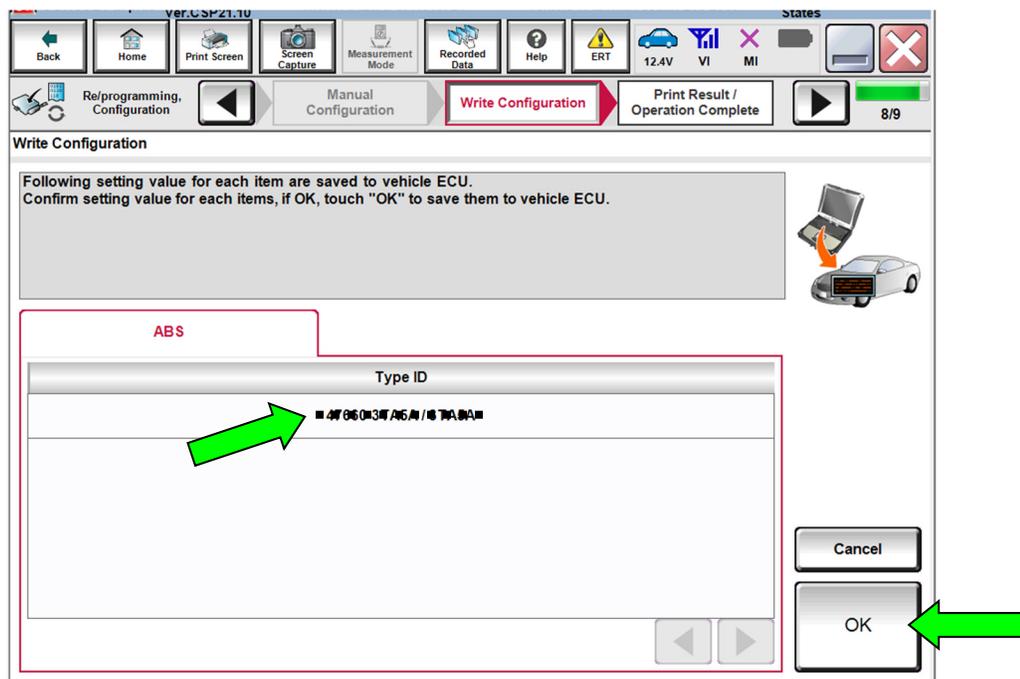
Figure 9

18. Confirm the correct Type ID number is selected.

19. Select **OK**.

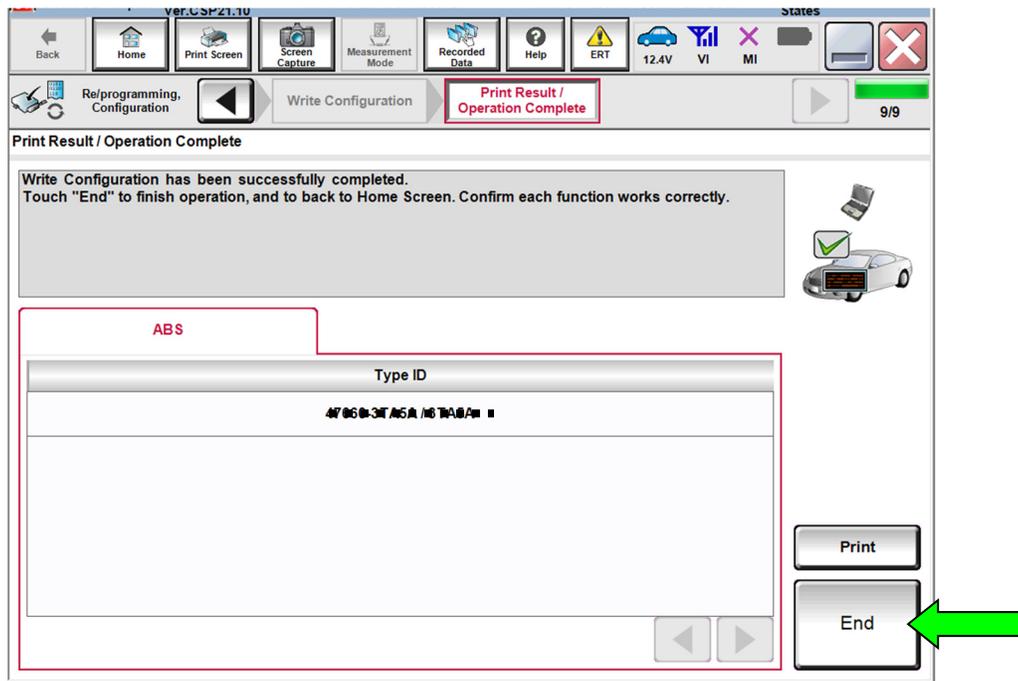
Figure 10

20. Configuration is complete, select **End**.
