VOLUNTARY SAFETY RECALL CAMPAIGN FLEET AND NEW INVENTORY 2017-2019 QX60; ABS ACTUATOR

CAMPAIGN ID #: R1921
APPLIED VEHICLES: 2017-2019 QX60 (L50)

Infiniti is conducting this voluntary safety recall campaign on certain specific model year 2017-2019 QX60 vehicles that are in fleet or new inventory to replace the ABS Actuator and Electric Unit (ABS control unit). This service will be performed at no charge to the customer for parts or labor.

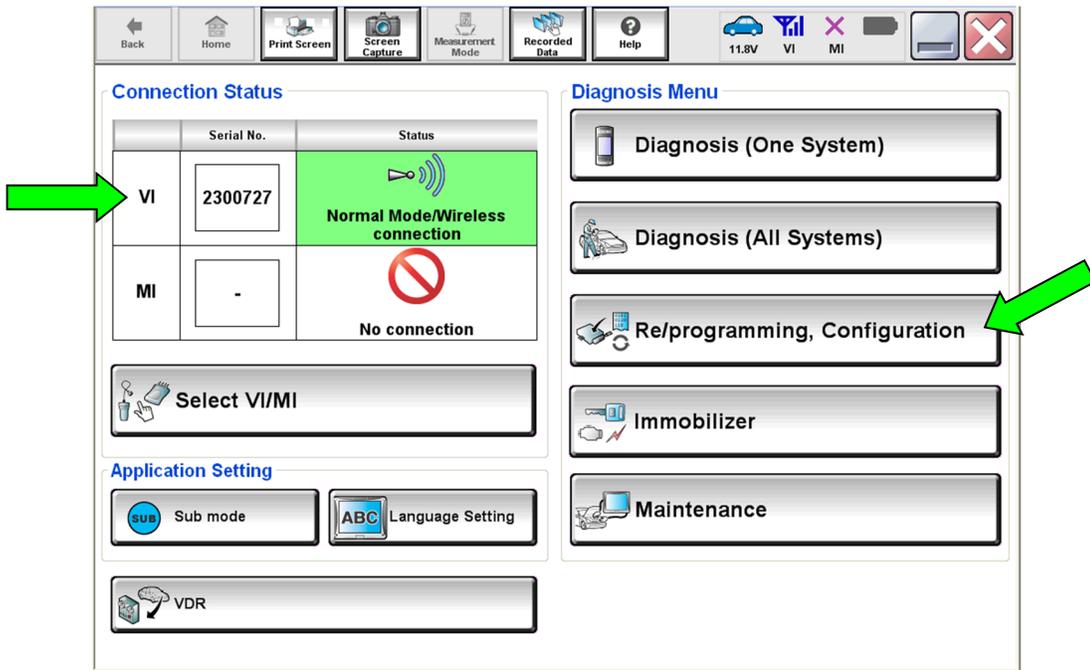
Figure 1

6. Select Re/programming, Configuration.

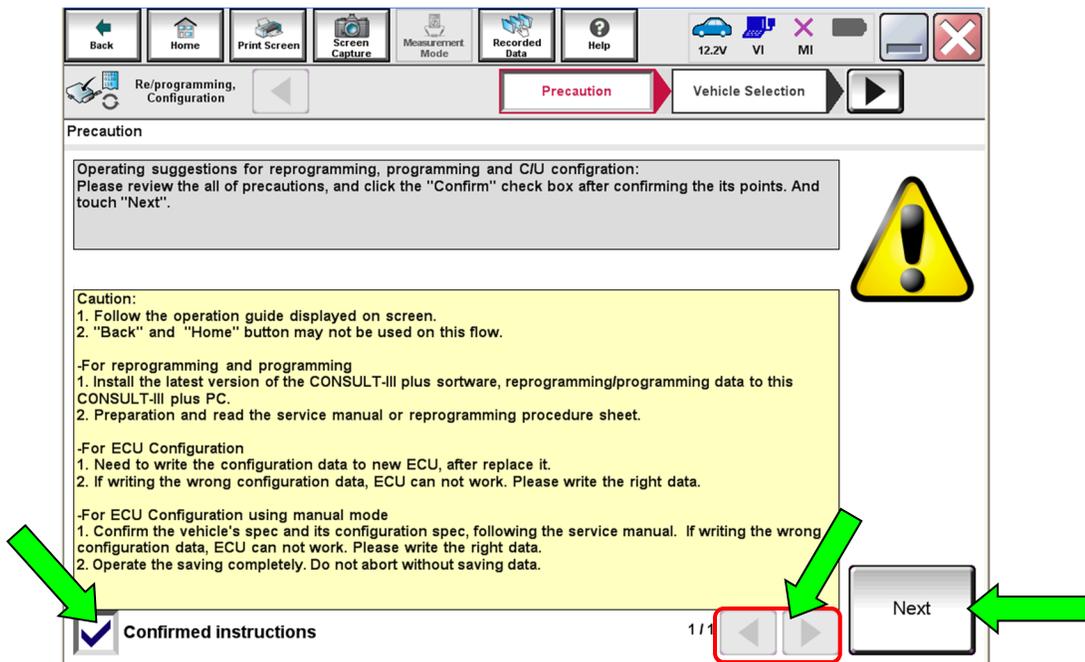
Figure 2

7. Use arrows (if needed) to view and read all precautions.
8. Check the box confirming the precautions have been read.
9. Select Next.

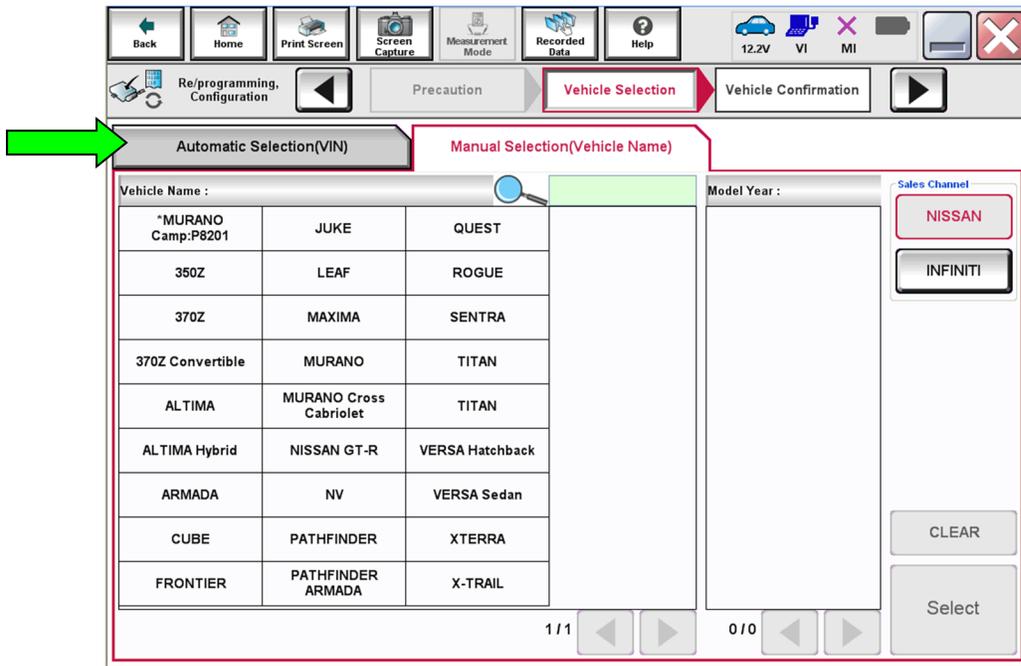
10. If the screen in Figure 3 displays, select **Automatic Selection(VIN)**.
 - If the screen in Figure 3 does not display, skip to step 11.

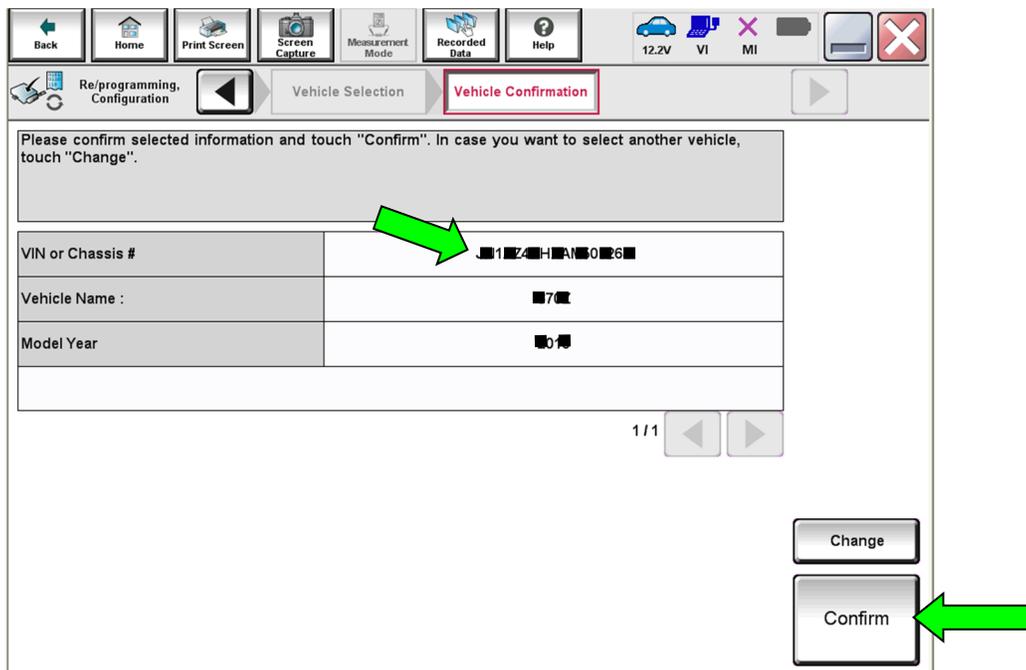
Figure 4

11. Make sure **VIN or Chassis #** matches the vehicle's VIN.
12. Select **Confirm**.

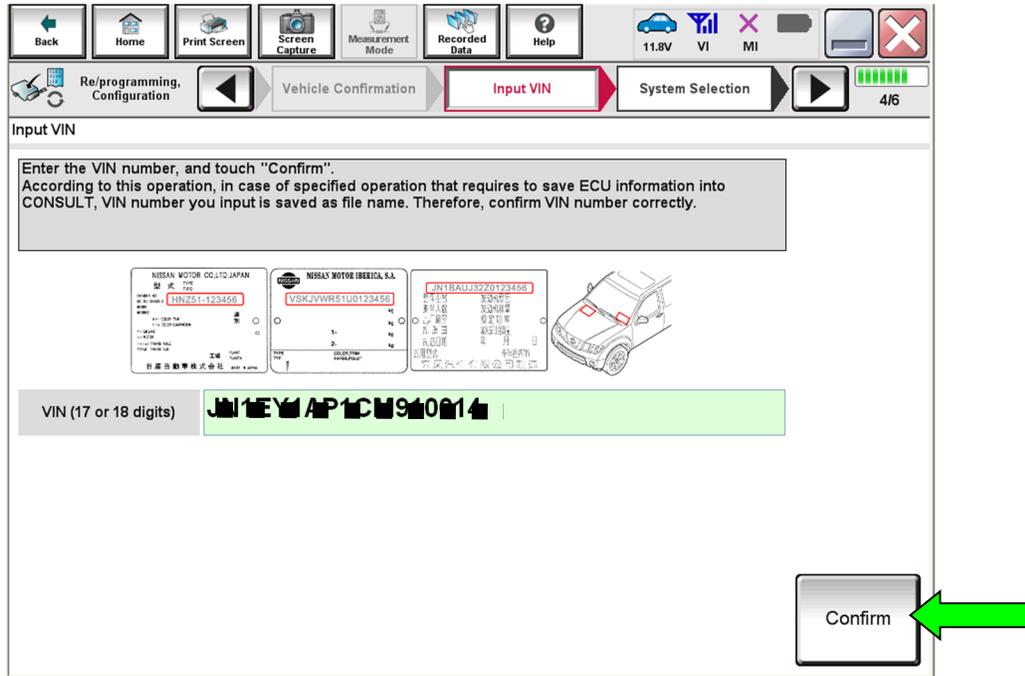
Figure 5

13. Select Confirm.

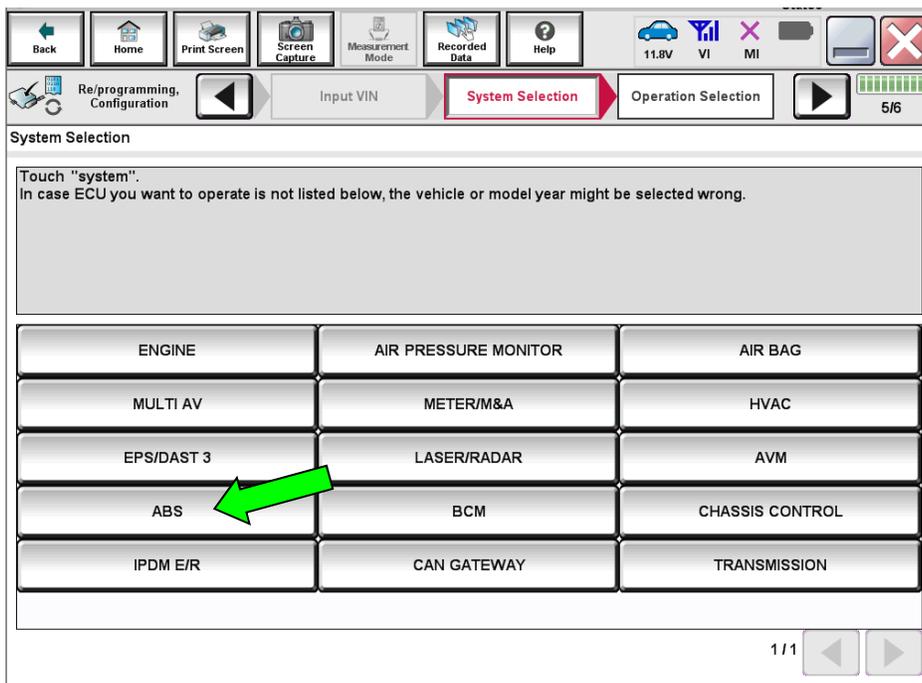
Figure 6

14. Select ABS.

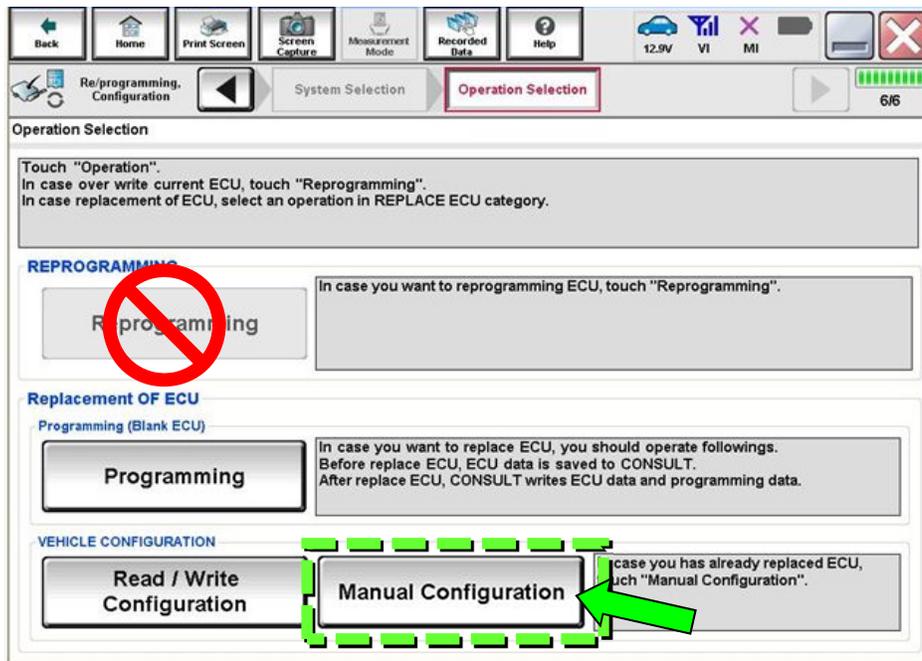
Figure 7

15. Select **Manual Configuration**.
 - **DO NOT** select Reprogramming.

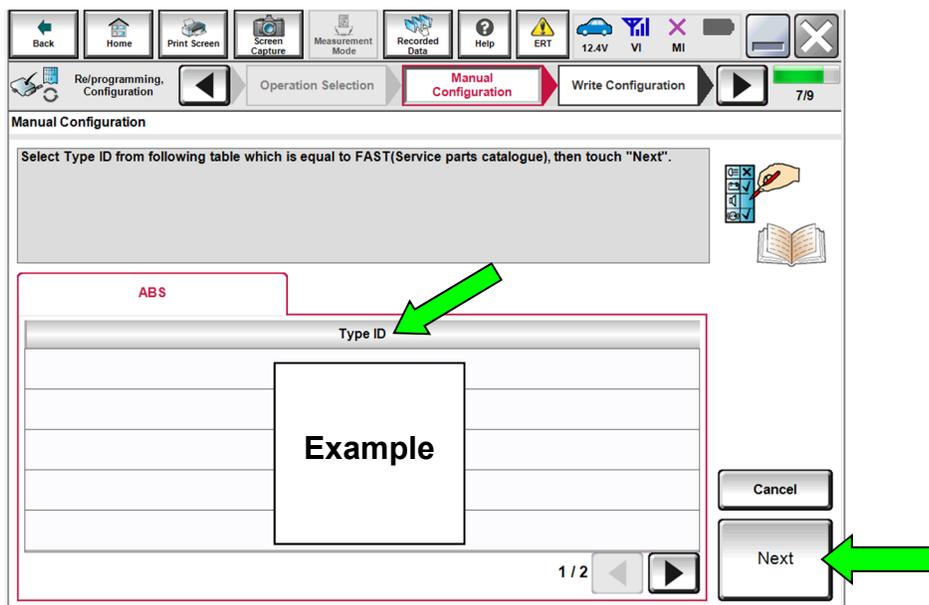
Figure 8

16. Select the correct **Type ID** number.
 - Refer to **Table A** (see page 7) for the correct **Type ID** number for the vehicle you are working on.
 - If needed, use scroll arrows to find the correct number.

NOTE: When a vehicle has only one configuration available, a list will not be displayed. Select **Next** (step 17), and C-III plus will select the correct configuration.

17. Select **Next**.

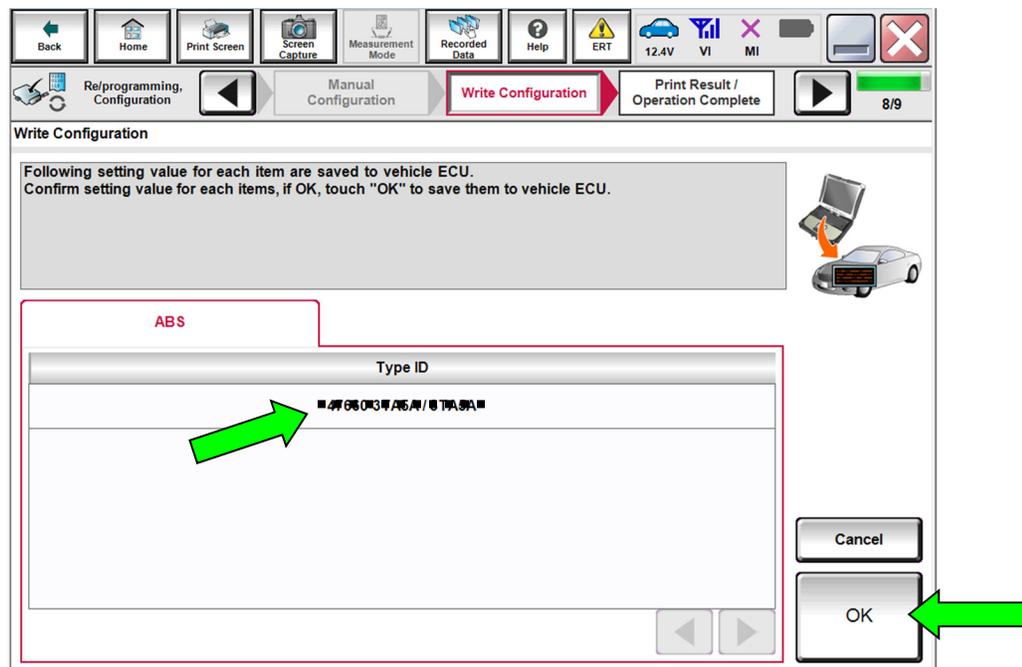
Figure 9

18. Confirm the correct Type ID number is selected.

19. Select OK.

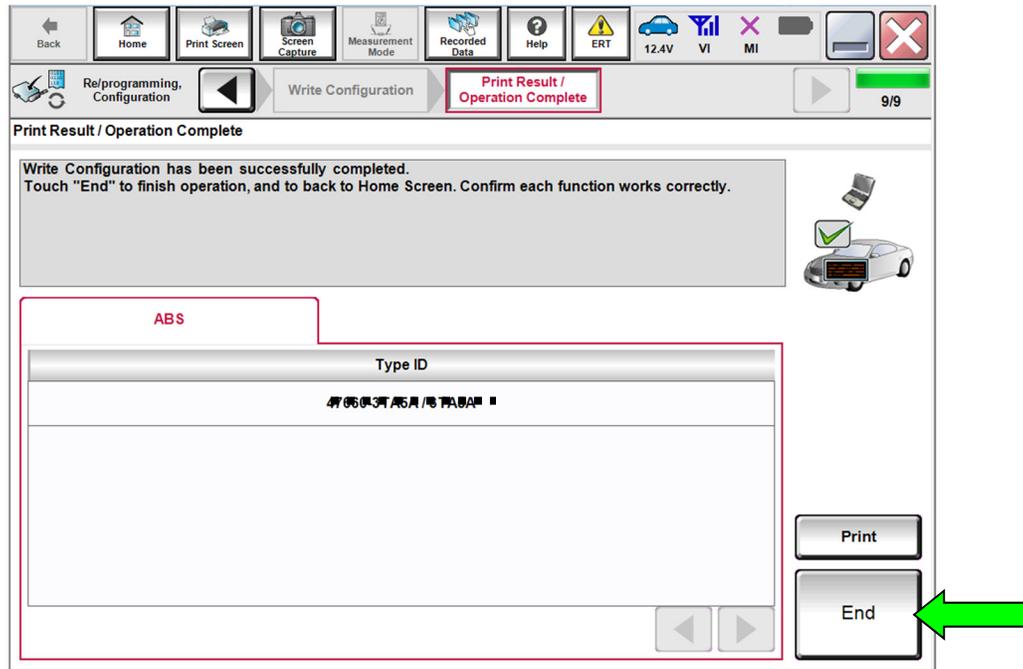
Figure 10

20. Configuration is complete, select **End**.
