VOLUNTARY SAFETY RECALL CAMPAIGN FLEET AND NEW INVENTORY 2017-2019 QX60; ABS ACTUATOR

CAMPAIGN ID #: R1921
APPLIED VEHICLES: 2017-2019 QX60 (L50)

Infiniti is conducting this voluntary safety recall campaign on certain specific model year 2017-2019 QX60 vehicles that are in fleet or new inventory to replace the ABS Actuator and Electric Unit (ABS control unit). This service will be performed at no charge to the customer for parts or labor.

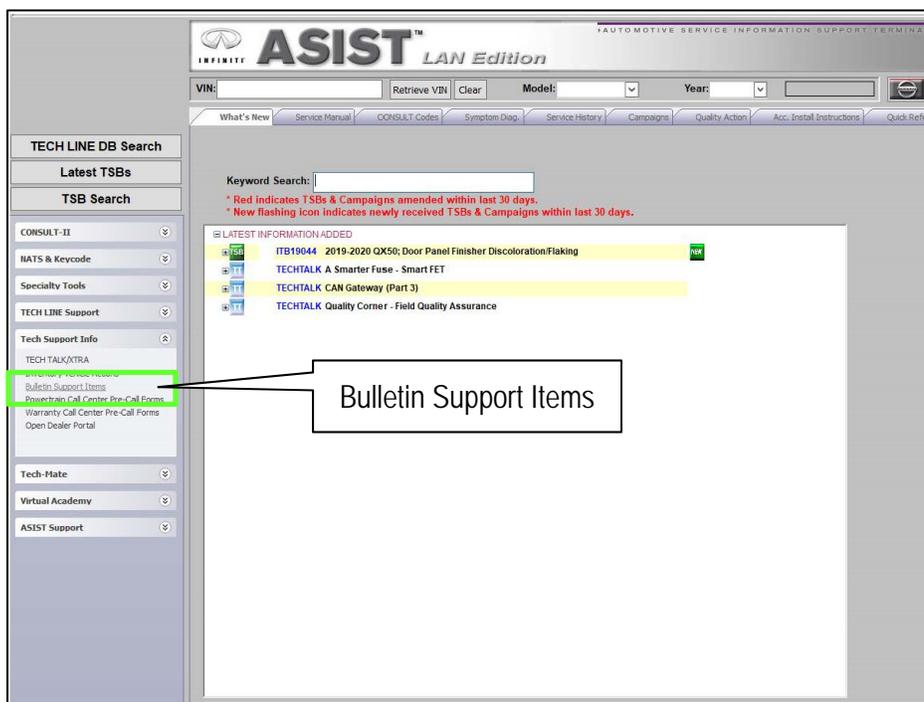
Figure 1

2. Find the correct Type ID, refer to **ASIST > Bulletin Support Items > R1917/R1921 ABS Part Number Selection Tool** as follows (This will be needed in step 17):
 - a. Select **Bulletin Support Items**.

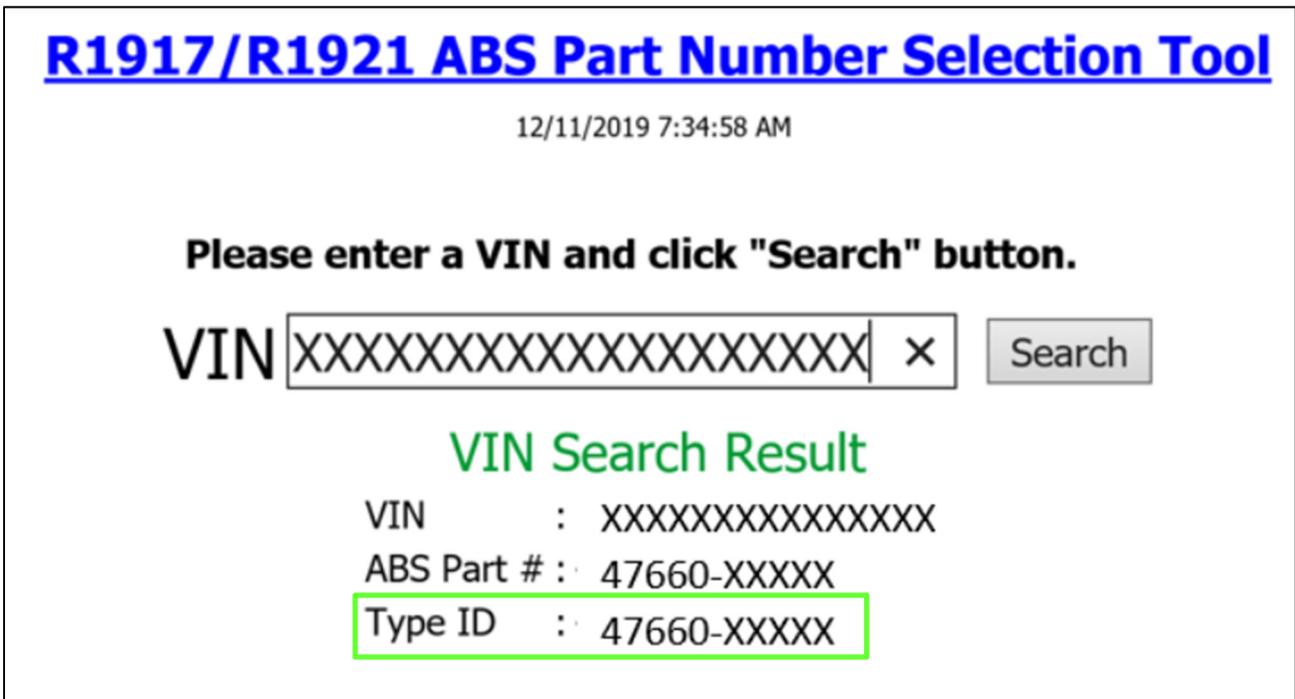
Figure 3

c. Enter the VIN of the vehicle, and then select Search.

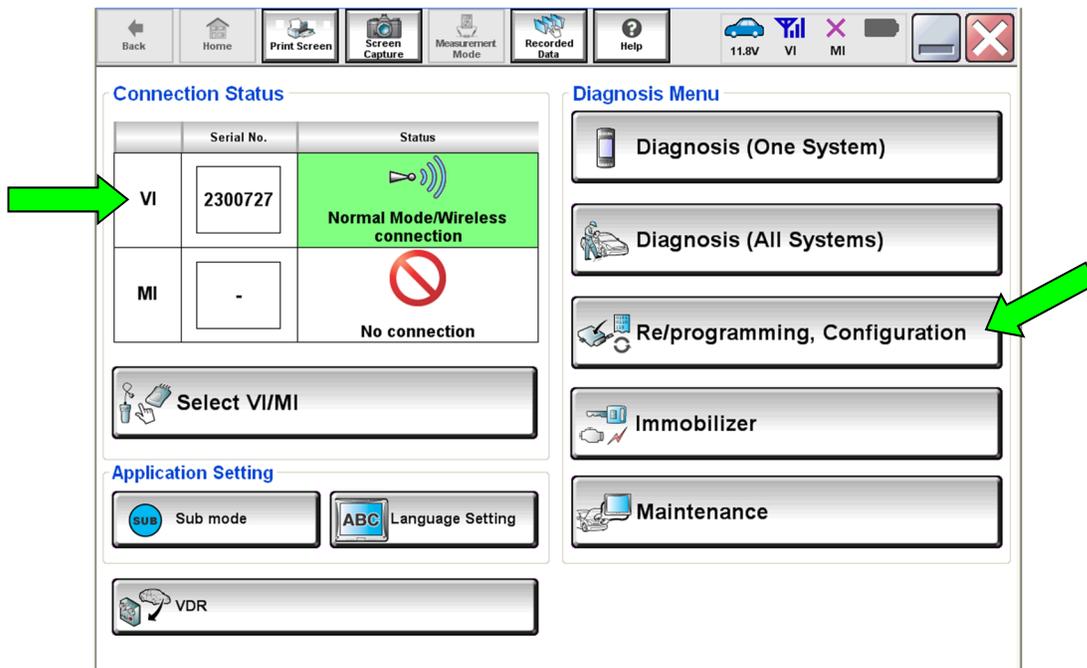
Figure 4

3. Connect CONSULT-III plus to the vehicle.
4. Turn the ignition ON.
5. Open / start C-III plus.
6. Wait for the plus VI to be recognized.
 - The serial number will display when the plus VI is recognized.
7. Select **Re/programming, Configuration**.

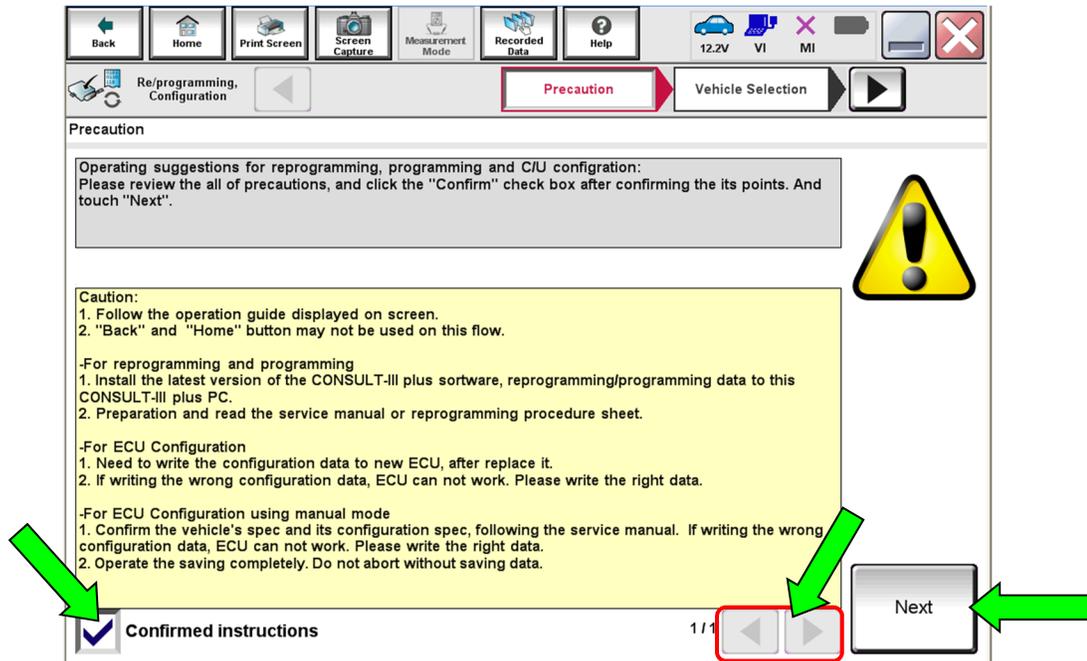
Figure 5

8. Use arrows (if needed) to view and read all precautions.
9. Check the box confirming the precautions have been read.
10. Select Next.

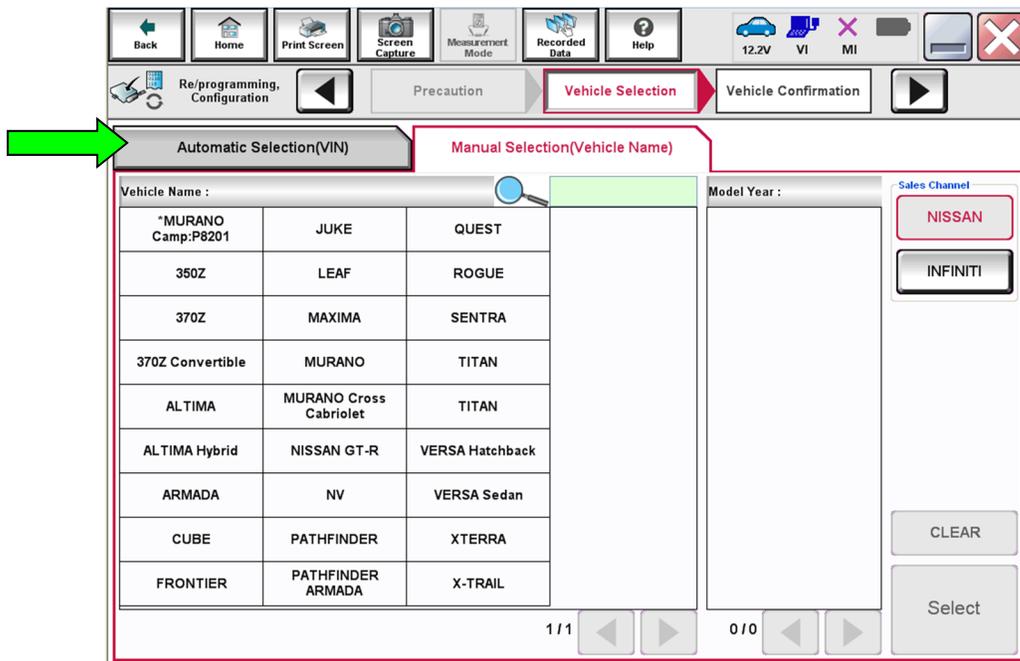
11. If the screen in Figure 6 displays, select **Automatic Selection(VIN)**.
 - If the screen in Figure 6 does not display, skip to step 12.

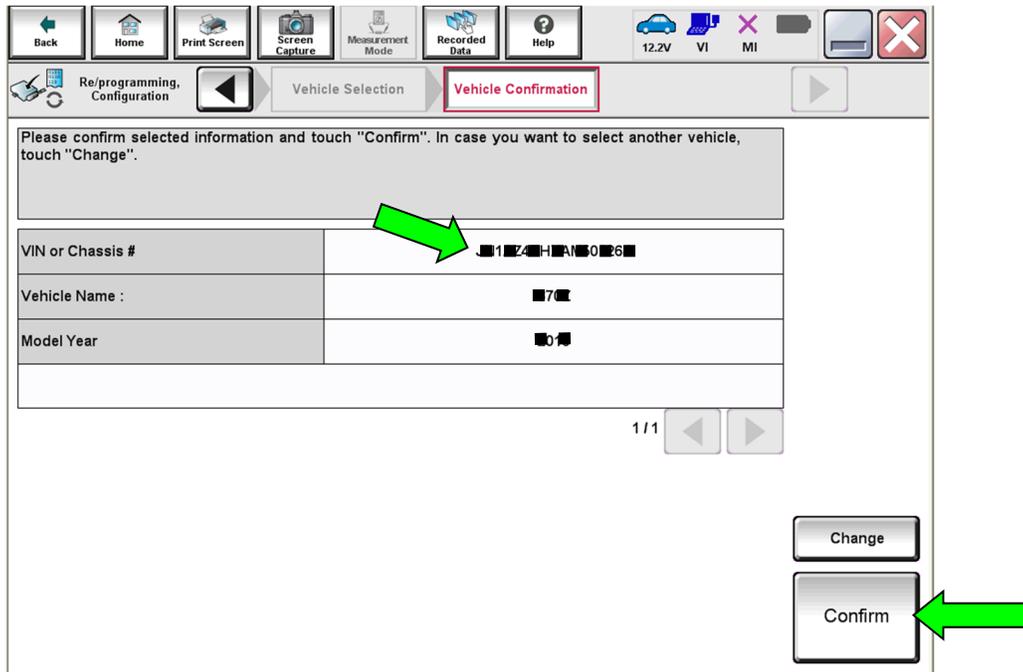
Figure 7

12. Make sure VIN or Chassis # matches the vehicle's VIN.
13. Select Confirm.

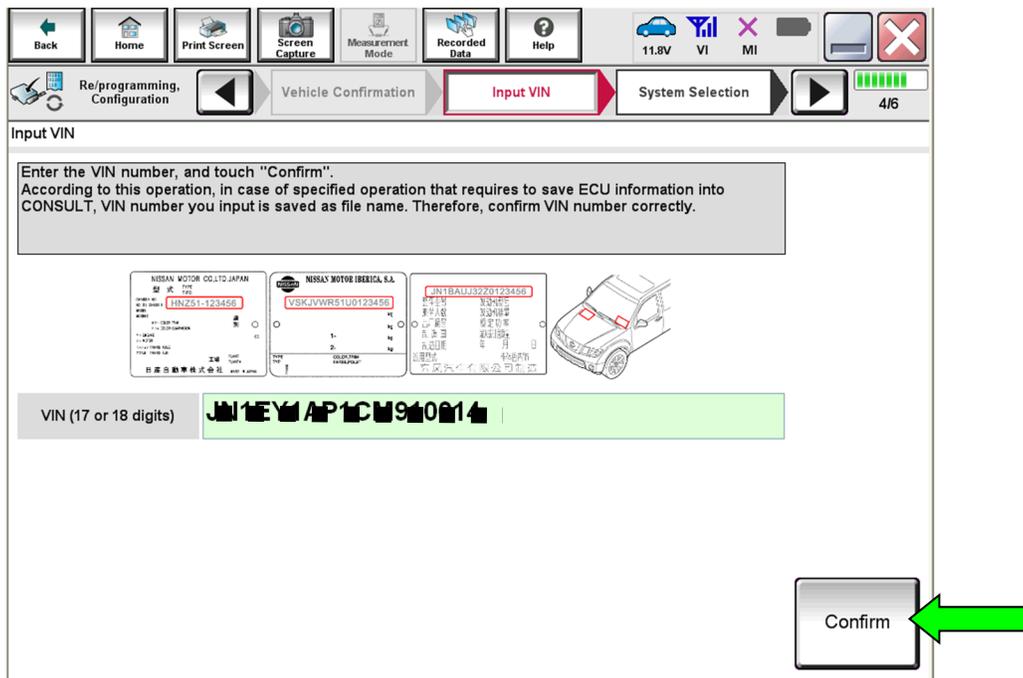
Figure 8

14. Select Confirm.

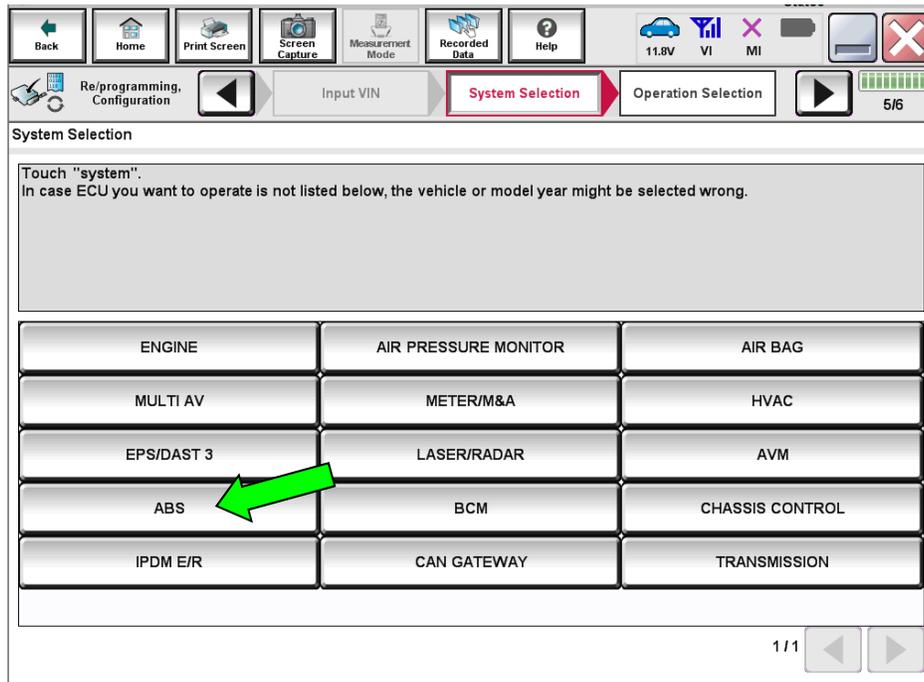
Figure 9

15. Select ABS.

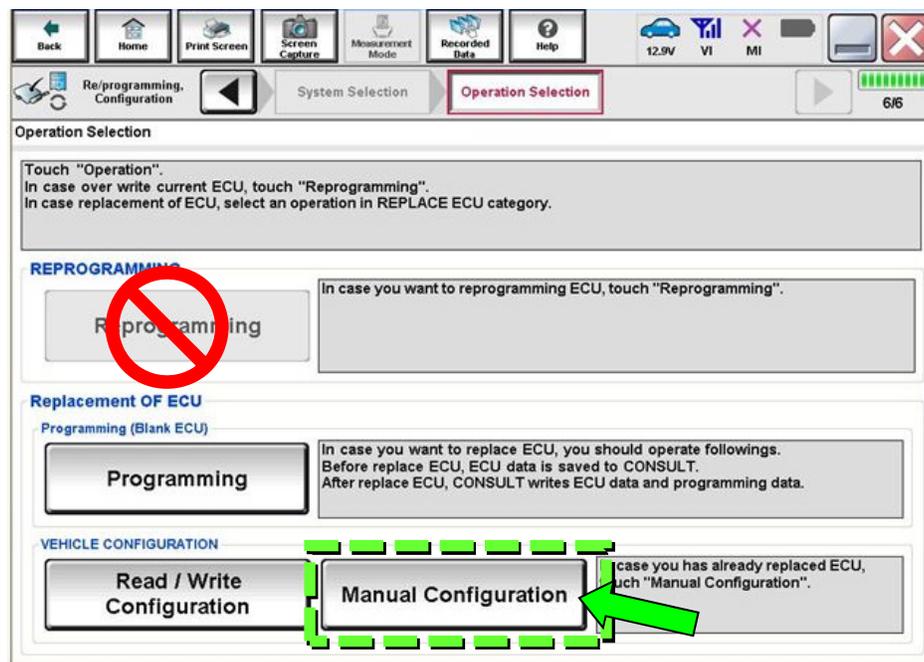
Figure 10

16. Select Manual Configuration.

- DO NOT select Reprogramming.

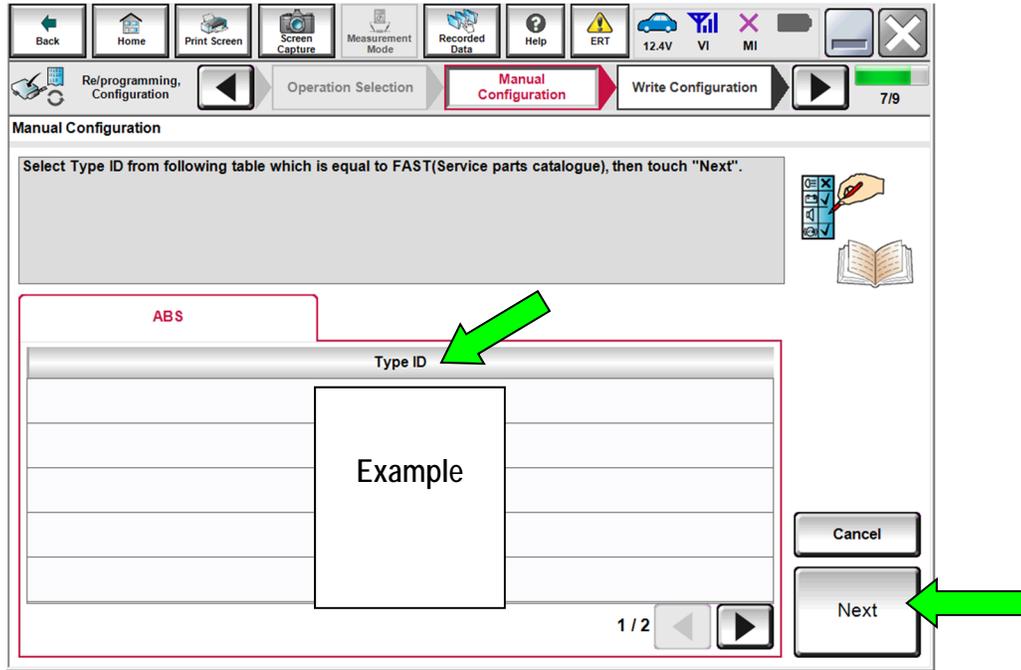
Figure 11

17. Select the Type ID (Figure 11) that was generated with the R1917/R1921 ABS Part Number Selection Tool in step 2.
 - If needed, use scroll arrows to find the correct number.

NOTE: When a vehicle has only one configuration available, a list will not be displayed. Select **Next** (step 18), and C-III plus will select the correct configuration.

18. Select **Next**.

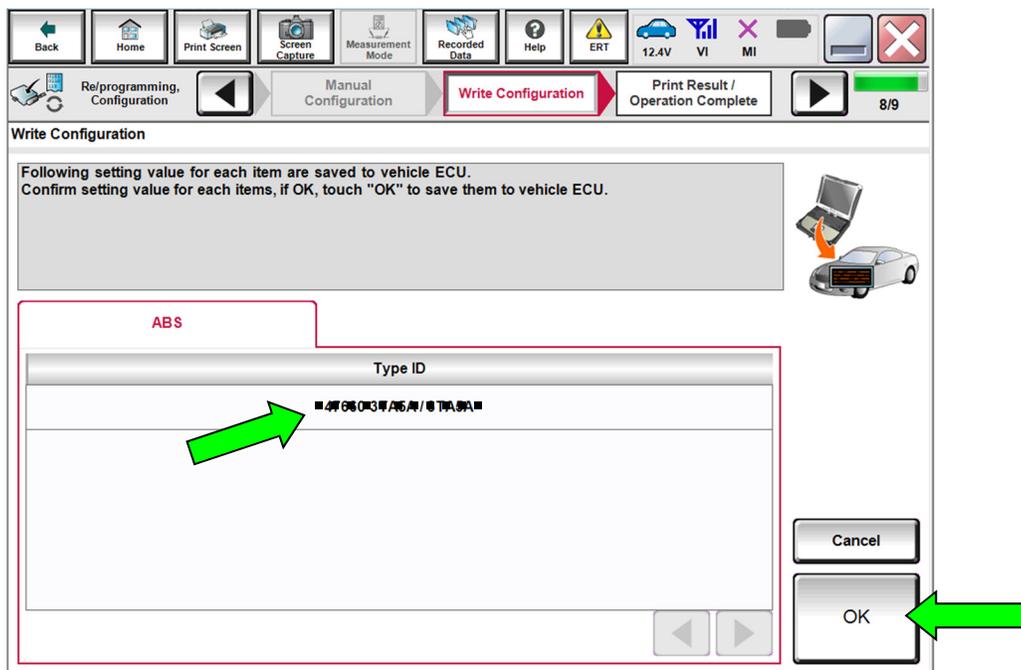
Figure 12

19. Confirm the correct Type ID number is selected.

20. Select **OK**.

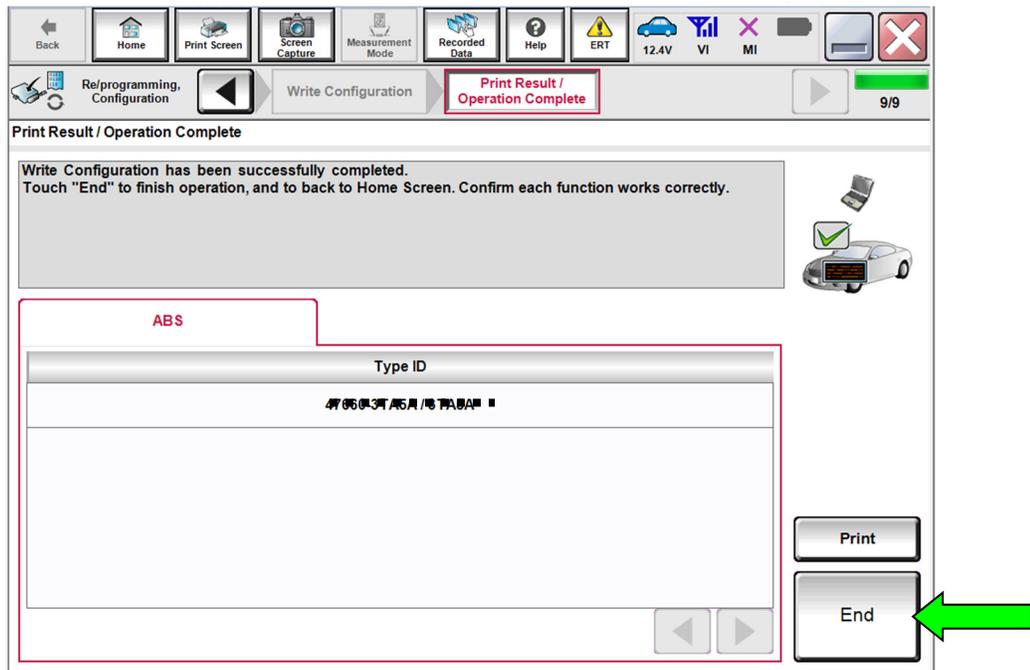
Figure 13

21. Configuration is complete, select **End**.
