Safety Recall Code: 69Q8

TAKATA Driver Frontal Airbag Inflator

U.S.A. & CANADA: Certain 2006-2007 MY Volkswagen Passat Sedan & Passat Wagon vehicles equipped with a Takata driver frontal airbag

Replace the driver frontal airbag inflator with a newly manufactured version. This repair is the <u>final</u> remedy.

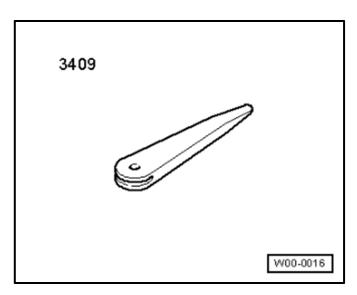
• Trim Removal Wedge – 3409 (or equivalent)

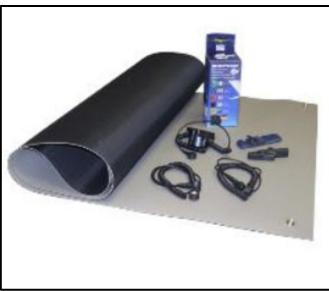
• ESD Work surface - VAS 6613

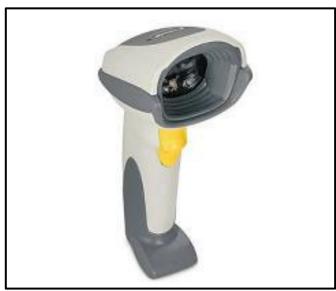
• Bar Code Scanner - VAS6161/1

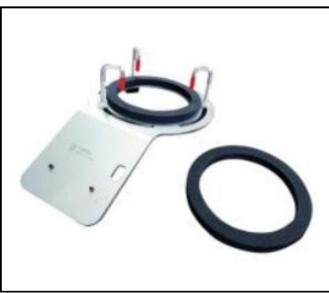
• Airbag Support - T10568

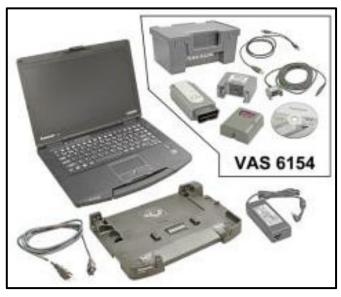
• VAS6150D - Diagnostic Tester (or equivalent)

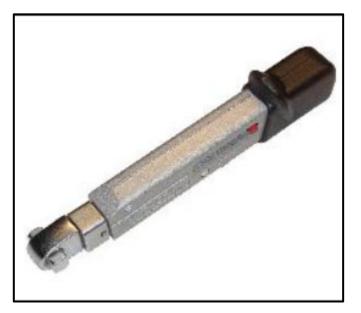
VAG1410 – Torque Wrench (or equivalent)

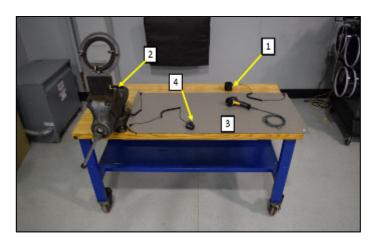
- Prior to beginning work, all parts and tools are to be placed on the ESD table mat.
- The workstation must be in the vicinity of the vehicle.
- Assemble ESD workplace -VAS 6613- <1, 2, 3, and 4>.
- Plug ESD workplace into a wall socket using plug <1>.

The wall socket or extension cord must have a sufficient ground.

- Clamp Airbag Support T10568 <2> into the vice.
- Connect crocodile clip <1> to airbag support <2> and ESD workplace -VAS 6613-.

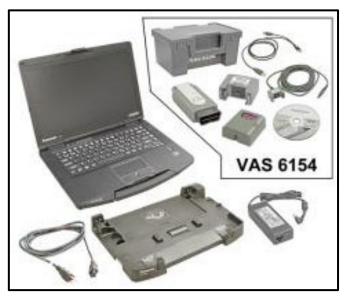
- Ensure ODIS is updated to the latest version.
- Connect vehicle diagnostic tester.
- Select Start Diagnosis function and identify vehicle.
- After identification of control units, Guided Fault Finding is started automatically.
- Follow the instructions on screen.

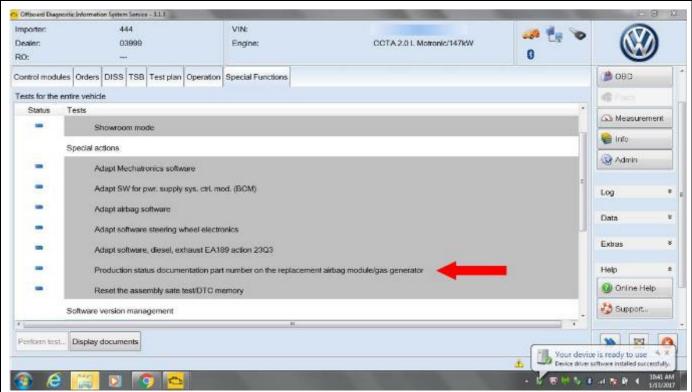
In operating mode <u>Special Functions</u>, Select "Production status documentation part number on the replacement airbag module/gas generator" <arrow>.

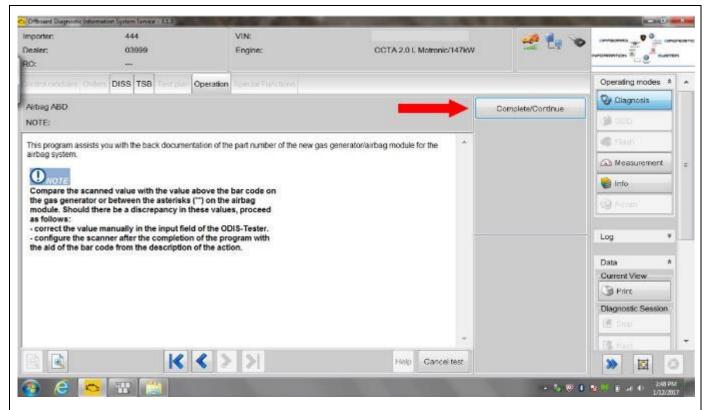
- Scanning the data matrix code during this test plan step calibrates the scanner to avoid error messages.
- Scanning the calibrating data matrix code may not have to be done every time (only when the scanner requires calibration). You will know if the scanner needs calibrating if the scanner does not scan the inflator's data matrix code.
- If the inflator data matrix code cannot be scanned, then print out this matrix shown below and scan the printout.

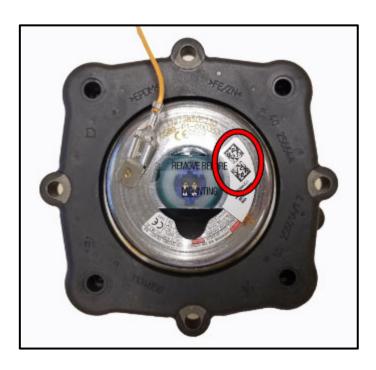
- Place the new inflator on the ESD mat.
- Scan the data matrix code of the new inflator at a distance of about 15 cm.

The photo is for reference only. The inflator that is installed may be either a single stage or dual stage inflator.

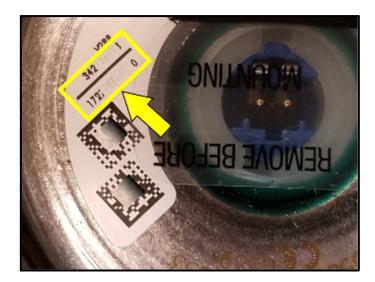
The data matrix code includes the values as shown.

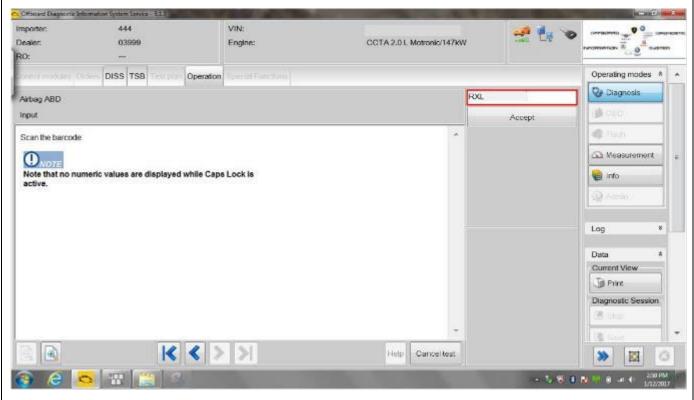
Once the new inflator has been successfully scanned, press "Accept"

- Compare the scanned value with the value shown above the data matrix code on the new inflator.
- If there is a discrepancy, manually enter the value from the new inflator in the input field.
- If no value appears, recalibrate the scanner.

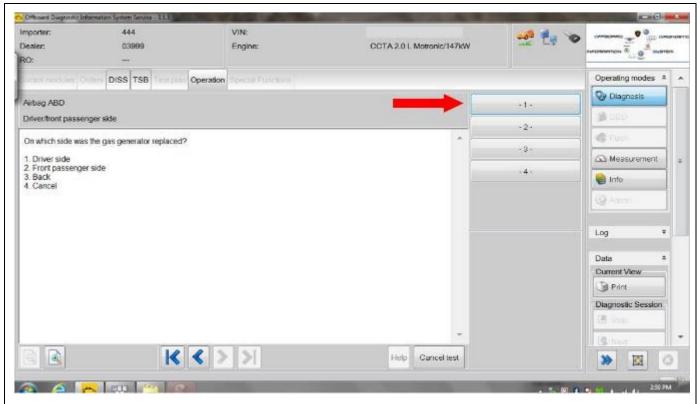
- Select option 1 indicating that the Driver side inflator was replaced.
- After selecting option 1, a valid GeKo ID will need to be entered in order to upload the new inflator identification.
- Upload diagnostic log online.

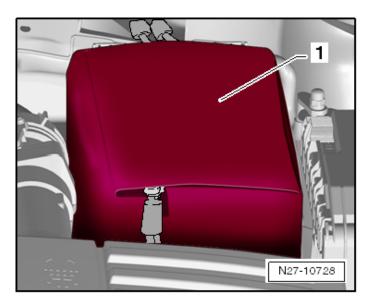
Accident risk. When working on pyrotechnic components (such as airbags and belt tensioners), the battery must be disconnected with the ignition switched **ON**.

- Open the battery protective covering <1>.
- Loosen the nut <1>.
- Remove and isolate the battery ground cable terminal from the battery terminal.

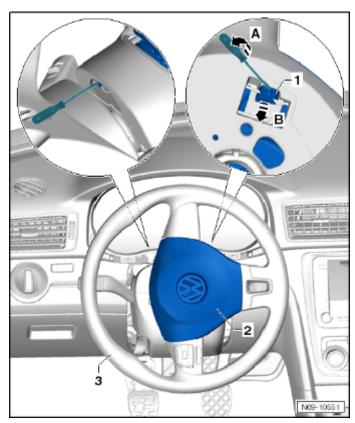
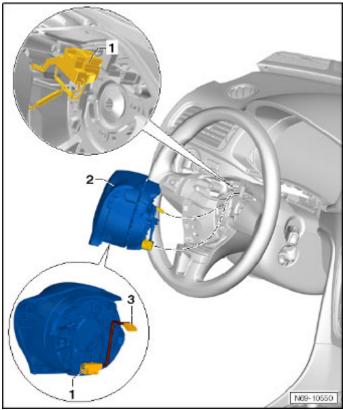
Procedure illustrated is for a three spoke steering wheel. The procedure for a four spoke steering wheel is the same.

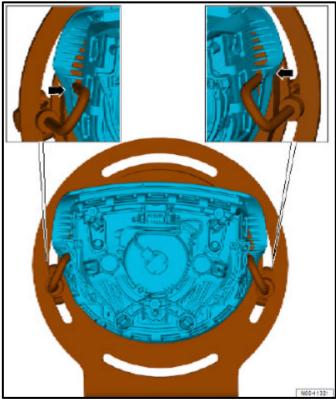
Clamp airbag centrally in airbag support. Securing points on the sides <arrows> and parallel opposite each other.

The clamps must be placed in the positions shown <arrows> to prevent damage to the airbag. Damage to the airbag is not covered under this action.

The clamps must be placed in the positions shown <arrows> to prevent damage to the airbag. Damage to the airbag is not covered under this action.

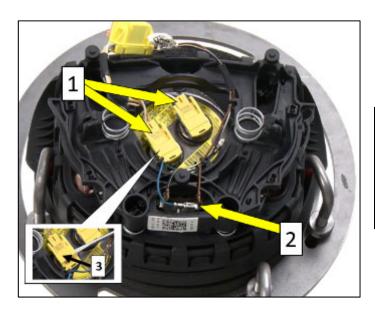
- Disengage connector locks <3> using a small flat bladed screwdriver.
- Remove connectors <1> using needle nose pliers.
- Remove ground cable <2>.

- Do not use a screwdriver to pry off connectors <1> or damage to the connectors could occur.
- Damage to the airbag connectors will not be covered under this action.

- Do not use a screwdriver to pry off connector
 <1> or damage to the connector could occur.
- Damage to the airbag connectors will not be covered under this action.

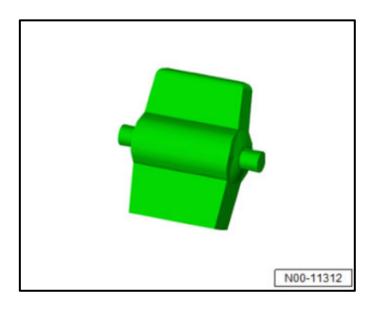
- The locking pins are to be reused.
- There may be instances in which short locking pins are fitted. These can be levered out with a small screwdriver.

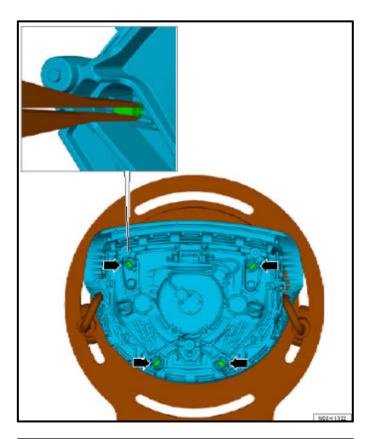
Remove locking pins <arrows> for horn ring with aid of longnose pliers.

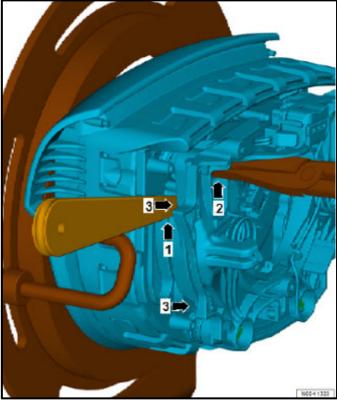
Apply removal wedge -3409- between horn ring and inflator <1> and press together locking elements using longnose pliers <2>. Lever off horn ring at plastic lugs <3>.

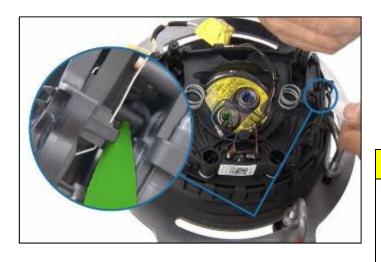
- Position the removal wedge -3409- on the plastic lugs to prevent damage to the conductor strip.
- Insert the removal wedge -3409- between the inflator and horn ring to prevent the horn ring from engaging again.
- Repeat work steps on other side.

Use extreme care when removing the horn ring. If horn ring is damaged during removal, airbag replacement will be necessary. Replacement of the airbag due to damage during horn ring removal will not be covered under this action.

- When removing the horn ring, take care that the springs are not lost as they are not available separately.
- **ONE** replacement spring is included in the inflator kit in the event a spring is lost or damaged.
- If more than one spring is lost, replacement of the airbag is required. Replacement of the airbag is required if a spring is lost and is not covered under this action.

- Position the removal wedge -3409- on the plastic lugs to prevent damage to the conductor strip.
- Insert the removal wedge -3409- between the inflator and horn ring to prevent the horn ring from engaging again.
- Repeat work steps on other side.

Use extreme care when removing the horn ring. If horn ring is damaged during removal, airbag replacement will be necessary. Replacement of the airbag due to damage during horn ring removal will not be covered under this action.

- When removing the horn ring, take care that the springs are not lost as they are not available separately.
- **ONE** replacement spring is included in the inflator kit in the event a spring is lost or damaged.
- If more than one spring is lost, replacement of the airbag is required. Replacement of the airbag is required if a spring is lost and is not covered under this action.

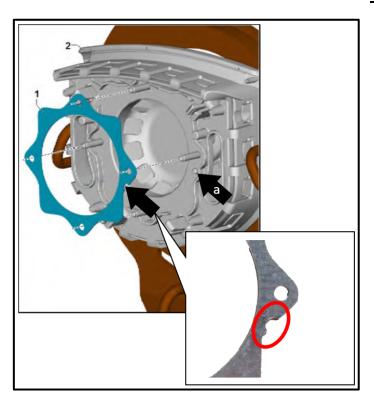
- Included in the replacement parts kit is a baffle plate. This must be used when installing the new inflator.
- Fit baffle plate <1> onto airbag <2> so that the notch <circle> lines up with the pin <arrow a> on the airbag.

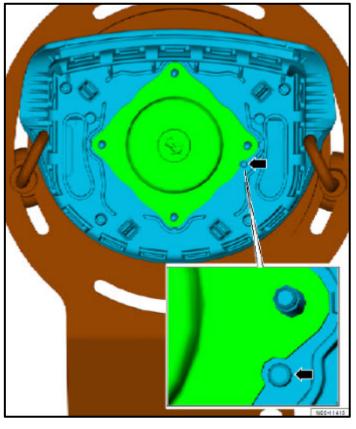
Insert new inflator and check to ensure it is seated correctly. Note the recess <arrow>.

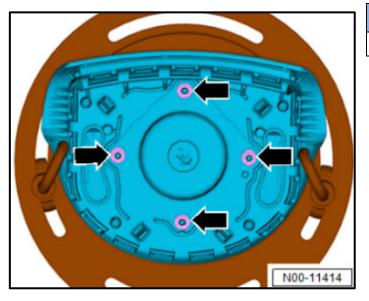
The nuts are self-locking and must be replaced

Install new nuts <arrows> and torque to 5 Nm ± 0.4 Nm.

The nuts are self-locking and must be replaced.

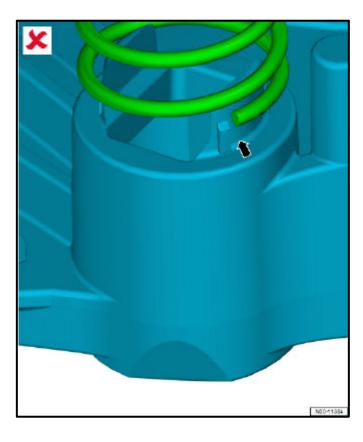
- If one of the springs is damaged or has been lost, it can be replaced with a spring from the bag of spares included.
- Note the examples shown for reference of proper spring seating.
- Spring seated incorrectly <arrow>.

- If one of the springs is damaged or has been lost, it can be replaced with a spring from the bag of spares included.
- Note the examples shown for reference of proper spring seating.
- Spring seated incorrectly <arrow>.

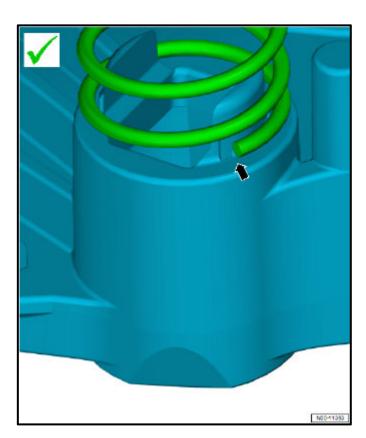
• Spring seated correctly <arrow>.

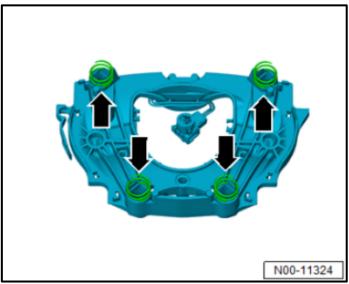
• Fit springs <arrows> for horn ring again if necessary.

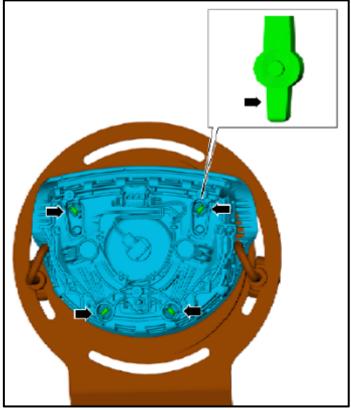
Position horn ring with springs on securing clips and press firmly in place. Ensure that springs are seated correctly on both sides <arrows>.

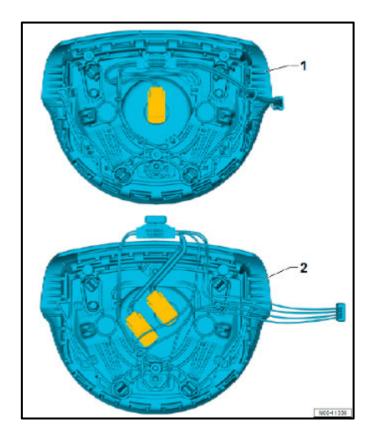
- Connect central connector(s) <1> on inflator.
- Press central connector lock(s) in until fully locked.
- Connect ground cable <2>.

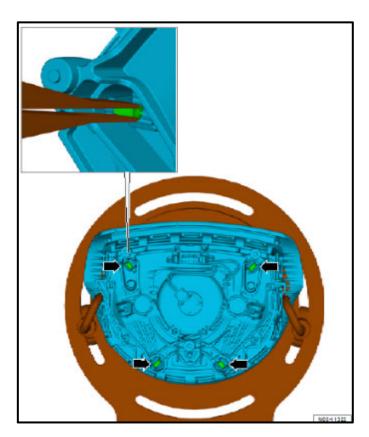
- The locking pins are to be reused.
- There may be instances in which short locking pins are fitted. These can be levered out with a small screwdriver.

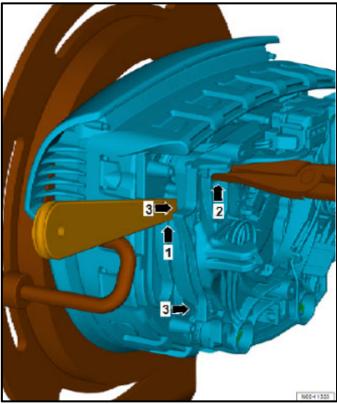
Remove locking pins <arrows> for horn ring with aid of longnose pliers.

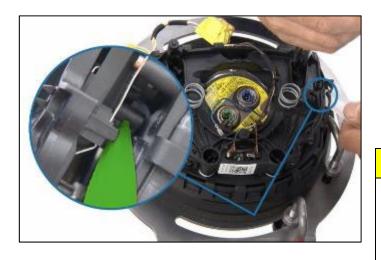
Apply removal wedge -3409- between horn ring and inflator <1> and press together locking elements using longnose pliers <2>. Lever off horn ring at plastic lugs <3>.

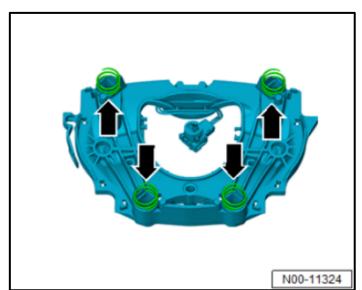
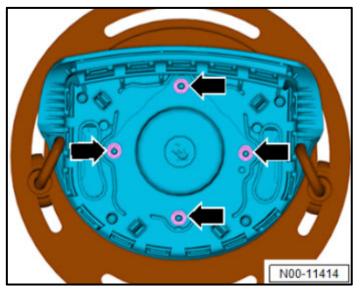
- Remove and discard nuts <arrows>.
- Remove the inflator and place in the original packaging.

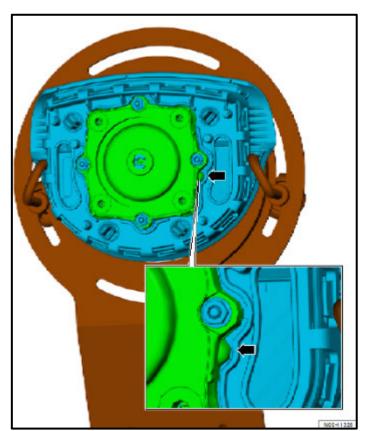
• Insert new inflator and check to ensure it is seated correctly. Note the recess <arrow>.

Criteria	Inflator Kit Part Number	
T1	3C0 898 201 G

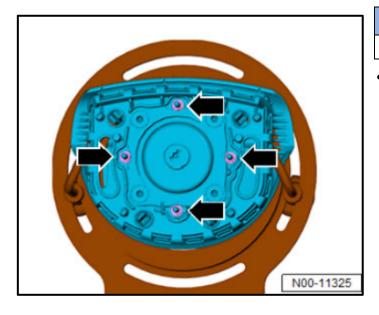
Install new nuts <arrows> and torque to 5 Nm ± 0.4 Nm.

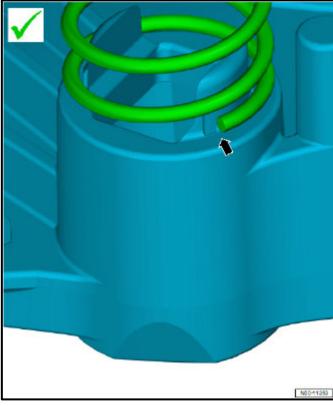
Spring seated correctly <arrow>.

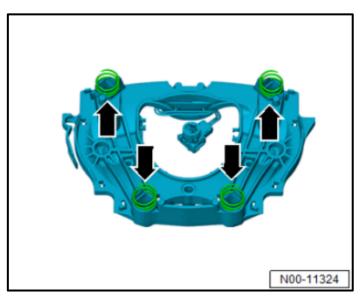
Fit springs <arrows> for horn ring again if necessary.

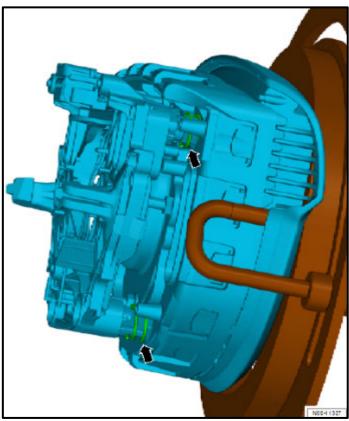
Position horn ring with springs on securing clips and press firmly in place. Ensure that springs are seated correctly on both sides <arrows>.

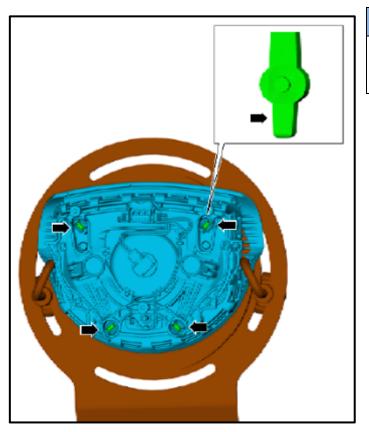
If a pin is damaged or has been lost, it can be replaced with a locking pin from the bag of spares included.

Using long-nose pliers, insert four locking pins in retaining lugs with narrow side facing downwards <arrow in magnification>. Pins must engage audibly.

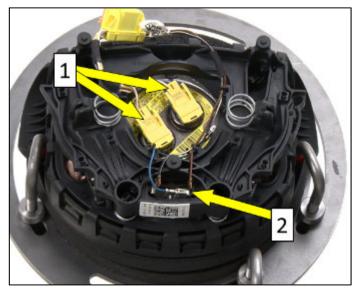
- Connect central connector(s) <1> on inflator.
- Press central connector lock(s) in until fully locked.
- Connect ground cable <2>.

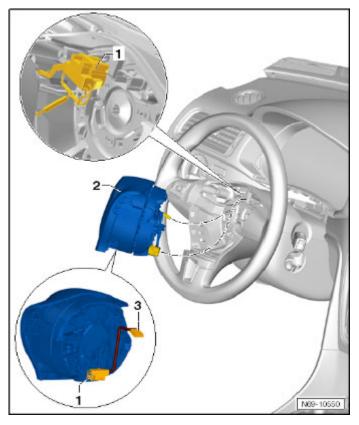
- The battery must be disconnected before installing the airbag back into the vehicle.
- Before handling pyrotechnic components (for example, disconnecting the connector), the person handling it must "discharge static electricity". This can be done by touching the door striker, for example.
- Connect the connector <1>. The connector must click into place.
- Press the connector lock on the connector <1>.
- Connect the connector <3> (if equipped).
- Insert the airbag unit <2> into the steering wheel but do not press on it.

Procedure illustrated is for a three spoke steering wheel. The procedure for a four spoke steering wheel is the same.

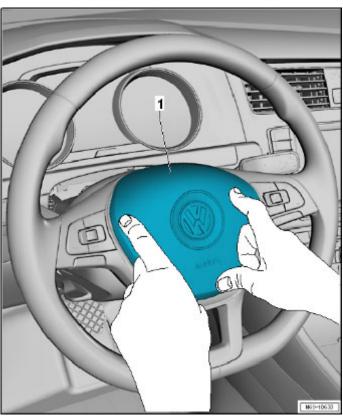
- Press on the edge of the airbag unit <1> with both hands until it locks into place.
- Gently pull on the airbag unit to make sure the airbag unit is secured correctly at all three attachment points in the steering wheel.
