# Safety Recall Code: 69Q8

Subject	TAKATA Driver Frontal Airbag Inflator			
Document History	Date Summary			
Bocument mistory	April 30, 2024 Updated part return/disposal information			
Affected Vehicles	U.S.A. & CANADA: Certain 2006-2007 MY Volkswagen Passat Sedan & Passat Wago vehicles equipped with a Takata driver frontal airbag			
	Check Campaigns/Actions screen in Elsa on the day of repair to verify that a VIN qualifies for repair under this action. Elsa is the <u>only</u> valid campaign inquiry & verification source.			
	<ul> <li>✓ Campaign status must show "open."</li> <li>✓ If Elsa shows other open action(s), inform your customer so that the work can also be completed the same time the vehicle is in the workshop for this campaign.</li> </ul>			
Problem Description	The driver airbag may explode in a crash with airbag deployment. Sharp metal fragments can hit people and cause serious injury or death.			
Corrective Action	Replace the driver frontal airbag inflator with a newly manufactured version. This repair is the <u>final</u> remedy.

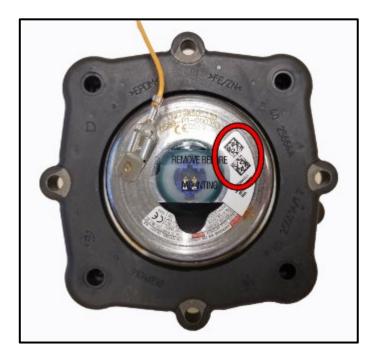
- Place the new inflator on the ESD mat.
- Scan the data matrix code of the new inflator at a distance of about 15 cm.

Ensure the correct inflator data matrix code is scanned at this time.						
<u>Criteria</u>	Part Number					
N1	3C0 898 201 F					
T1	3C0 898 201 G

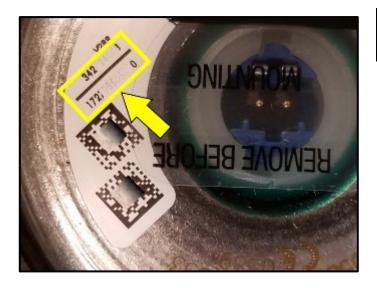
The photo is for reference only. The inflator that is installed may be either a single stage or dual stage inflator.

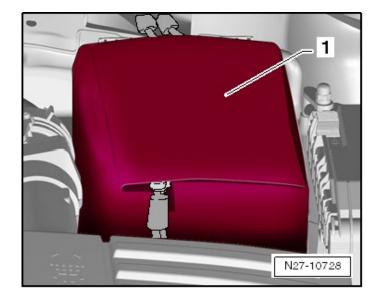
Accident risk. When working on pyrotechnic components (such as airbags and belt tensioners), the battery must be disconnected with the ignition switched **ON**.

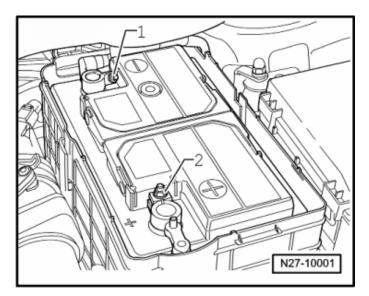
- Open the battery protective covering <1>.
- Loosen the nut <1>.
- Remove and isolate the battery ground cable terminal from the battery terminal.

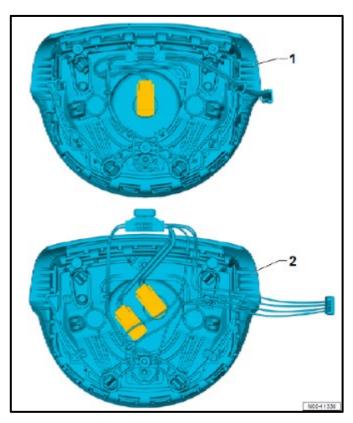
The inflator comes as a single-stage <1> or two-stage <2> version. The work steps for inflator renewal are the same.

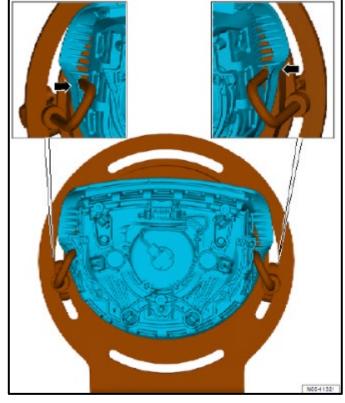
- The four spoke steering wheel has two mounting points.
- Tighten mounting by hand to prevent damage.
- Adjust three knurled nuts of securing hooks to <dimension a> 50mm.

The clamps must be placed in the positions shown <arrows> to prevent damage to the airbag. Damage to the airbag is not covered under this action.

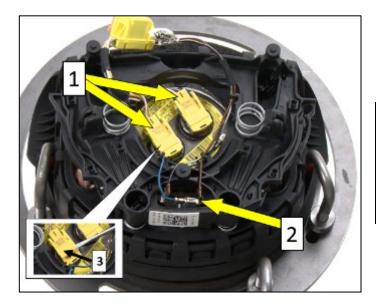
- Disengage connector locks <3> using a small flat bladed screwdriver.
- Remove connectors <1> using needle nose pliers.
- Remove ground cable <2>.

- Do not use a screwdriver to pry off connectors <1> or damage to the connectors could occur.
- Damage to the airbag connectors will not be covered under this action.

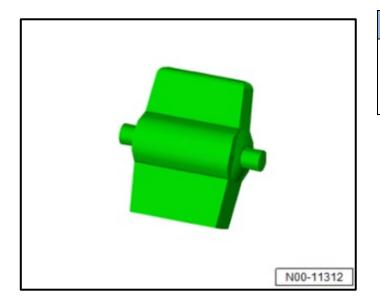
- The locking pins are to be reused.
- There may be instances in which short locking pins are fitted. These can be levered out with a small screwdriver.

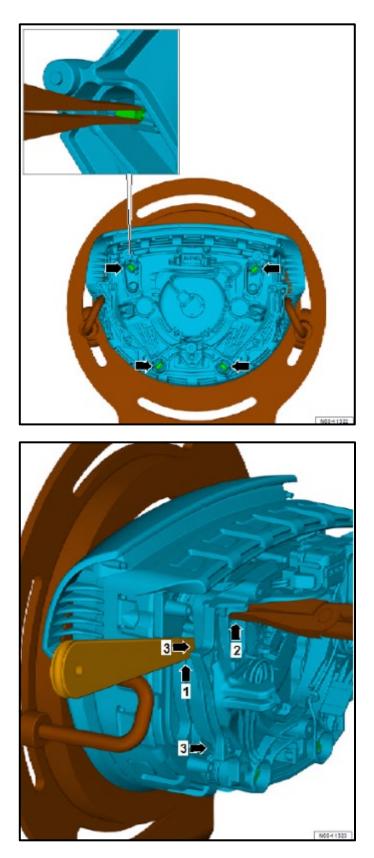
• Remove locking pins <arrows> for horn ring with aid of longnose pliers.

• Apply removal wedge -3409- between horn ring and inflator <1> and press together locking elements using longnose pliers <2>. Lever off horn ring at plastic lugs <3>.

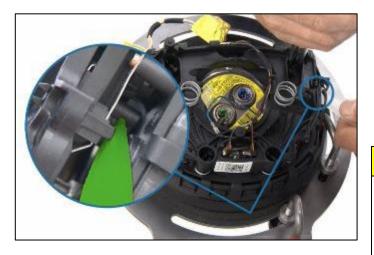
- Position the removal wedge -3409- on the plastic lugs to prevent damage to the conductor strip.
- Insert the removal wedge -3409- between the inflator and horn ring to prevent the horn ring from engaging again.
- Repeat work steps on other side.

Use extreme care when removing the horn ring. If horn ring is damaged during removal, airbag replacement will be necessary. Replacement of the airbag due to damage during horn ring removal will not be covered under this action.

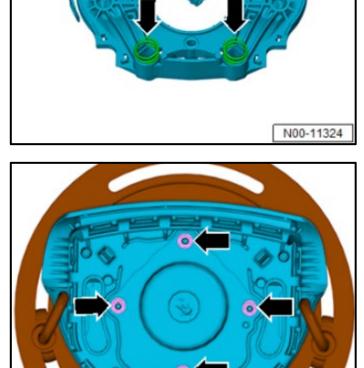
- Remove and discard nuts <arrows>.
- Remove the inflator and place in the original packaging.

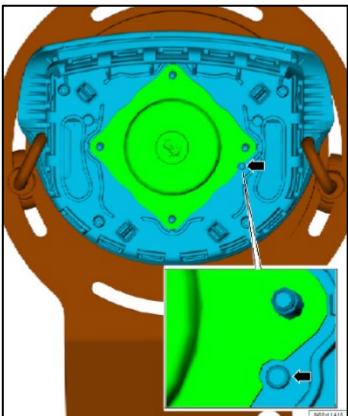
- Included in the replacement parts kit is a baffle plate. This must be used when installing the new inflator.
- Fit baffle plate <1> onto airbag <2> so that the notch <circle> lines up with the pin <arrow a> on the airbag.

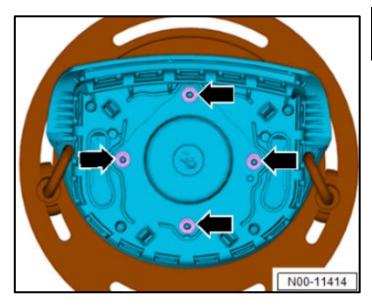
The nuts are self-locking and must be replaced

Install new nuts <arrows> and torque to 5 Nm ± 0.4 Nm.

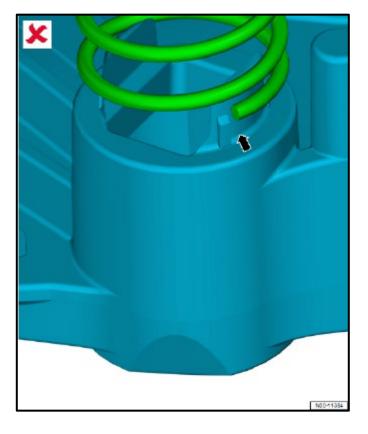
- If one of the springs is damaged or has been lost, it can be replaced with a spring from the bag of spares included.
- Note the examples shown for reference of proper spring seating.
- Spring seated incorrectly <arrow>.

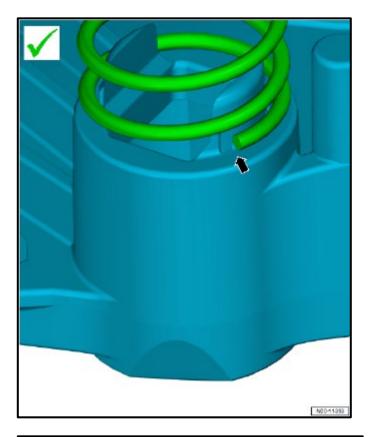
• Spring seated correctly <arrow>.

• Fit springs <arrows> for horn ring again if necessary.

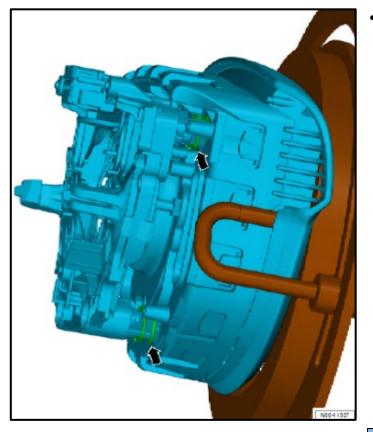
Position horn ring with springs on securing clips and press firmly in place. Ensure that springs are seated correctly on both sides <arrows>.

• Using long-nose pliers, insert four locking pins in retaining lugs with narrow side facing downwards <arrow in magnification>. Pins must engage audibly.

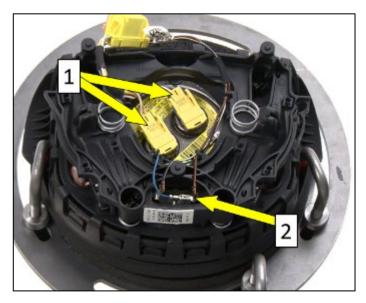
- Connect central connector(s) <1> on inflator.
- Press central connector lock(s) in until fully locked.
- Connect ground cable <2>.

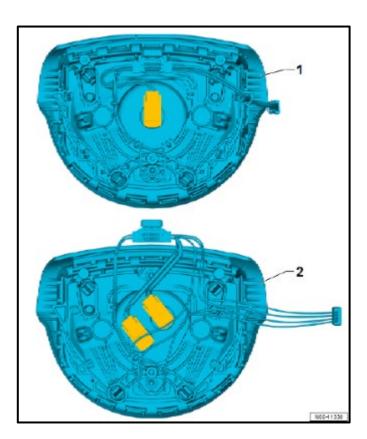
- The inflator comes as a single-stage <1> or two-stage <2> version. The work steps for inflator renewal are the same.
- Tighten mounting by hand to prevent damage.

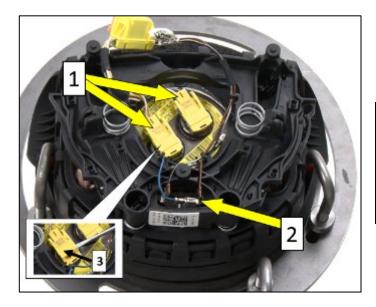
- Disengage connector locks <3> using a small flat bladed screwdriver.
- Remove connectors <1> using needle nose pliers.
- Remove ground cable <2>.

- Do not use a screwdriver to pry off connector <1> or damage to the connector could occur.
- Damage to the airbag connectors will not be covered under this action.

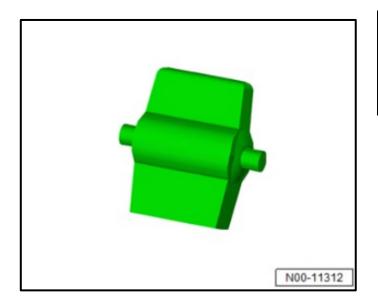
- The locking pins are to be reused.
- There may be instances in which short locking pins are fitted. These can be levered out with a small screwdriver.

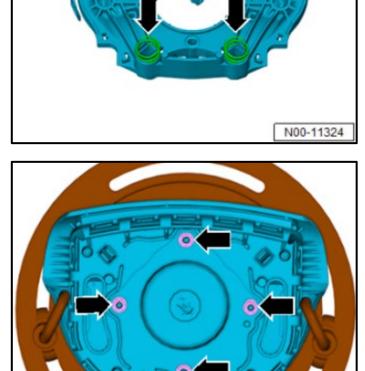
- Remove and discard nuts <arrows>.
- Remove the inflator and place in the original packaging.

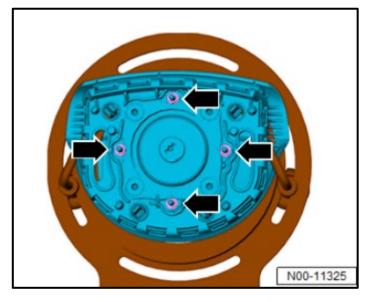
• Insert new inflator and check to ensure it is seated correctly. Note the recess <arrow>.

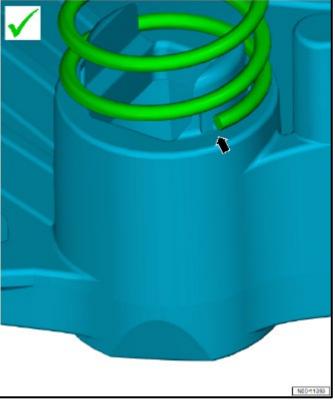
- If one of the springs is damaged or has been lost, it can be replaced with a spring from the bag of spares included.
- Note the examples shown for reference of proper spring seating.
- Spring seated incorrectly <arrow>.

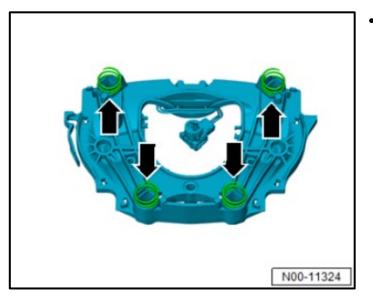
• Spring seated correctly <arrow>.

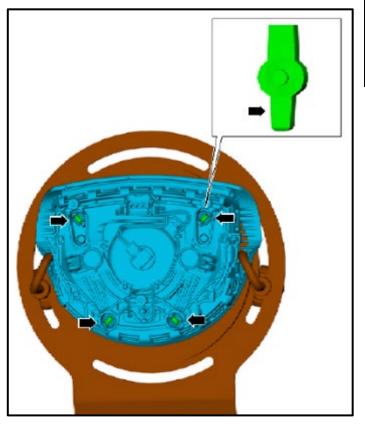
• Position horn ring with springs on securing clips and press firmly in place. Ensure that springs are seated correctly on both sides <arrows>.

- When removing the horn ring, take care that the springs are not lost as they are not available separately.
- **ONE** replacement spring is included in the inflator kit in the event a spring is lost or damaged.
- If more than one spring is lost, replacement of the airbag is required. Replacement of the airbag is required if a spring is lost and is not covered under this action.

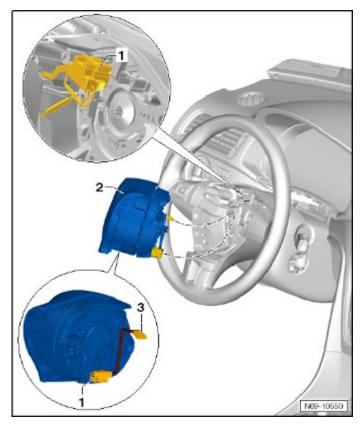
- The battery must be disconnected before installing the airbag back into the vehicle.
- Before handling pyrotechnic components (for example, disconnecting the connector), the person handling it must "discharge static electricity". This can be done by touching the door striker, for example.
- Connect the connector <1>. The connector must click into place.
- Press the connector lock on the connector <1>.
- Connect the connector <3> (if equipped).
- Insert the airbag unit <2> into the steering wheel but do not press on it.

Procedure illustrated is for a three spoke steering wheel. The procedure for a four spoke steering wheel is the same.

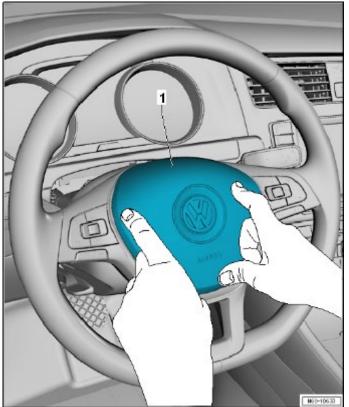
- Press on the edge of the airbag unit <1> with both hands until it locks into place.
- Gently pull on the airbag unit to make sure the airbag unit is secured correctly at all three attachment points in the steering wheel.
