Safety Recall Code: 69Q9

| Subject | TAKATA SDI Driver Frontal Airbag Inflator | | |
| Corrective Action | Replace the driver frontal airbag inflator with a newly manufactured version. This repair is the <u>final</u> remedy. | | |

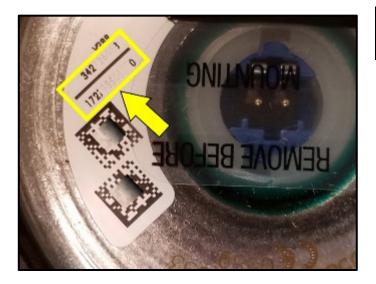
- Place the new inflator on the ESD mat. •
- Scan the data matrix code of the new inflator at a distance of about 15 cm.

The photo is for reference only. The inflator that is installed may be either a single stage or dual stage inflator.

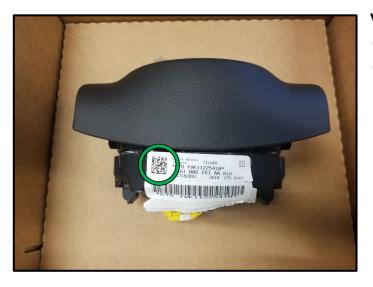
The data matrix code includes the values as shown.

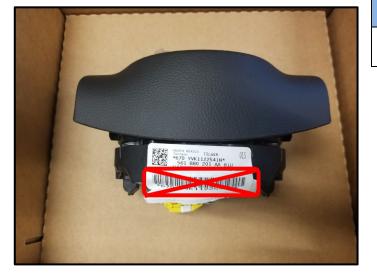
- Place the new airbag on the ESD mat. .
- Scan the data matrix code <circle> of the new • airbag at a distance of about 15 cm.

Scanning the bar code on the new airbag will result in an "implausible barcode" message.

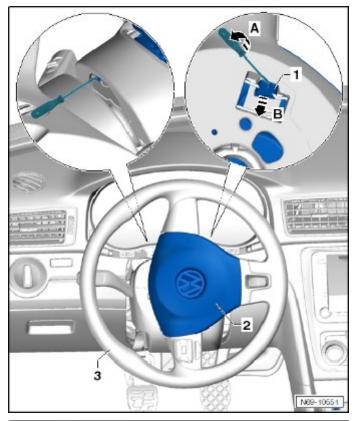
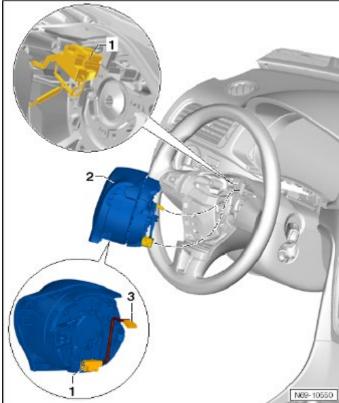
Procedure illustrated is for a three spoke steering wheel. The procedure for a four spoke steering wheel is the same.

- Lower the steering wheel <3> as far as possible.
- Adjust steering wheel depth (reach) <3> so it is in the fully extended position.
- Turn the steering wheel <3> to the position illustrated.
- Insert a screwdriver all the way into the hole on the back of the steering wheel (approximately 8 mm).
- Turn the screwdriver toward the driver door <arrow A>. This will unlock the airbag unit <2> locking mechanism <1> in direction of <arrow>, on the right side of the steering wheel.
- Turn the steering wheel 180° and repeat the procedure on the opposite side.

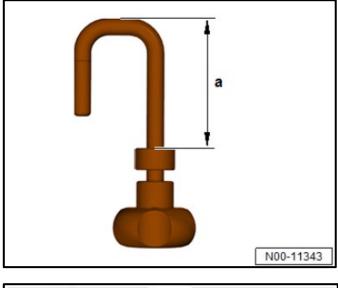
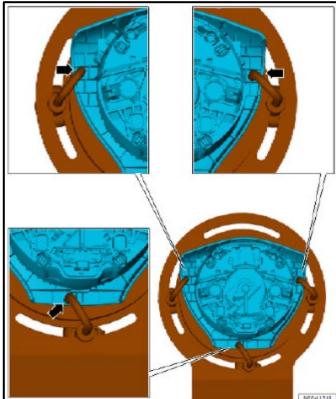
- The three spoke steering wheel has three • mounting points.
- Tighten mounting by hand to prevent damage.
- Adjust three knurled nuts of securing hooks to <dimension a> 50mm.

Clamp airbag centrally in airbag support. There are securing points on the sides <arrows>, parallel, opposite each other, and below.

The clamps must be placed in the positions shown <arrows> to prevent damage to the airbag. Damage to the airbag is not covered under this action.

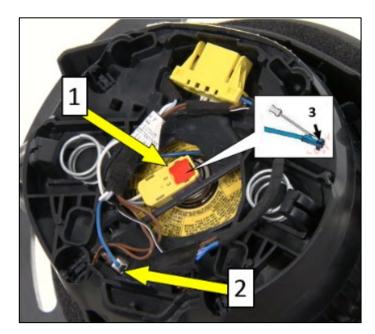
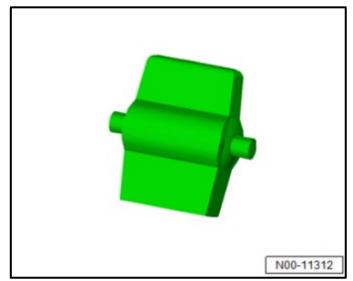
- Disengage connector lock <3> using a small flat bladed screwdriver.
- Remove connector <1> using needle nose pliers. •

- Do not use a screwdriver to pry off connector • <1> or damage to the connector could occur.
- Damage to the airbag connectors will not be covered under this action.
- Remove ground cable <2>.

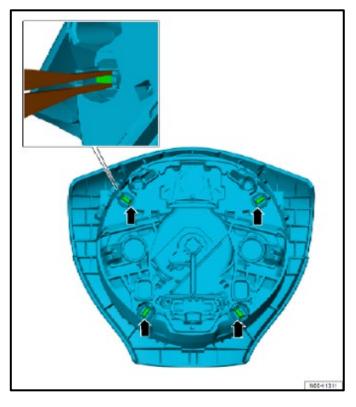
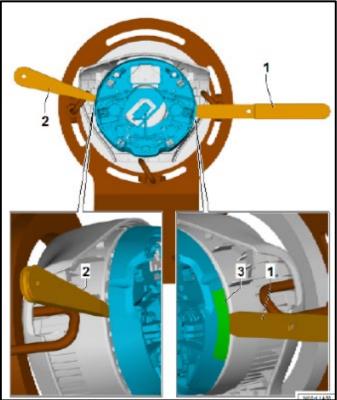
Remove locking pins <arrows> for horn ring with aid of longnose pliers.

- Apply lever -T10571- <1> in shaded area <3>. At • the same time, apply removal wedge -3409- on the other side <2> and lever off horn ring.
- Repeat work steps on other side.

Use extreme care when removing the horn ring. If horn ring is damaged during remove, airbag replacement will be necessary. Replacement of the airbag due to damage during horn ring removal will not be covered under this action.

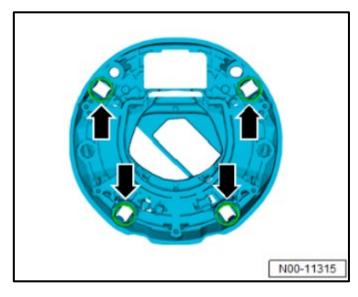
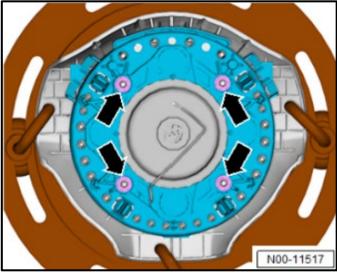
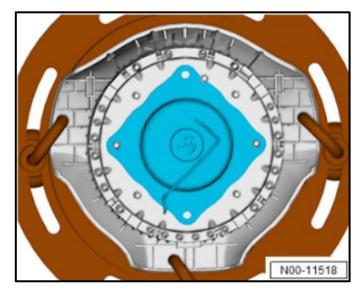
Remove horn ring with springs <arrows>.

- When removing the horn ring, take care that the springs are not lost as they are not available sepereately.
- ONE replacement spring is included in the inflator kit in the event a spring is lost or damaged.
- If more than one spring is lost, replacement of the airbag is required. Replacement of the airbag is required if a spring is lost and is not covered under this action.
- Remove and discard nuts <arrows>.
- Remove cover for inflator.

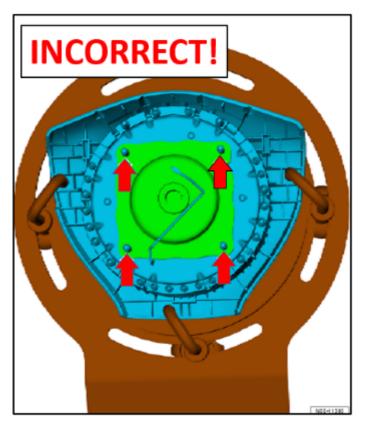
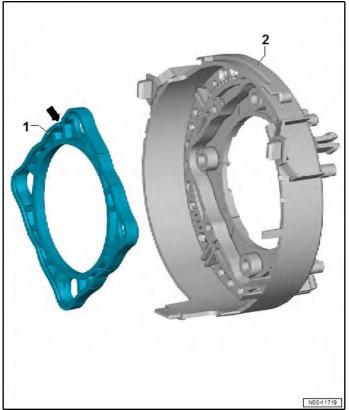
Note installation position:

The inflator must NOT be placed on the studs <arrows>.

Included in the replacement parts kit is an insert ٠ ring <1>. This must be used when installing a new inflator and placed in the horn ring <2>.

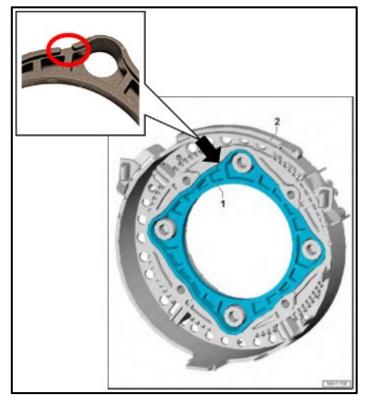
Fit insert ring <1> into horn ring <2>. The notch • (circle) in the insert ring must be at top <arrow> when doing this.

- It should be possible to fit the insert ring from the • replacement parts kit with ease.
- It is essential to adhere to the installation position.
- The notch must be at the top <arrow>.

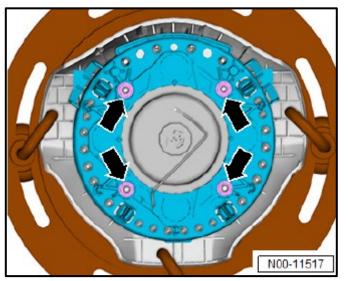
The nuts are self-locking and must be replaced

Fit cover for inflator and tighten 4 nuts <arrows> • to 5 Nm ± 0.4 Nm.

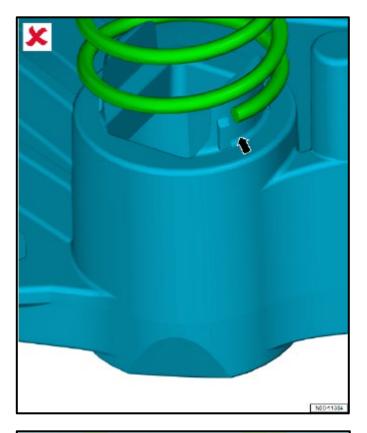
- If one of the springs is damaged or has been lost, it can be replaced with a spring from the bag of spares included.
- Note the examples shown for reference of proper spring seating.
- Spring seated incorrectly <arrow>.

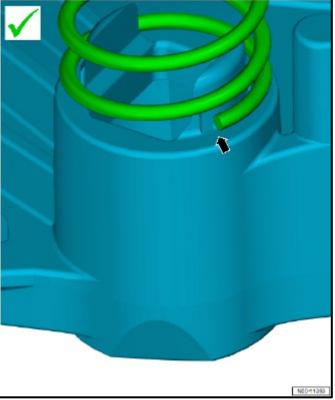
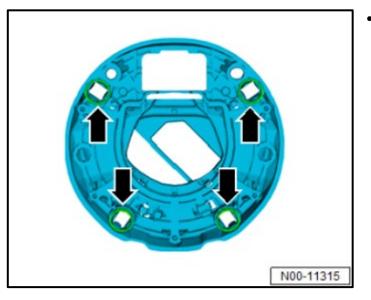
• Spring seated correctly <arrow>.

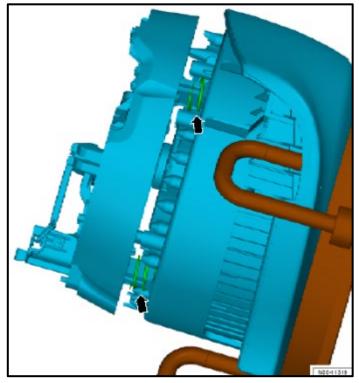
Fit springs <arrows> for horn ring again and allow to engage audibly.

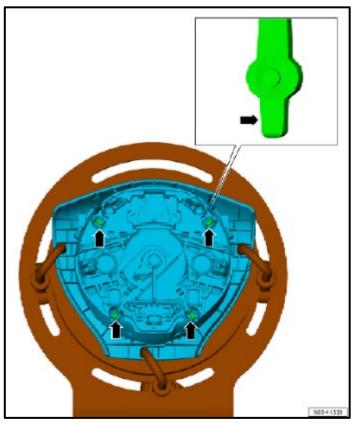
Position horn ring <arrows> with springs on • securing clips and press firmly in place. Ensure that springs are seated correctly on both sides.

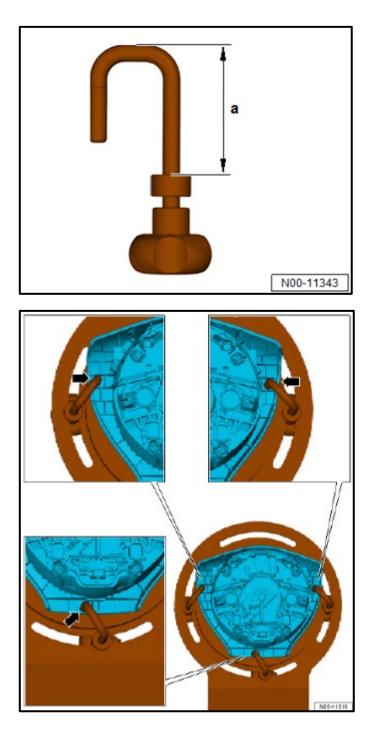
Subsection 2 – Inflator, three spoke steering wheel, with vibration absorption

- The three spoke steering wheel has three • mounting points.
- Tighten mounting by hand to prevent damage.
- Adjust three knurled nuts of securing hooks to <dimension a> 50mm.

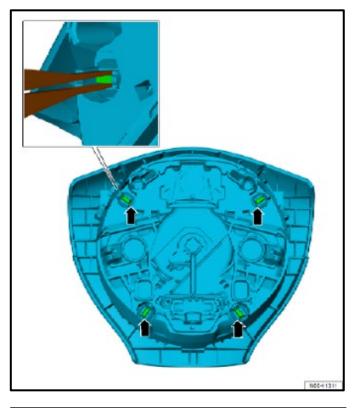
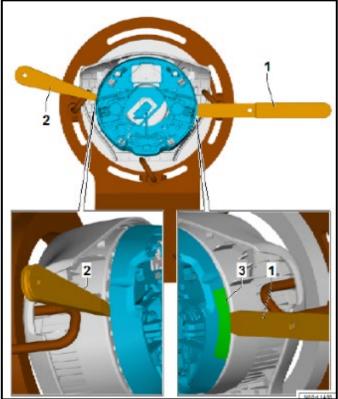
- The locking pins are to be reused. •
- There may be instances in which short locking • pins are fitted. These can be levered out with a small screwdriver.

Remove locking pins <arrows> for horn ring with aid of longnose pliers.

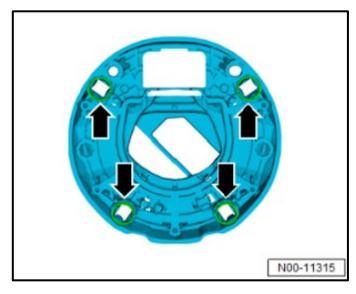
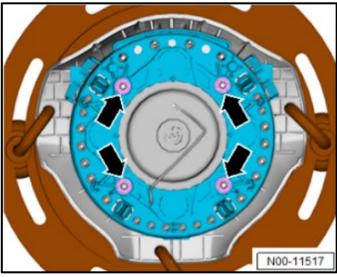
- Apply lever -T10571- <1> in shaded area <3>. At • the same time, apply removal wedge -3409- on the other side <2> and lever off horn ring.
- Repeat work steps on other side.

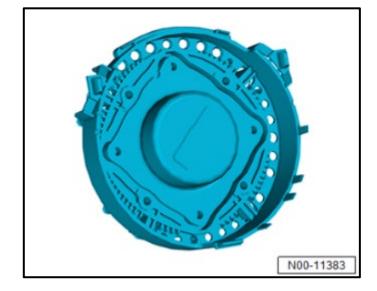
Remove horn ring with springs <arrows>.

- When removing the horn ring, take care that the springs are not lost as they are not available sepereately.
- ONE replacement spring is included in the inflator kit in the event a spring is lost or damaged.
- If more than one spring is lost, replacement of the airbag is required. Replacement of the airbag is required if a spring is lost and is not covered under this action.
- Remove and discard nuts <arrows>.

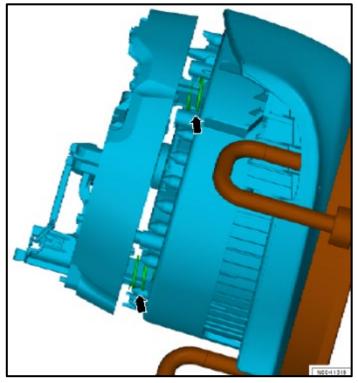
Fit springs <arrows> for horn ring again and allow to engage audibly.

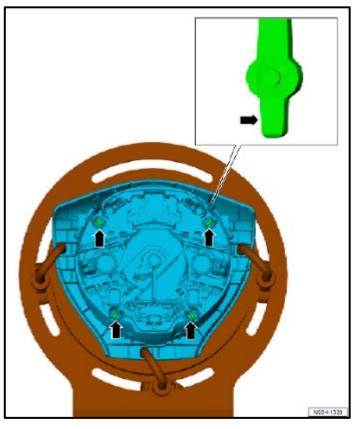
Position horn ring <arrows> with springs on • securing clips and press firmly in place. Ensure that springs are seated correctly on both sides.

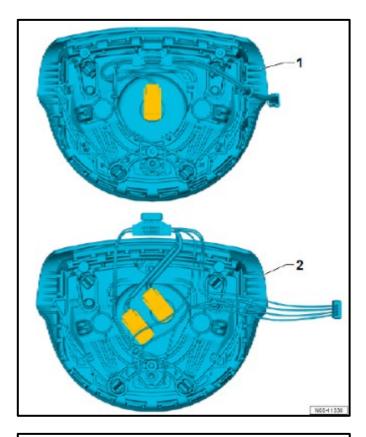
The inflator comes as a single-stage <1> or two-stage <2> version. The work steps for inflator renewal are the same.

- The four spoke steering wheel has two mounting • points.
- Tighten mounting by hand to prevent damage. •
- Adjust three knurled nuts of securing hooks to <dimension a> 50mm.

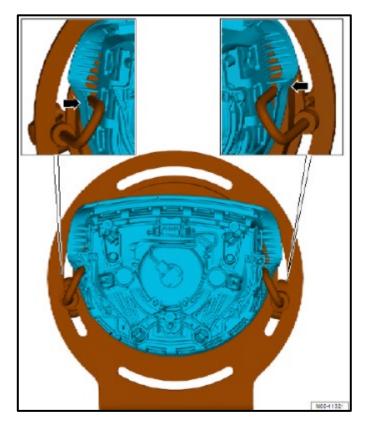
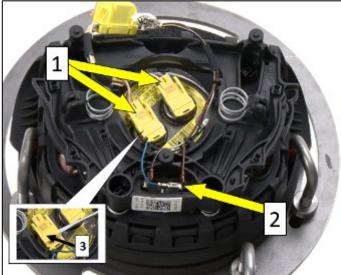
Clamp airbag centrally in airbag support. Securing points on the sides <arrows> and parallel, opposite each other.

The clamps must be placed in the positions shown <arrows> to prevent damage to the airbag. Damage to the airbag is not covered under this action.

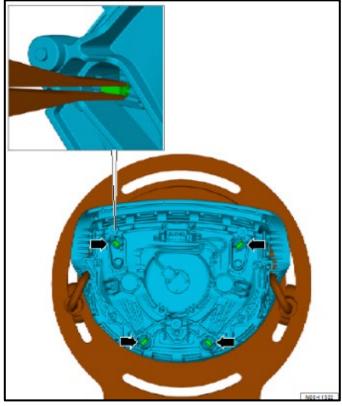
- The locking pins are to be reused. •
- There may be instances in which short locking • pins are fitted. These can be levered out with a small screwdriver.

Remove locking pins <arrows> for horn ring with • aid of longnose pliers.

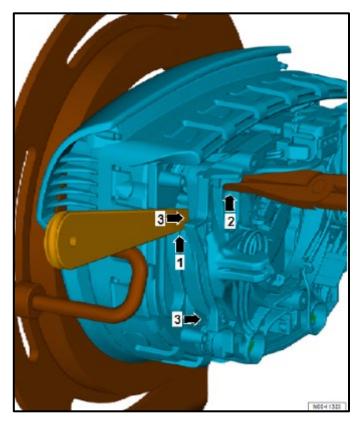
Apply removal wedge -3409- between horn ring and inflator <1> and press together locking elements using longnose pliers <2>. Lever off horn ring at plastic lugs <3>.

- Position the removal wedge -3409- on the plastic lugs to prevent damage to the conductor strip.
- Insert the removal wedge -3409- between the inflator and horn ring to prevent the horn ring from engaging again.
- Repeat work steps on other side. •

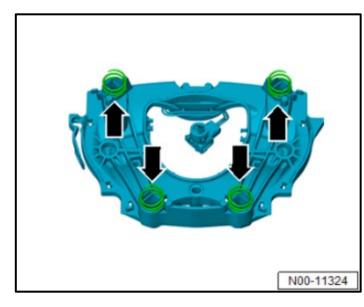
Remove horn ring with springs <arrows>.

- When removing the horn ring, take care that the • springs are not lost as they are not available sepereately.
- ONE replacement spring is included in the inflator • kit in the event a spring is lost or damaged.
- If more than one spring is lost, replacement of the airbag is required. Replacement of the airbag is required if a spring is lost and is not covered under this action.
- Remove and discard nuts <arrows>. •
- Remove the inflator and place in the original packaging.

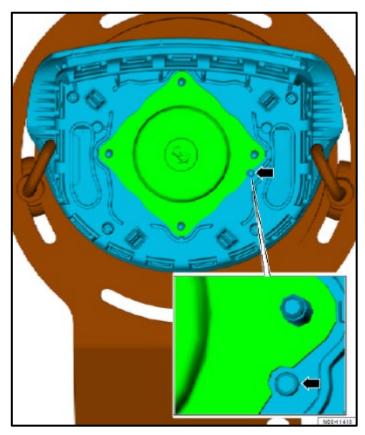
Insert new inflator and check to ensure it is • seated correctly. Note the recess <arrow>.

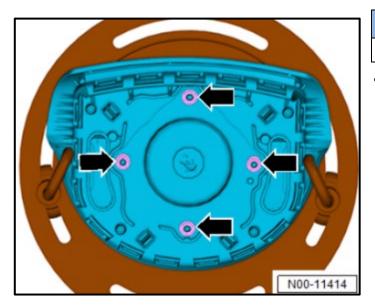
The nuts are self-locking and must be replaced

Install new nuts <arrows> and torgue to 5 Nm ± 0.4 Nm.

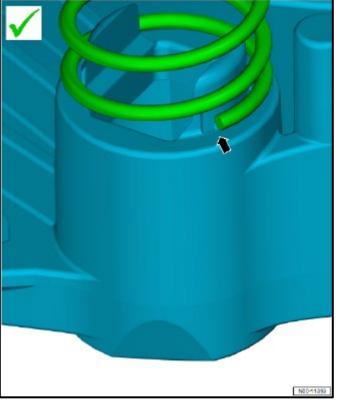
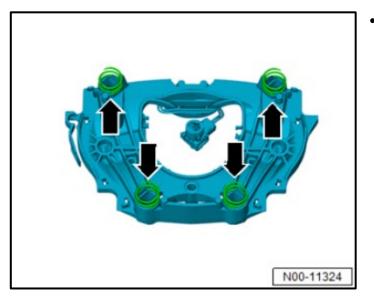
- If one of the springs is damaged or has been lost, it can be replaced with a spring from the bag of spares included.
- Note the examples shown for reference of proper spring seating.
- Spring seated incorrectly <arrow>.

• Spring seated correctly <arrow>.

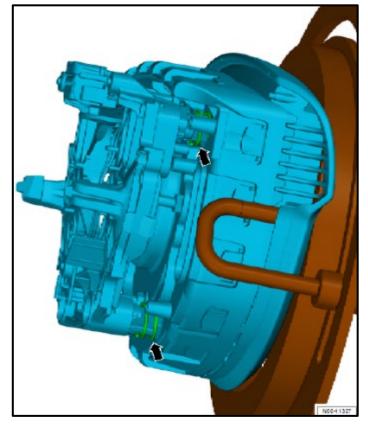
Fit springs <arrows> for horn ring again if necessary.

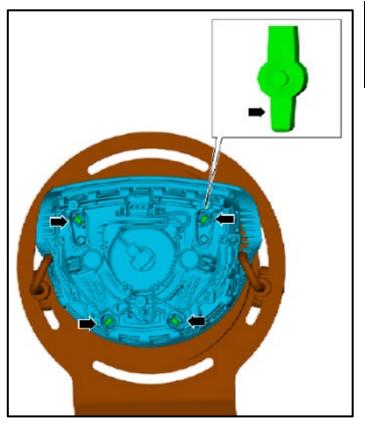
Position horn ring with springs on securing clips • and press firmly in place. Ensure that springs are seated correctly on both sides <arrows>.

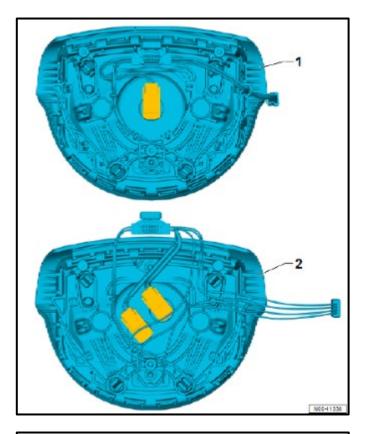
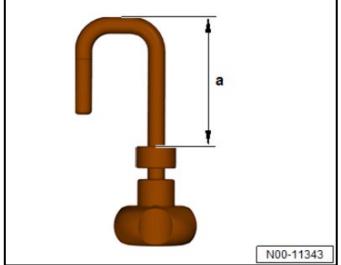
- The inflator comes as a single-stage <1> or two-stage <2> version. The work steps for inflator renewal are the same.
- Tighten mounting by hand to prevent damage.

- The four spoke steering wheel has two mounting points.
- Tighten mounting by hand to prevent damage.
- Adjust three knurled nuts of securing hooks to <dimension a> 50mm.

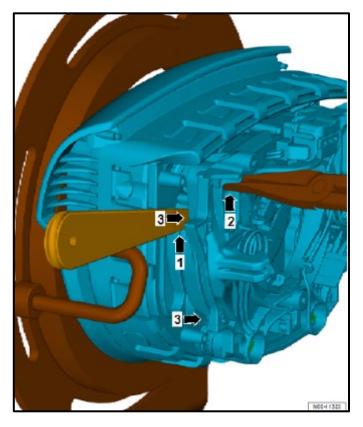
Apply removal wedge -3409- between horn ring and inflator <1> and press together locking elements using longnose pliers <2>. Lever off horn ring at plastic lugs <3>.

- Position the removal wedge -3409- on the plastic lugs to prevent damage to the conductor strip.
- Insert the removal wedge -3409- between the inflator and horn ring to prevent the horn ring from engaging again.
- Repeat work steps on other side. •

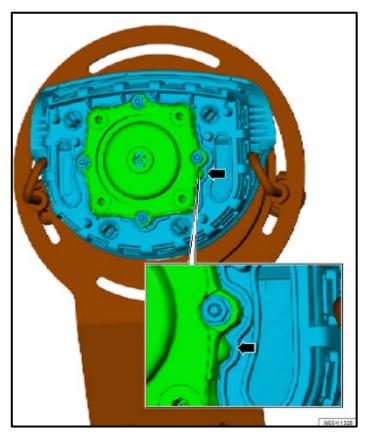
Insert new inflator and check to ensure it is • seated correctly. Note the recess <arrow>.

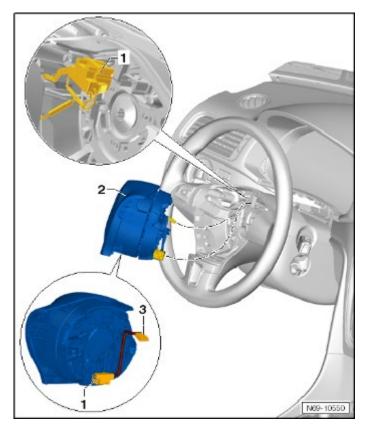
- The battery must be disconnected before • installing the airbag back into the vehicle.
- Before handling pyrotechnic components (for example, disconnecting the connector), the person handling it must "discharge static electricity". This can be done by touching the door striker, for example.
- Connect the connector <1>. The connector must click into place during this.
- Press the connector lock on the connector <1>. •
- Connect the connector <3> (if equipped).
- Insert the airbag unit <2> into the steering wheel but do not press on it.

Procedure illustrated is for a three spoke steering wheel. The procedure for a four spoke steering wheel is the same.

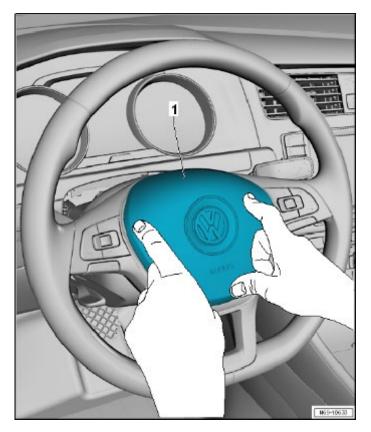
- Press on the edge of the airbag unit <1> with both • hands until it locks into place.
- Gently pull on the airbag unit to make sure the airbag unit is secured correctly at all three • attachment points in the steering wheel.
