Safety Recall **Code: 69Q9**

Subject	TAKATA SDI Driver Frontal Airbag Inflator		
Release Date	December 10, 2021		
Revision Summary	USA ONLY		
	Added Rental Car/Loaner program claiming instructions		
	Added Appendix for Rental Car/Loaner program FAQs		
Affected Vehicles	U.S.A. & CANADA: Certain 2007-2014 MY Volkswagen vehicles equipped with a Takata SDI driver frontal airbag		
	Check Campaigns/Actions screen in Elsa on the day of repair to verify that a VIN qualifies for repair under this action. Elsa is the <u>only</u> valid campaign inquiry & verification source.		
	✓ Campaign status must show "open."		
	 If Elsa shows other open action(s), inform your customer so that the work can also be completed at the same time the vehicle is in the workshop for this campaign. 		
Problem Description	The driver airbag may explode in a crash with airbag deployment. Sharp metal fragments can hit people and cause serious injury or death.		
Corrective Action	Replace the driver frontal airbag inflator with a newly manufactured version. This repair is the <u>final</u> remedy.

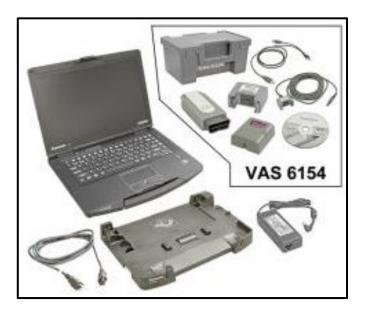
VAS6150D - Diagnostic Tester (or equivalent)

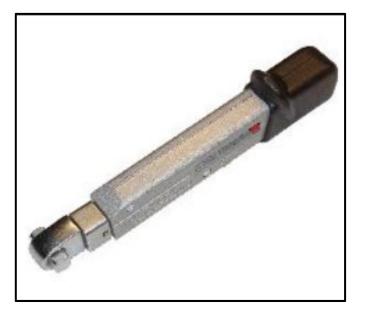
VAG1410 – Torque Wrench (or equivalent)

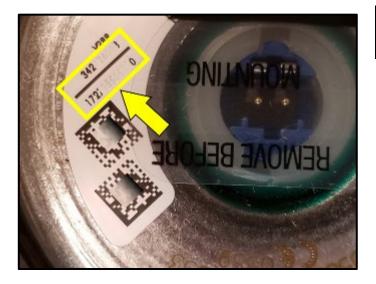
- Place the new inflator on the ESD mat. •
- Scan the data matrix code of the new inflator at a distance of about 15 cm.

The photo is for reference only. The inflator that is installed may be either a single stage or dual stage inflator.

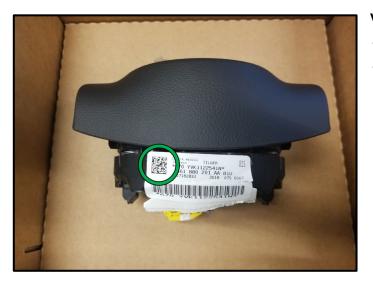
The data matrix code includes the values as shown.

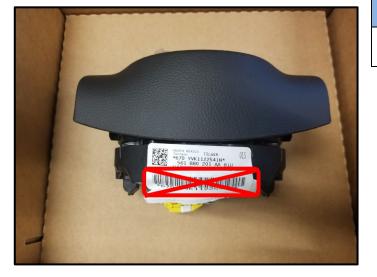
- Place the new airbag on the ESD mat. .
- Scan the data matrix code <circle> of the new • airbag at a distance of about 15 cm.

Scanning the bar code on the new airbag will result in an "implausible barcode" message.

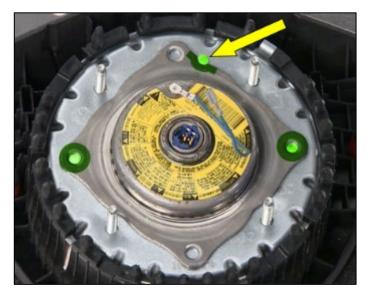
Insert the new inflator as shown. Note the recess <arrow>.

The photo is for reference only. The inflator that is installed may be either a single stage or dual stage inflator.

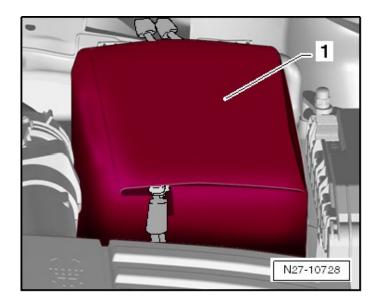
- Close the cover <1>.
- Cycle the ignition off and back on.
- Bring driver seat to an upright position.
- Store previously recorded radio presets (if necessary).
- Set clock to local time.
- Activate the power window regulator one-touch up/down function.
- Check the DTC memories of all the control units and erase under-voltage faults if necessary.
 - (!) **NOTE (Vehicles with Criteria T3)**
