Stop Delivery Remedial Measure

911 Carrera (992), MY 2020

AKC1 Stop Delivery – Reprogramming control unit for the front center console and updating software for various control units

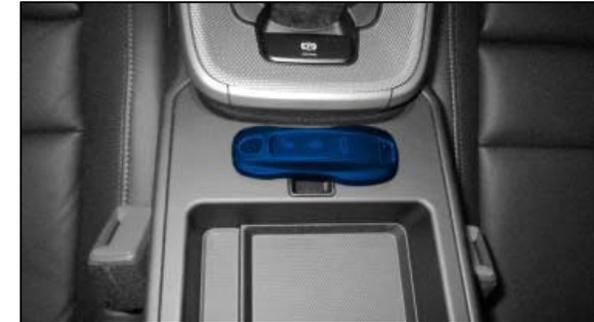
Emergency start tray

1. Connect a suitable battery charger, e.g. **VAS 5908 - Battery charger 90A**, to the jump-start terminals in the luggage compartment and switch on.
2. Place the **driver's key** with the back facing down in the area in front of the storage compartment under the armrest (**emergency start tray**) in order to guarantee a permanent radio link between the vehicle and driver's key. ⇒ *Emergency start tray*
