## 2. VEHICLE INSPECTION PROCEDURE

2019-2020 Model Year Mazda3 vehicles, equipped with smart brake support (SBS)

**B. Reprogram the VCM (Vehicle control module) and IC (Instrument Cluster) using MDRT also used for SSPC5 and Recall 4621B**

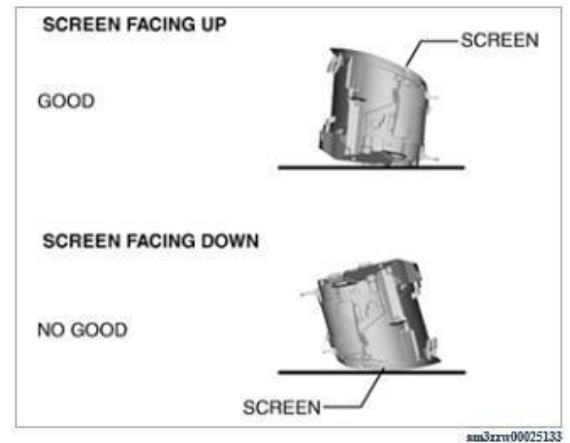
- If the instrument cluster is left for a long time with its screen facing down, grease applied to the needles may spill and the needles may not operate smoothly. When storing the instrument cluster, store it with its screen facing upward.

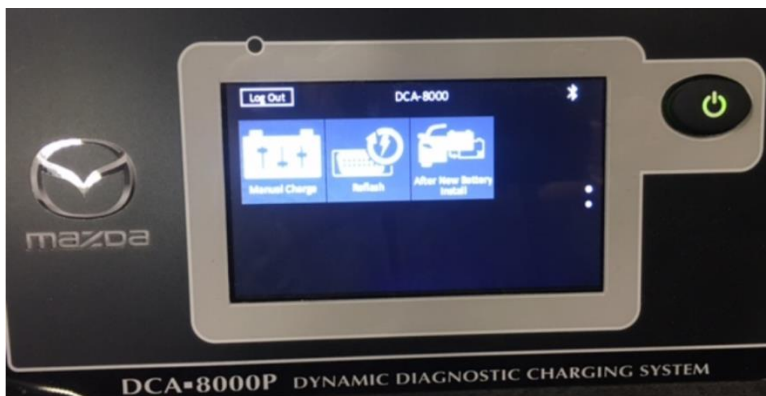
- a. During reprogramming, connect the DCA8000 battery charger using the Reflash mode

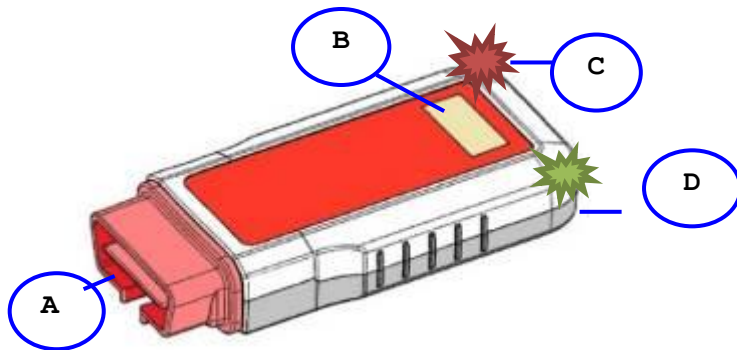
A	OBDII connector
B	Display
C	LED light (Red)
D	LED light (Green or Blue)

LED lights show the configuration status.

\*There are two LED types for MDRT.

1. Green & Red (Serial number up to 02217)
2. Blue & Red (Serial number after 02218)

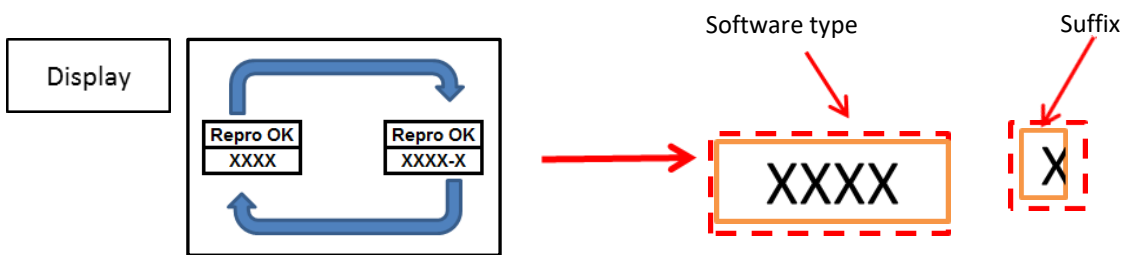
Confirm that the display shows a message after completing reprogramming.

Lower message on the display indicates each of the soft type & suffix

If a suffix becomes higher, Reprogramming is completed.

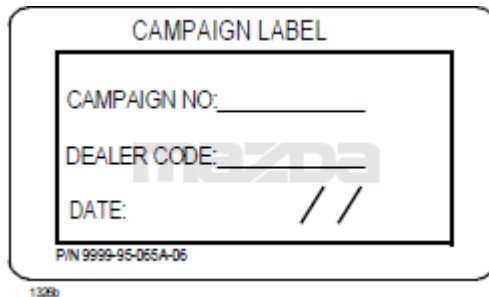
1. Fill out a blue “Campaign Label” (9999-95-065A-06) with Campaign No: “4219L”, your dealer code, today’s date.

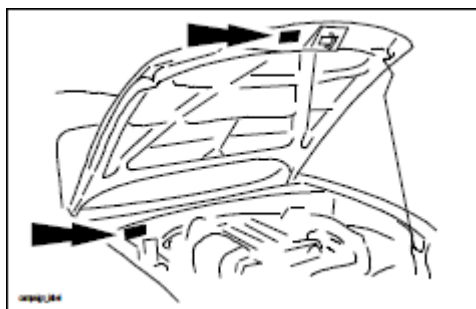
2. Affix it to the hood or bulkhead as shown:
