1. Flowchart - **READ SERVICE CAUTION FOR PROGRAMMING!**

2. VEHICLE INSPECTION PROCEDURE

2019-2020 Mazda3 vehicles, equipped with smart brake support (SBS)

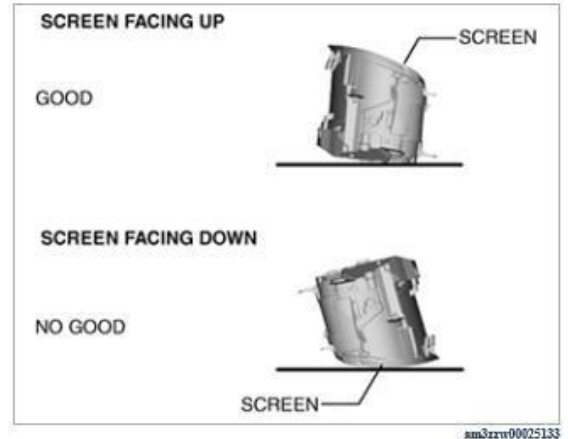
- If the instrument cluster is left for a long time with its screen facing down, grease applied to the needles may spill and the needles may not operate smoothly. When storing the instrument cluster, store it with its screen facing upward.

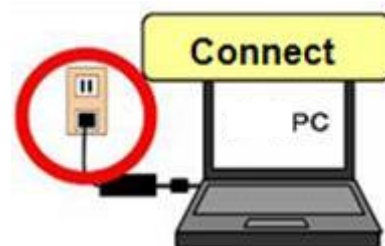
- a. Make sure that the following connections are firmly connected, and then do NOT touch the VCM and DLC cable to prevent from causing noise and poor connection.

- Between the vehicle-side connector and the DLC cable
- Between the PC-side connector and USB port of PC

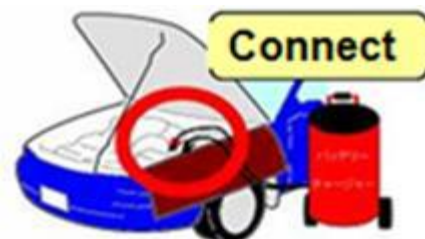
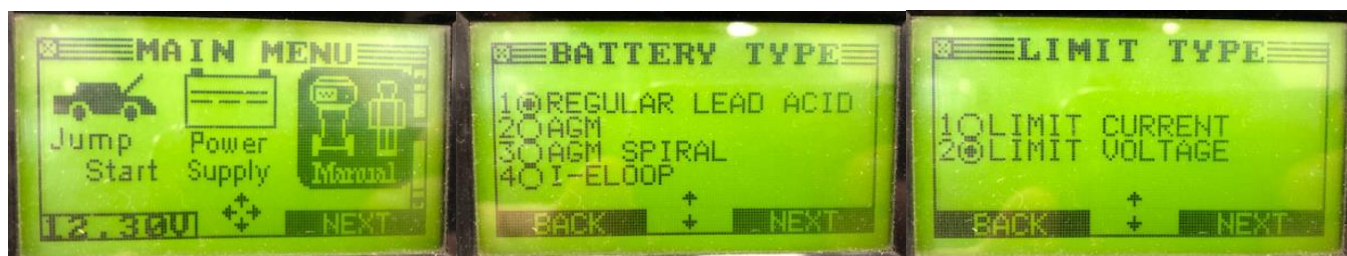
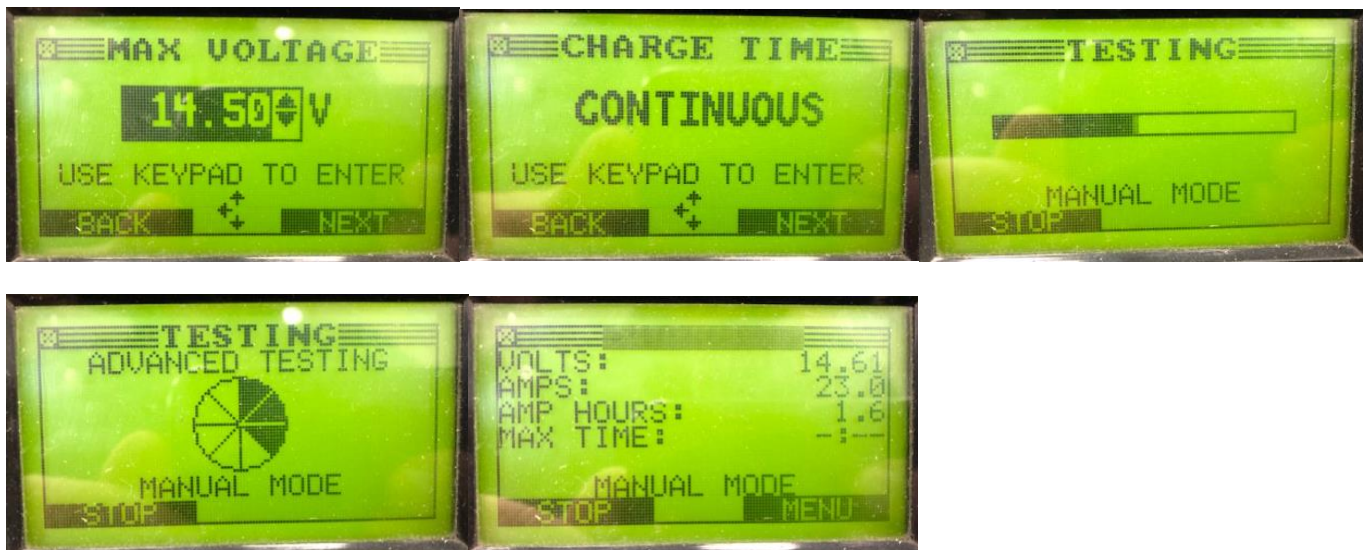
- c. During reprogramming, connect **GR8 battery charger, Manual Mode set to 14.5 volts and continuous charging** to the vehicle to minimize any voltage fluctuation. See the below screen shots to set the GR8 battery charger correctly. **DO NOT USE ANY OTHER CHARGER!**

GR8 Screenshots in order from left to right to set the correct stable charging voltage.

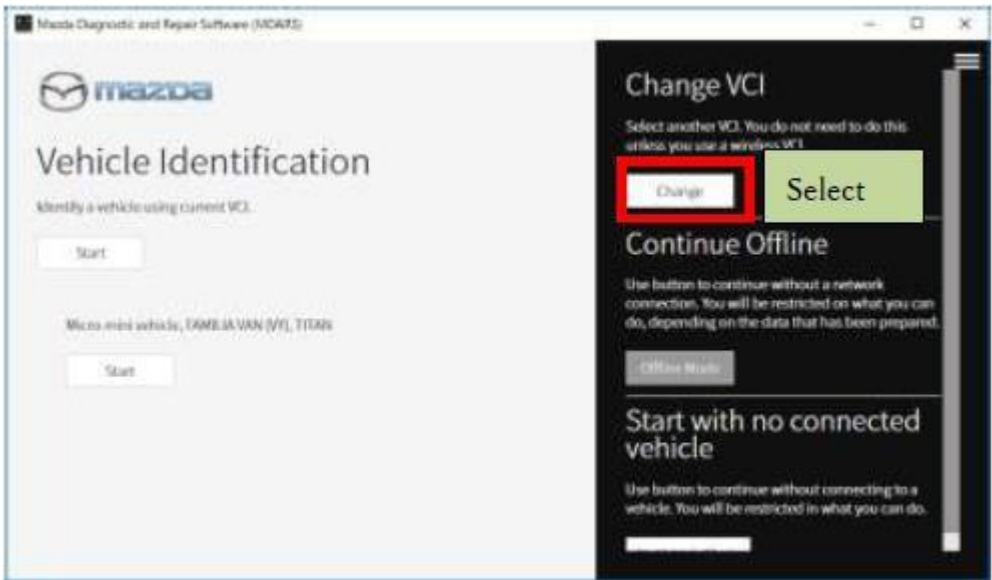
- 1. Thoroughly read the service cautions on the prior pages to avoid module damage!
- 2. Confirm VCI Settings before vehicle identification. Select 'Change VCI'
CAUTION: The Instrument Cluster (IC) could be damaged if Step 2 is not performed

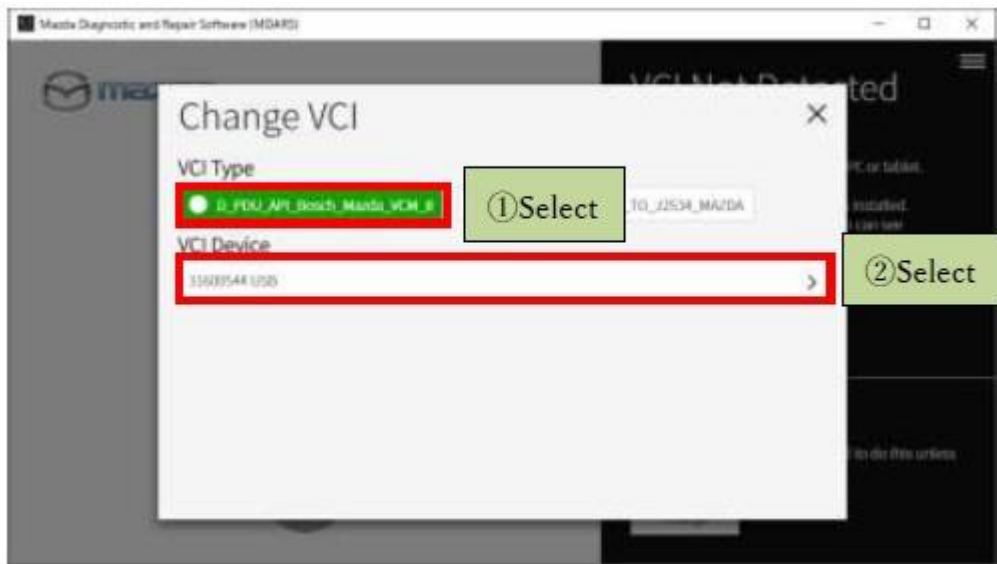
- 3. A Pop up screen will appear, click 'OK'
- 4. Ensure "D_PDU_API_Bosch_Mazda_VCM_II" is selected (highlighted green)
- 5. Under VCI Device, ensure the proper VCM serial number is shown

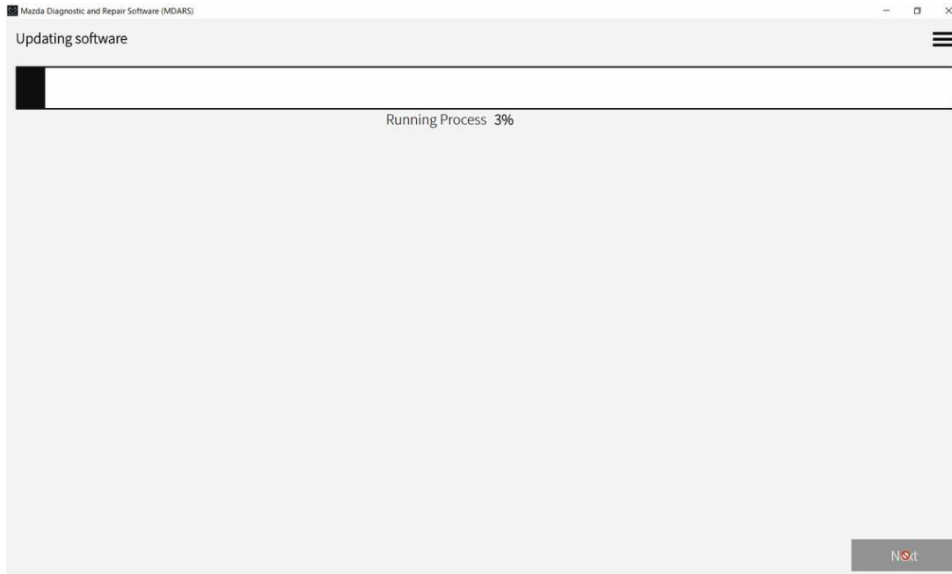
This takes about 3 minutes to complete the Running Process.

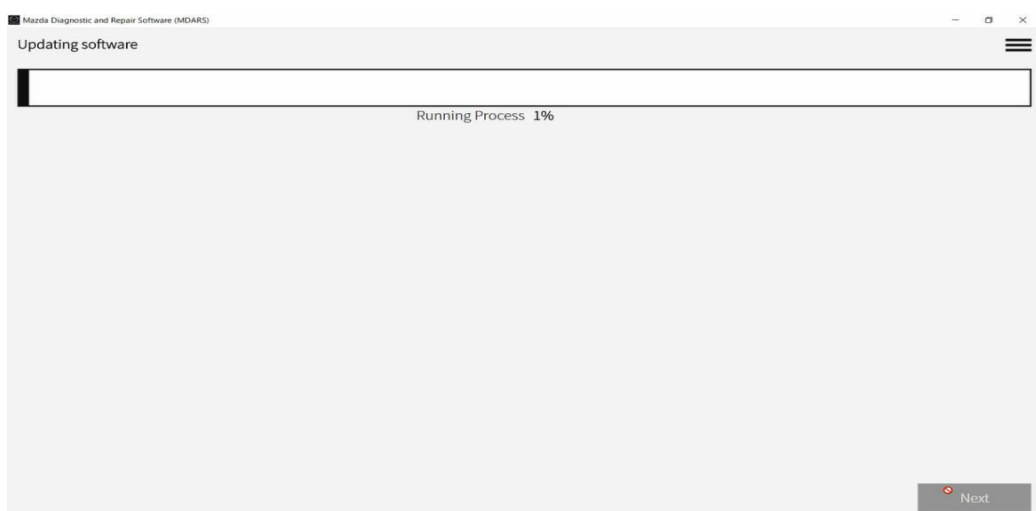
It takes about 4 minutes to complete the running process. Select 'Next' when Running Process is finished.

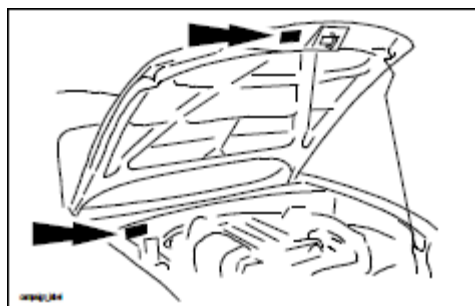
2. Affix it to the hood or bulkhead as shown:
