March 2021
FL859A-W
NHTSA #20V-485

Subject: OptiView Dash Cluster Brightness

Models Affected: Specific Model Year 2015-2019 Freightliner Custom Chassis Corporation XCL, XCM, XCP, XCR, and XCS chassis manufactured October 21, 2014, through May 7, 2019.

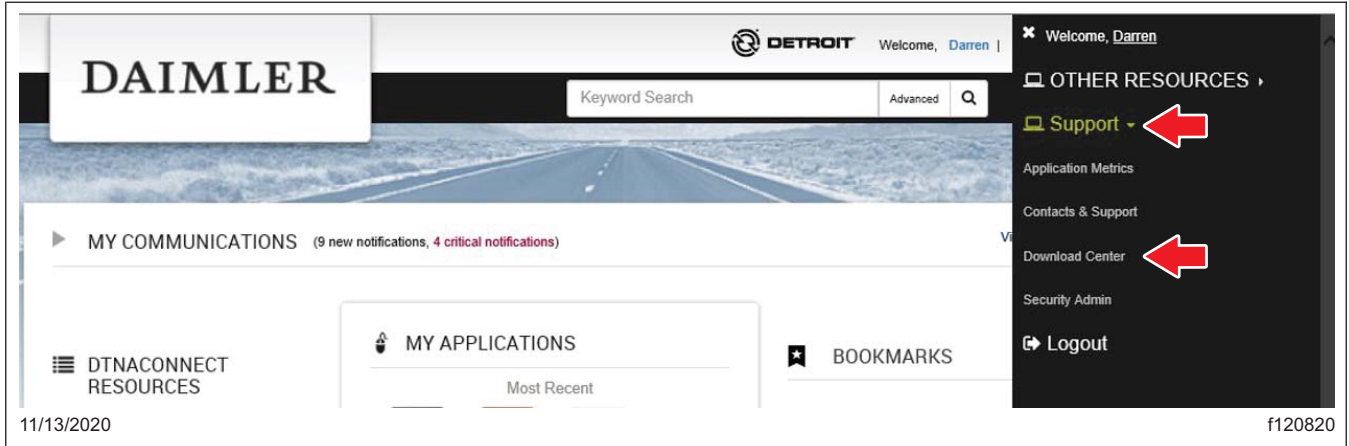
Fig. 2, Selecting Support and Download Center Screen

5. Select 'Support,' then select 'Download Center.' See [Fig. 2](#).

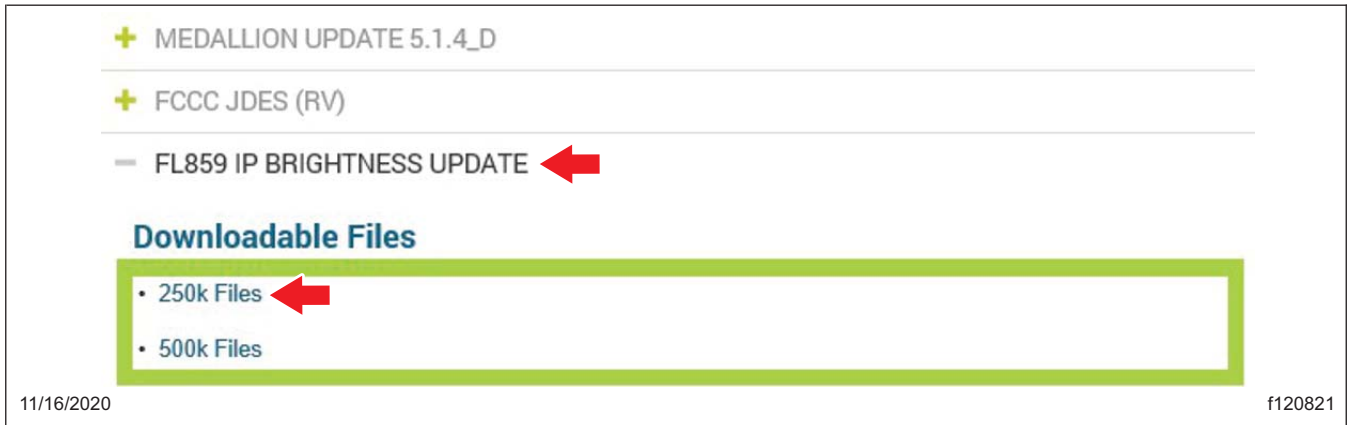
Fig. 3, Selecting the 250k Files Link

6. Scroll down to the 'FL859 IP Brightness Update' and select the '+' symbol, then select the '250k Files' link. See Fig. 3.

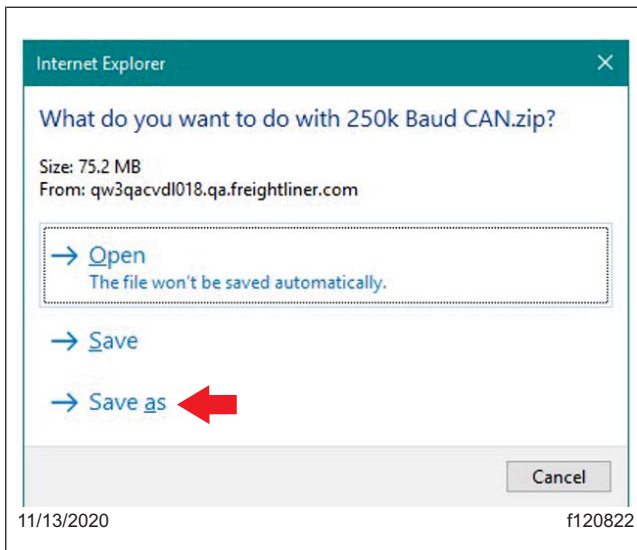
Fig. 4, Selecting Save As

7. Select 'Save As.' See Fig. 4.
8. A window will open, asking where to save the file; select 'Desktop,' as shown in Fig. 5.

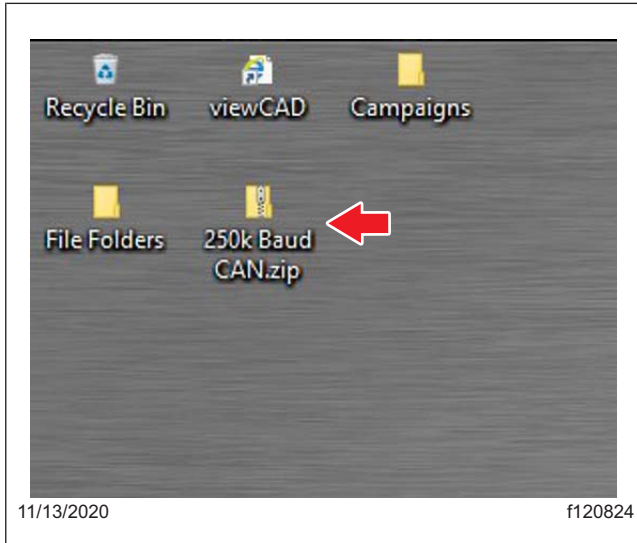
Fig. 6, 250k File on the Desktop

9. Navigate to the desktop and find the file named '250k Baud CAN.zip.' Right click on the file and select 'Extract All...' See [Fig. 6](#) and [Fig. 7](#).

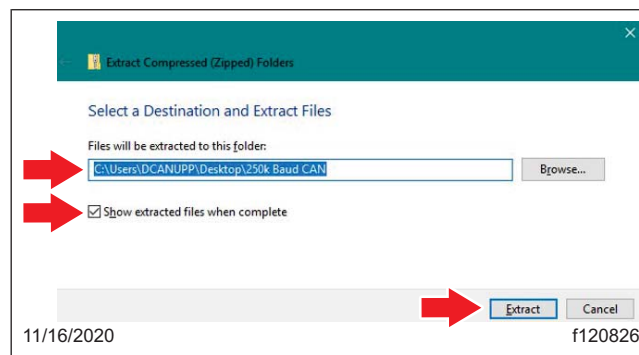
Fig. 8, Extracting the File

10. Allow the default folder location to be where the file is extracted. Make sure the 'Show extracted files when complete' box is checked, then select the extract button. See [Fig. 8](#).

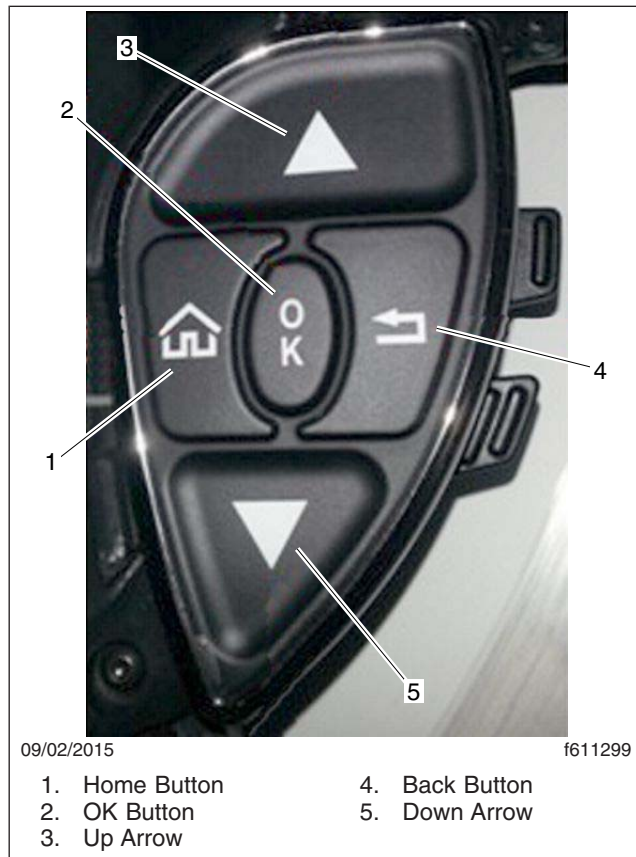
Fig. 12, Steering Wheel Buttons

2. With the ignition on, insert the flash drive labeled '250k, Step 1' in the open USB port on the Viper II module. Using the buttons on the steering wheel, shown in **Fig. 12**, navigate to Diagnostics, then System Information.

3. Hold the OK button to begin the update. See **Fig. 12**.

7. Using the buttons on the steering wheel, shown in [Fig. 12](#), navigate to Diagnostics, then System Information.
8. Hold the OK button to begin the update. Wait for the update to begin. When the update is complete, the system will restart.

11. Using the buttons on the steering wheel, shown in [Fig. 12](#), navigate to Diagnostics, then System Information.
12. Hold the OK button to select 'App.' App "H66-1_1_0_SP5.bin" will appear on the screen.

8. With the ignition on, insert the flash drive labeled '500k, Step 1' in the open USB port on the Viper II module. Using the buttons on the steering wheel, shown in [Fig. 12](#), navigate to Diagnostics, then System Information.

9. Hold the OK button to begin the update. See [Fig. 12](#).
- IMPORTANT:** Do not cycle power on the Viper II module.
10. When the update is complete, the system will restart. After the restart, wait another 10 to 15 seconds after the bulb check for the system to restart again.

13. Using the buttons on the steering wheel, shown in [Fig. 12](#), navigate to Diagnostics, then System Information.
14. Hold the OK button to begin the update and wait for the update to begin. When the update is complete, the system will restart.

17. Using the buttons on the steering wheel, shown in [Fig. 12](#), navigate to Diagnostics, then System Information.
18. Hold the OK button to select 'App.' App "H66-1_1_0_SP5.bin" will appear on the screen.

1. With the ignition in the OFF position, press and hold the up arrow, down arrow, and back button on the steering wheel, shown in [Fig. 12](#), while turning the ignition to the ON position.
2. This will open the configuration menu. See [Fig. 13](#). Examples of the six HMI Configuration menus are shown in [Fig. 14](#) and [Fig. 15](#).

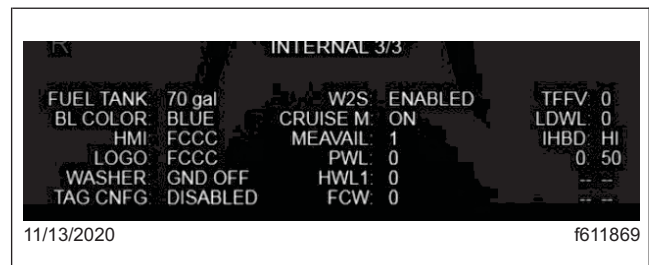
Fig. 17, Internal Diagnostics, Screen Three

4. The first configuration is the fuel tank size; the current active option is highlighted in blue text. Using the up and down arrow buttons on the steering wheel, highlight the correct option based on the table above. For example, 150 should be highlighted for group K.
5. Press OK to select the correct option.
6. Use the up and down arrows to select the next configuration option, then press OK. Repeat this process until all six configuration options have been selected.
7. Verify that all of the options are correct. From the main menu, scroll down to Diagnostics and press OK, then scroll down and highlight Internal Diagnostics and press OK again. See [Fig. 16](#).
8. Scroll down to page three of the Internal Diagnostics screens, shown in [Fig. 17](#), and confirm that the values displayed match the settings for that group in [Table 2](#).
