March 2021
FL859A-AK
NHTSA #20V-485
REVISED BULLETIN

Subject: OptiView Dash Cluster Brightness

Models Affected: Specific Model Year 2015-2019 Freightliner Custom Chassis Corporation XCL, XCM, XCP, XCR, and XCS chassis manufactured October 21, 2014, through May 7, 2019.

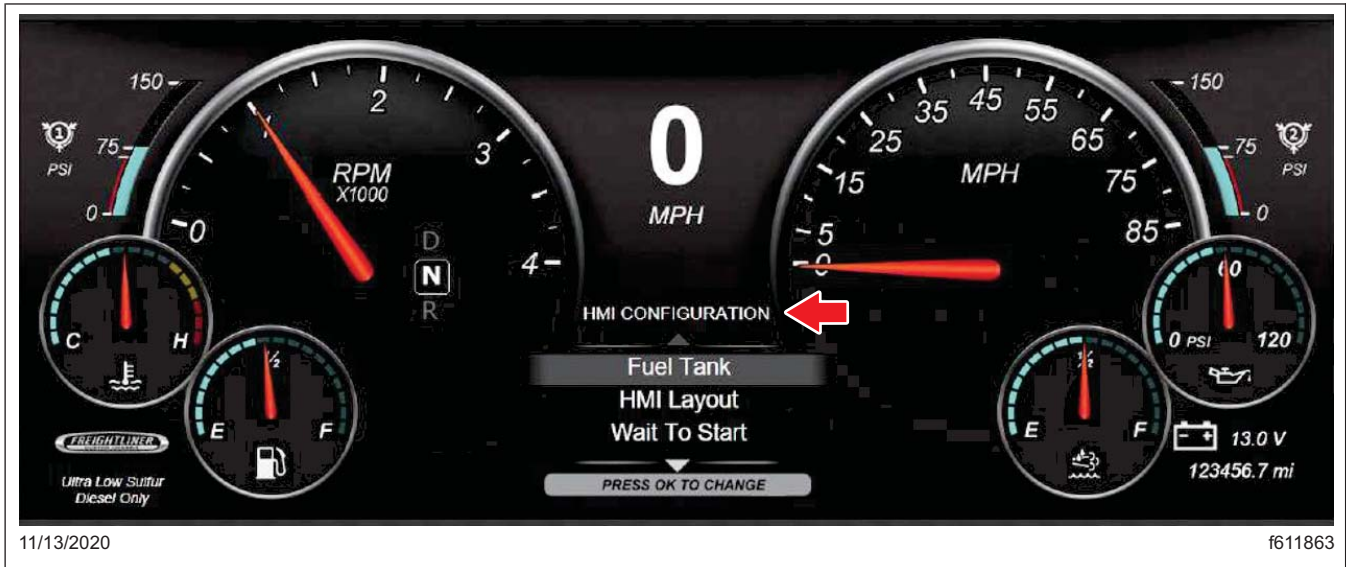
Fig. 13, Configuration Menu

- This will open the configuration menu. See [Fig. 13](#). Examples of the six HMI Configuration menus are shown in [Fig. 14](#) and [Fig. 15](#).

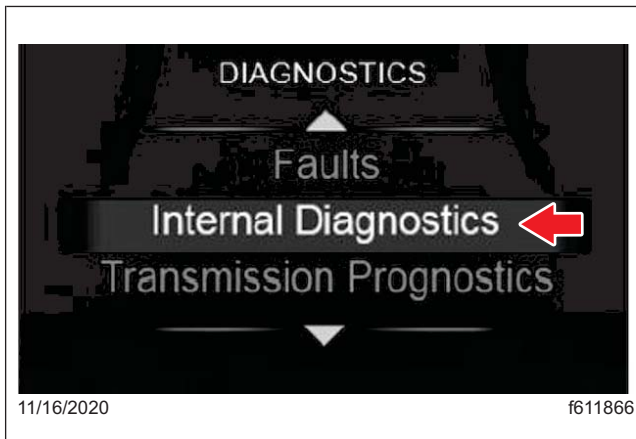
Fig. 16, Selecting Internal Diagnostics

8. Verify that all of the options are correct. From the main menu, scroll down to Diagnostics and press OK, then scroll down and highlight Internal Diagnostics and press OK again. See [Fig. 16](#).
9. Scroll down to page three of the Internal Diagnostics screens, shown in [Fig. 17](#), [Fig. 18](#) and [Fig. 19](#). Confirm that the values displayed match the settings for that group in [Table 3](#).

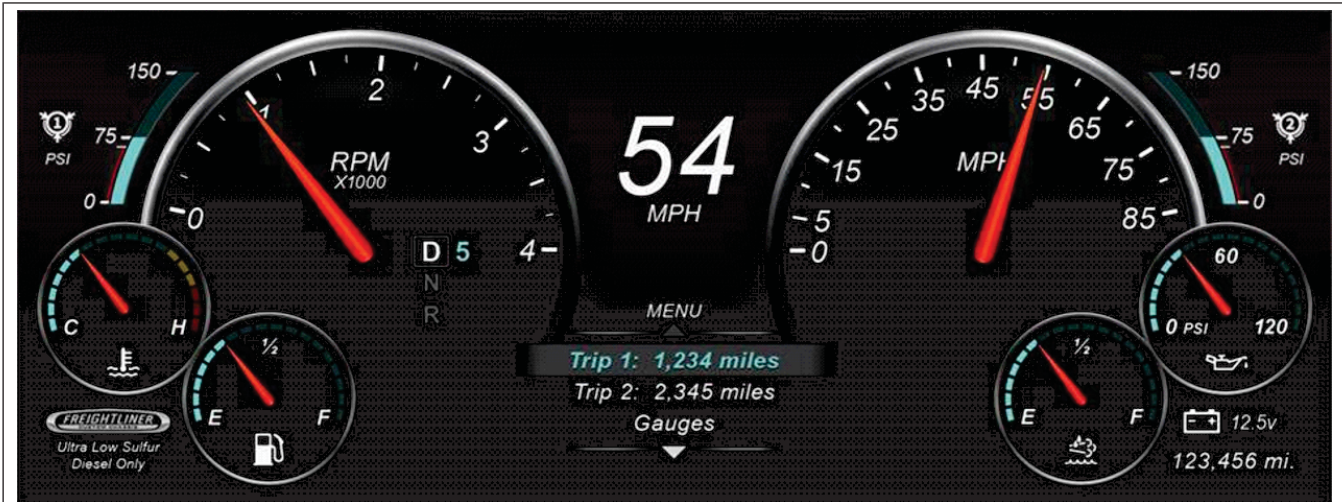
Fig. 20, HMI Configuration, FCC

16. Turn the ignition to ON, and start the engine. Verify the correct HMI Configuration is displaying. See [Fig. 20](#) for an FCC HMI and [Fig. 21](#) for ALT HMI.
