Product Safety Recall

15047 Front Passenger Air Bag Inflator

Release Date: February 2020

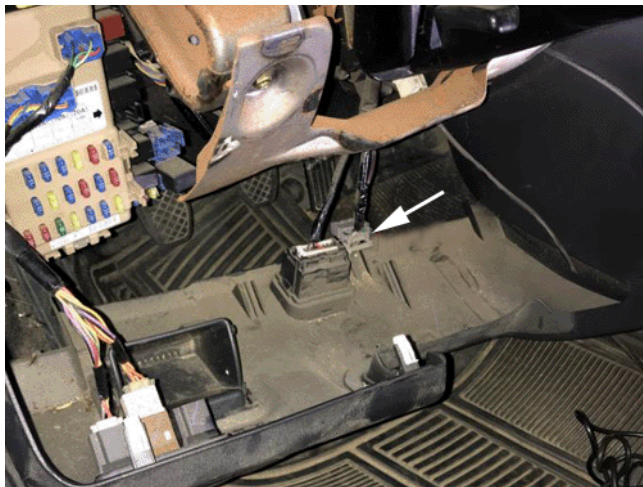
5145813

- 1.2 Remove 3 philips-head screws, pull the instrument panel lower cover at the clips (1) to remove.
- 1.3 Locate the B79 Check Connector near the OBDII connector.
- 1.4 Disconnect the two connectors to the switches on the left side of the panel to provide additional clearance.

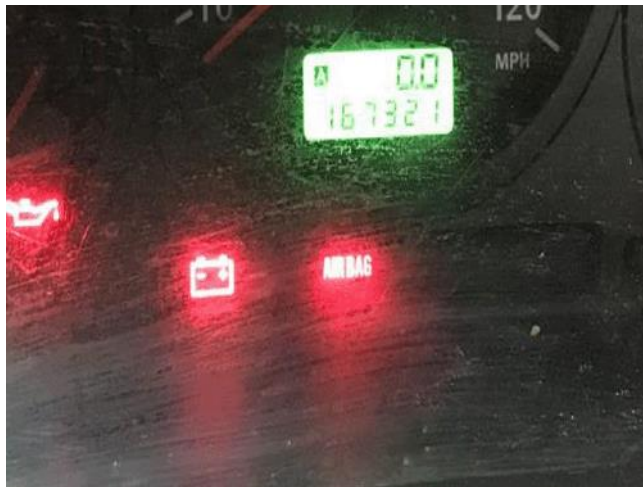
5145828

- 1.4 Watch the “AIRBAG” warning light in the cluster. It will begin to blink.
- 1.5 The long segments (1.2 seconds on) indicates a “ten”, and the short segment (0.3 seconds on) indicates a “one”. The warning light flashes a code corresponding to the fault.
- 1.6 There will be a brief pause approximately 6 seconds long between each DTC (No Light).
- 1.7 Read all codes until they begin to repeat. Write down all the codes.
- 1.8 See **DTC Code Listing chart – Table 1** at bottom of document for DTC code descriptions.

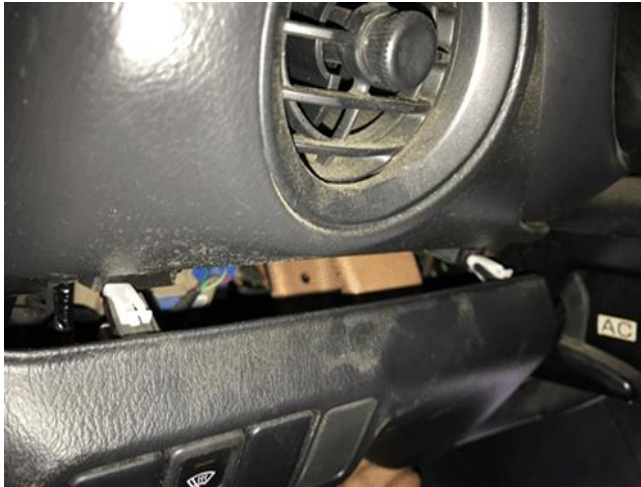
5145832

- 1.7 Rotate panel back to correct orientation.
- 1.8 Carefully line up the 3 upper clips that hold the panel on.

- 1.9 Snap the trim panel back into place.
- 1.10 Reinstall the 3 Phillips screws.
- 1.11 Turn Ignition Switch on.
- 1.12 Verify that the "AIRBAG" warning light comes on for 3 seconds and then goes out.

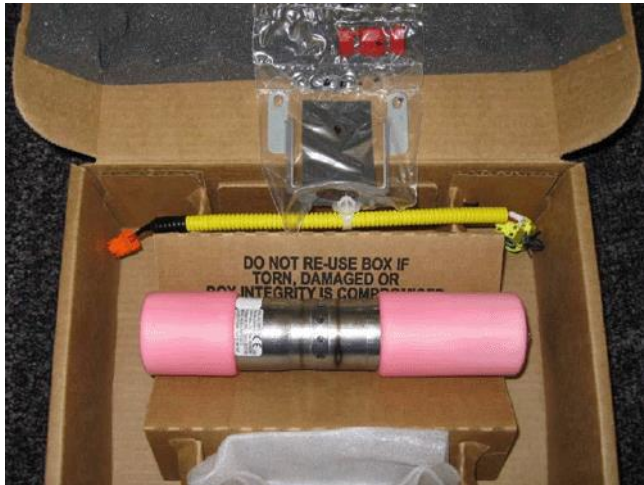
5145838

6. Open the front passenger air bag inflator kit box and confirm all the necessary components are included:
- 4 Self-Locking nuts
 - New Type 2 Inflator (pink collars on each end identify it as the replacement part)
 - New Inflator Harness
 - New Stopper Plate
 - Electro-Tap (red shorting crimp connector)
 - 1 ½" X 2 ¼" piece of self-adhesive Sponge Tape
 - Shipping Documentation and Instructions

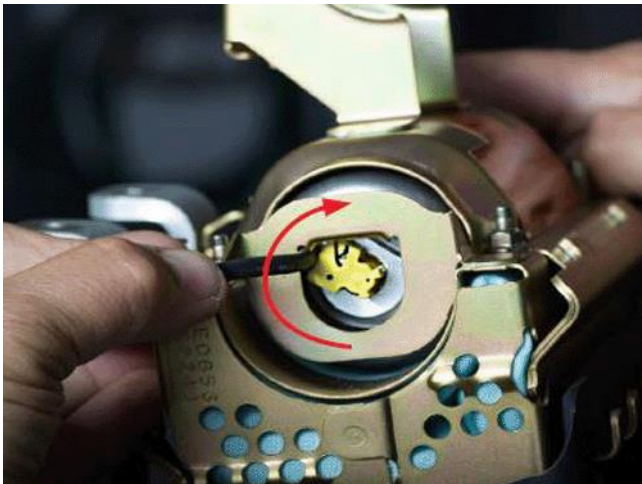
5145849

12. With the stopper plate removed and the other 2 self-locking nuts loosened, unseat the inflator off the mounting bracket end plate then rotate it slightly **CLOCKWISE** to make it easier to remove as shown in the photo to the right. Slide the inflator out of its mounting while feeding the cut off portion of the wiring harness through the “D-Shaped” hole in the end of the mounting bracket. **NEVER ATTEMPT TO REMOVE THE HARNESS FROM THE INFLATOR!**

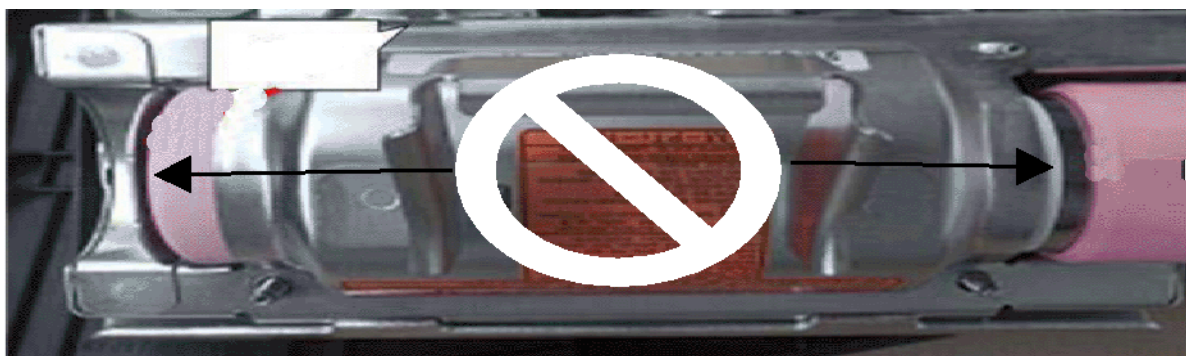
5145858

15. Inspect the new **Type 2** inflator to confirm the locating protrusions on each of the pink-collar portions are aligned as shown below. The “short” collar can be rotated as needed to align it with the protrusion on the “long” collar if necessary.

NOTE: The Type 2 inflator is installed in the opposite direction of the original. This change puts the connector on the other end. The new harness has been extended approximately 2” to compensate.

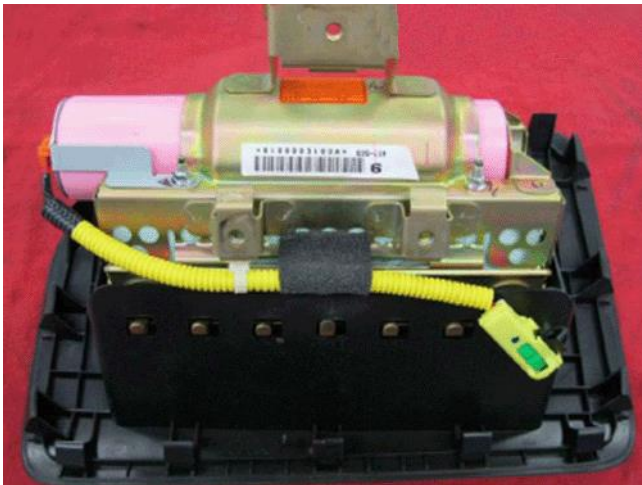
5145874

21. Peel the adhesive backing and install the new Sponge Tape onto the yellow harness tube first then adhere it to the air bag mounting bracket as shown.

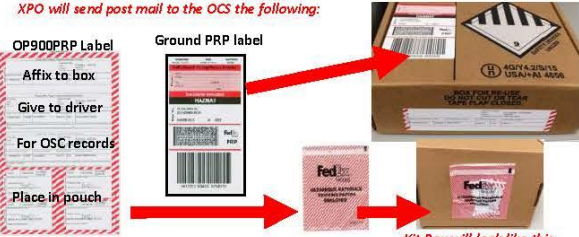
OP900PRP Label
Affix to box
Give to driver
For OSC records
Place in pouch

Ground PRP Label

1. Peel off the backing of the FedEx Ground PRP Shipping label and **affix to top of each box to left of the Class 9 label (see below)**
 - Use the scribe line on the box as a guide.
 - The FedEx Ground PRP Shipping label must not touch any portion right of the scribe line.
2. **OP900PRP label is a multiple part label, please see below for further instructions**
2. A single combined shipment of your individually labeled boxes will **be scheduled by XPO (Example: one shipment of 9 boxes)**
3. **Do Not** contact FedEx **unless you are instructed to by XPO.**
