Product Safety Recall

15048 Front Passenger Air Bag Inflator

Release Date: February 2020

| Correction | Dealers are to replace the front passenger air bag inflator. |

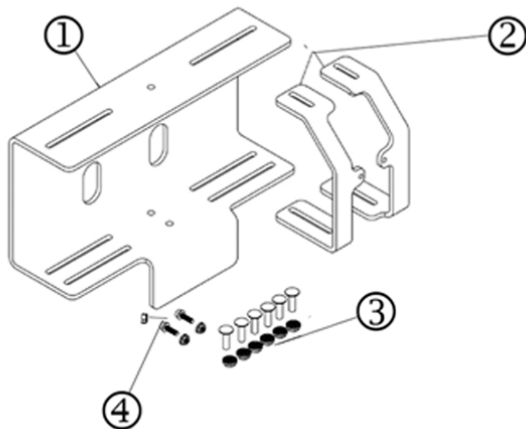
4006668

The air bag mounting bracket, shown below, must be used to safely perform the front passenger air bag inflator replacement procedure described in this bulletin. All GM dealers should already have at least one of these mounting brackets in their special tool inventory. They were provided by GM through Bosch Automotive Service Solutions in late 2015 to address previous Takata air bag safety recalls. The Bosch special tool number is EL-51377. If your dealership does not have the air bag mounting bracket, do not attempt to perform this service procedure and immediately contact Bosch at 1-800-GM-TOOLS for assistance. Attempting to replace the front passenger air bag inflator without using the bracket poses a safety risk for the technician and anyone else in the area.

(1) Mounting Bracket (2) Support Bars (3) Support Bar Hardware (4) Air Bag Mounting Hardware.

WARNING: The removed air bag assembly must be mounted to the air bag mounting bracket (Tool # EL-51377) as shown in the photo to better secure it during the inflator and wiring harness component replacement procedures.

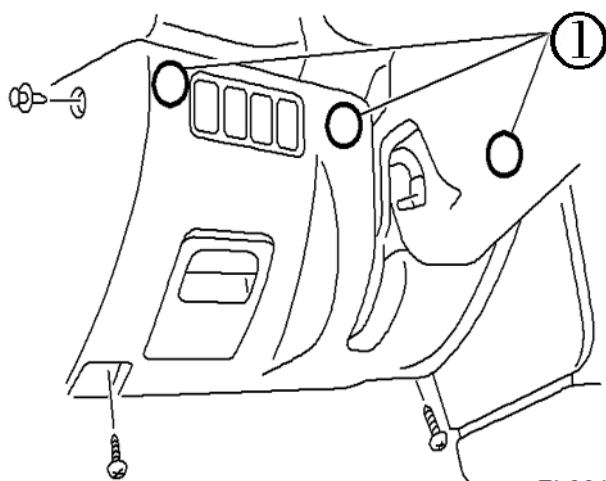
FIGURE 5145811

1. Air bag System – Diagnostic Trouble Code (DTC) read out. Determine if any pre-recall diagnostic trouble codes (DTCs) exist. Record set DTCs if present, on the job card. Notify the vehicle owner of condition, cause and correction recommendation and secure the owner's authorization to proceed with any non-recall related repairs prior to continuing with the recall procedure.
 - 1.1 Remove the lower steering column trim.

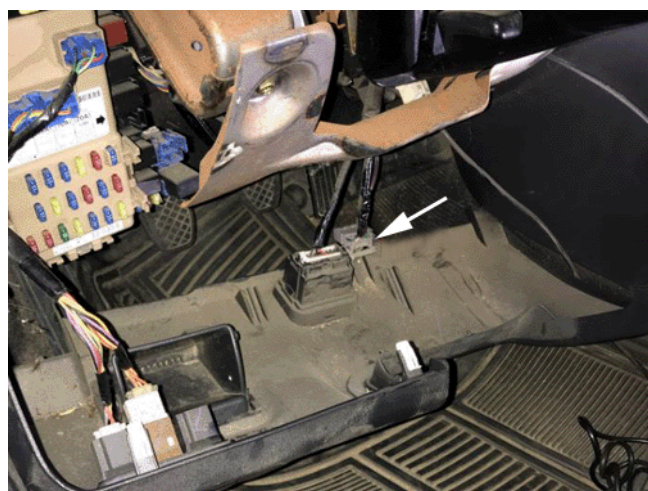
5145813

- 1.2 Remove 3 philips-head screws, pull the instrument panel lower cover at the clips (1) to remove.
- 1.3 Locate the B79 Check Connector near the OBDII connector.
- 1.4 Disconnect the two connectors to the switches on the left side of the panel to provide additional clearance.

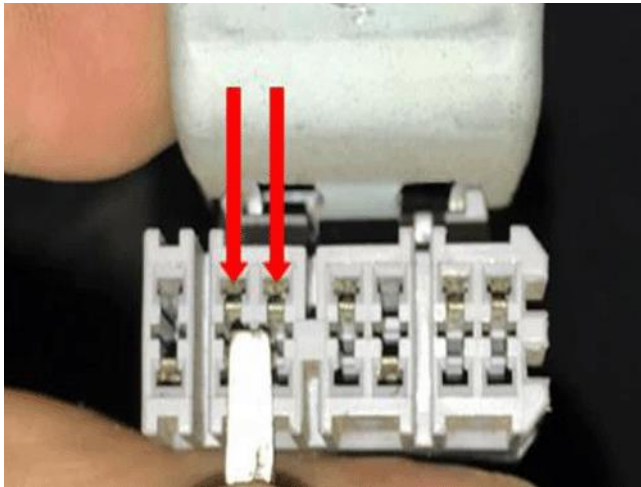
5145817

- 1.6 Remove the tape covering the Ground Terminals. You are now ready to check flashing codes by viewing the air bag light.

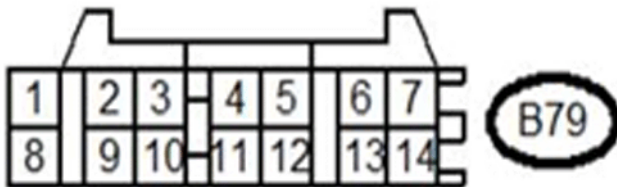
5145820

1.2 Locate B79 Check Connector Pins 2 and 3.

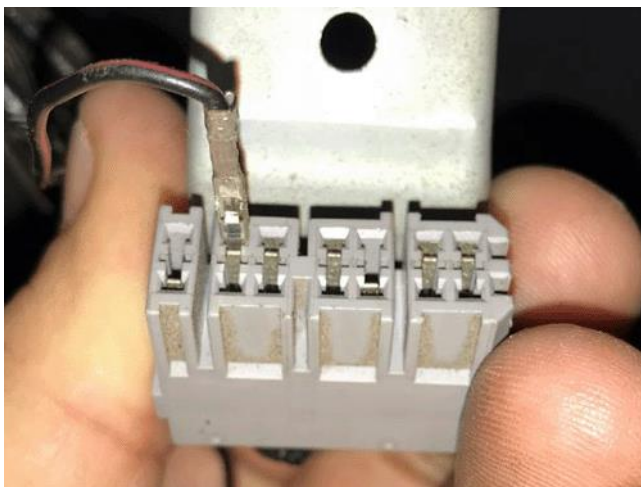
5145822

1.3 Connect either one of the Ground Terminals to B79 Check Connector pin 2.

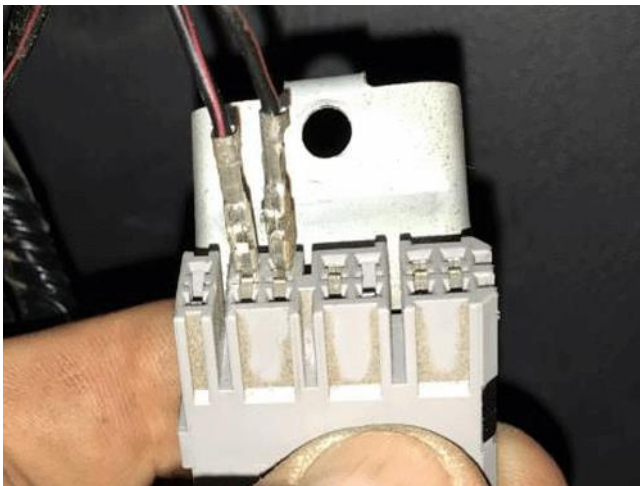
5145830

1. With the first Ground Terminal still connected and while the “AIRBAG” warning light flashes, connect the other Ground Terminal to the B79 Check Connector pin 3.
 - 1.1 Once the fault is repaired and the memory is erased, the warning light will flash one long time (1.2 seconds on) and then returns to the normal flash rate (0.6 sec on).
 - 1.2 If the warning light does not return the normal flash rate (0.6 sec on) this indicates that a fault remains. Once the repair has been made, erase the memory again and confirm that the normal flash rate has returned.
 - 1.3 When the memory has been cleared, disconnect the Ground Terminals from the B79 Check Connector.
 - 1.4 Apply insulating tape around the Ground Terminals and secure them to the harness with tape.
 - 1.5 Reattach the Check Connector to the panel with the Phillips screw.
 - 1.6 Turn the ignition switch off.

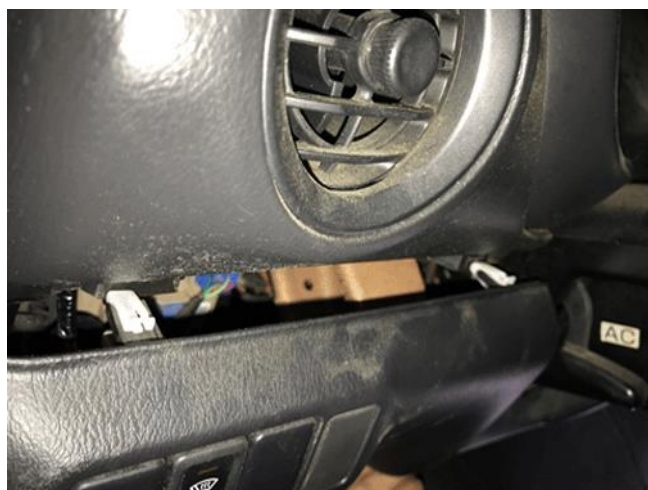
5145832

- 1.7 Rotate panel back to correct orientation.
- 1.8 Carefully line up the 3 upper clips that hold the panel on.

- 1.9 Snap the trim panel back into place.
- 1.10 Reinstall the 3 Phillips screws.
- 1.11 Turn Ignition Switch on.
- 1.12 Verify that the "AIRBAG" warning light comes on for 3 seconds and then goes out.

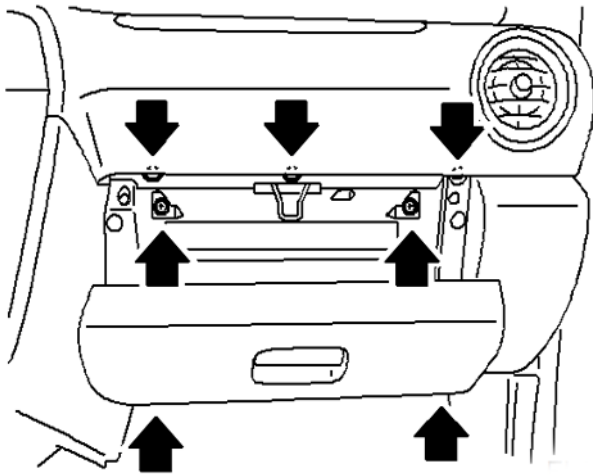
5145835

3. Remove the glove box assembly.
 - 3.1. Open the glove box.
 - 3.2. Remove the glove box screws.
 - 3.3. Remove the glove box.

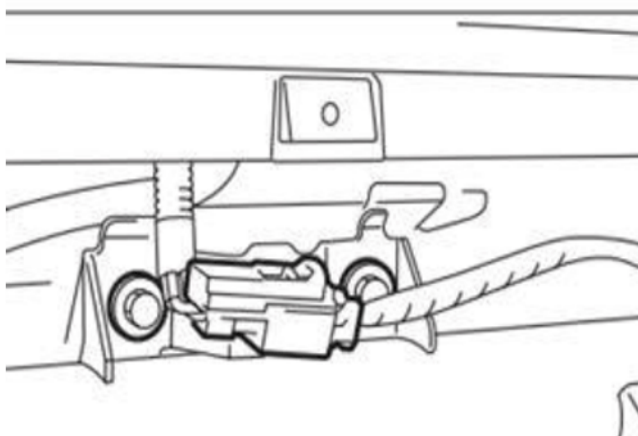
5145837

4. Disconnect the air bag assembly harness connector from the support beam bracket.
5. Remove the 3 retaining bolts and **CAREFULLY** remove the air bag assembly from the vehicle and place it on a clean cloth to protect the dash trim surface portion from damage.

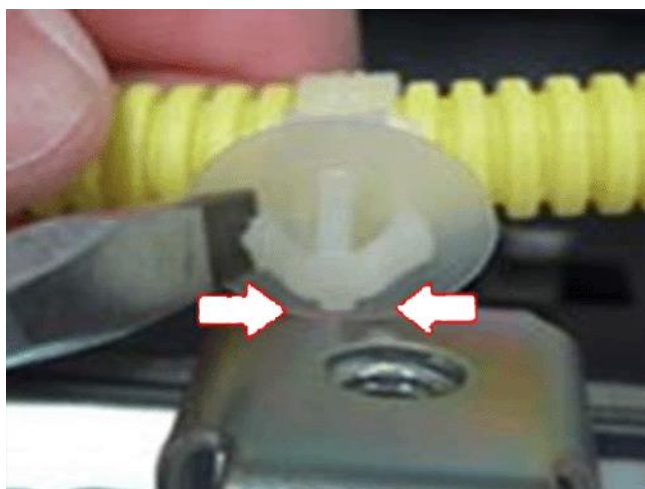
5145841

7. Peel the Sponge Tape and remove the harness clip from the retainer bracket by pushing the tangs inward with a flat-blade screwdriver as shown. Always remove any Sponge Tape adhesive residue from the air bag mounting bracket using mild solvent on a clean shop cloth.

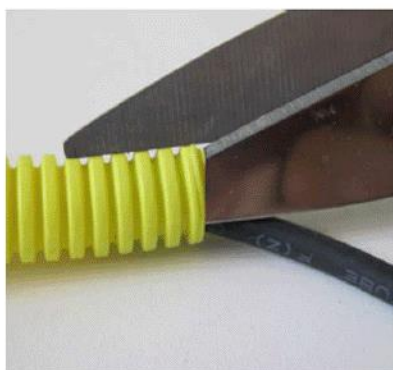
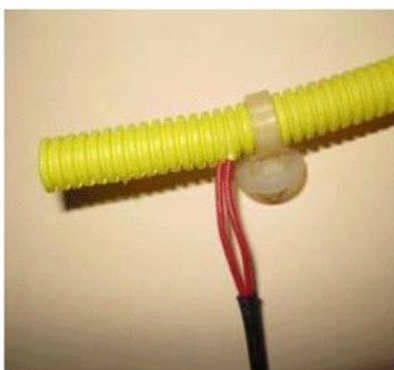
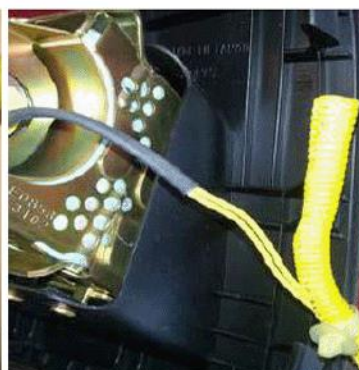
5145843

8. CAREFULLY cut the yellow harness cover enough (approximately 2 inches) to expose the 2 red (or yellow) wires inside and provide enough room to install the Electro-Tap (shorting) connector using a wire cutter or scissor (no knives or razors). TAKE YOUR TIME AND BE CAREFUL TO NOT CUT THE 2 WIRES!

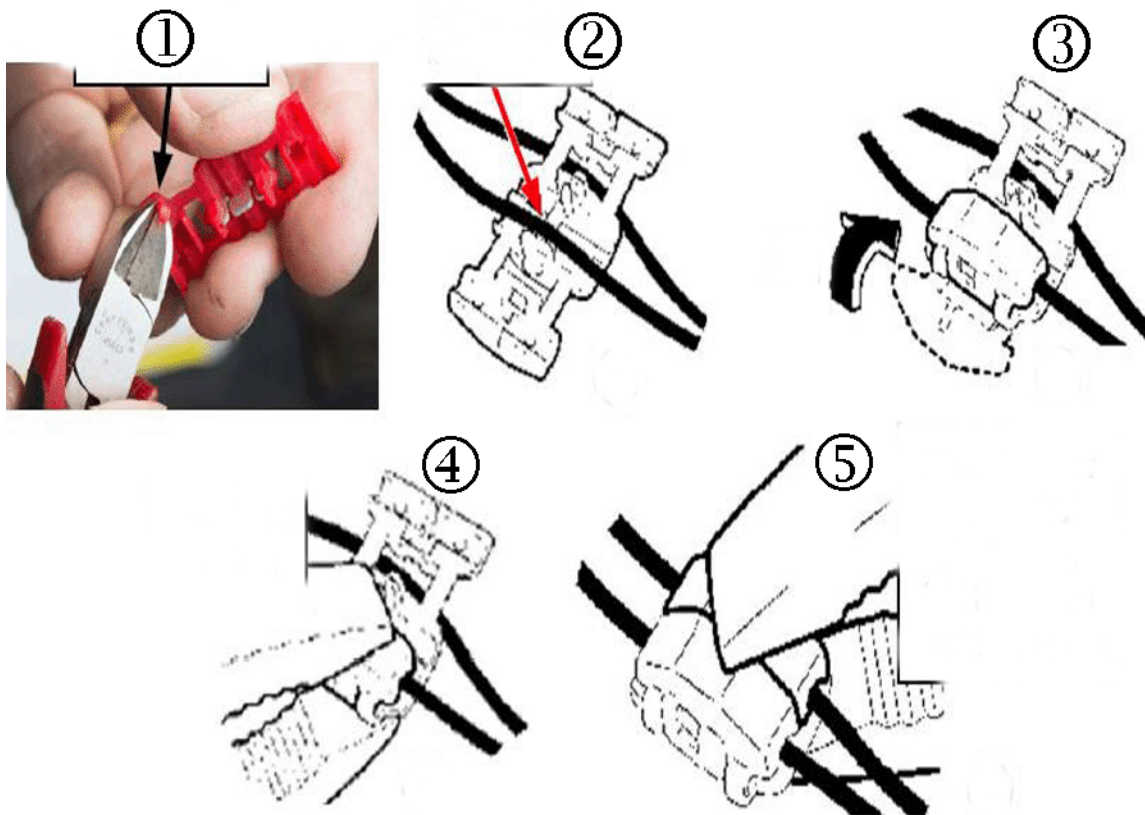
5145844

- (1) This tab must be cut off.
 - (2) Insert 1 wire in the Electro-Tap.
 - (3) Fold.
 - (4) Crimp closed with pliers.
 - (5) Place the other wire in the Electro-Tap, fold then crimp closed with pliers.
9. Short the 2 wires together by installing the Electro-Tap connector. The connector creates a short circuit which acts as a safeguard to prevent against static discharge that may deploy the removed inflator. The tab portion of the Electro-Tap connector **MUST** be cut off prior to use to ensure a good short-circuit is made as shown in the illustration below. **Follow the sequence** below for installing the Electro-Tap connector. Use pliers to squeeze closed the two sections of the connector together, **one section at a time**.

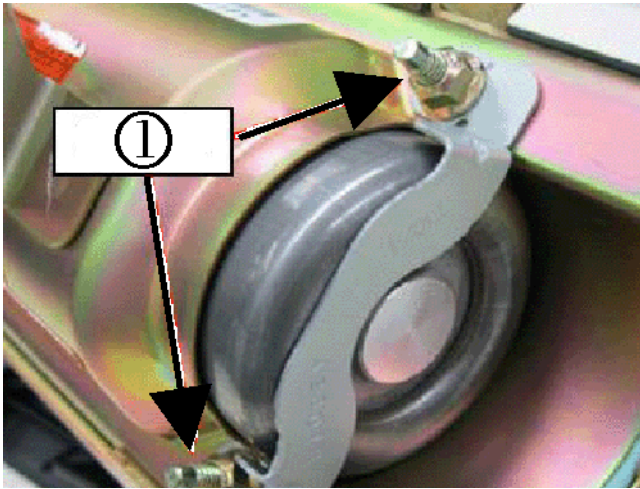
5145848

11. Remove the two 8mm self-locking nuts (1) securing the stopper plate. Loosen but do not remove the other two nuts on the mounting bracket as leaving them in place will help keep the air bag assembly together.

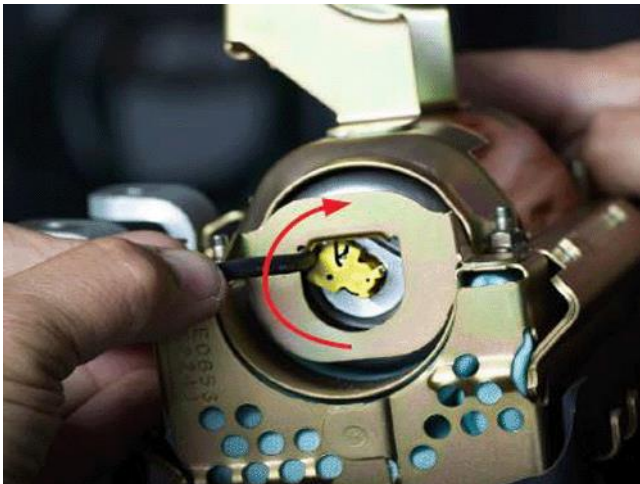
5145849

12. With the stopper plate removed and the other 2 self-locking nuts loosened, unseat the inflator off the mounting bracket end plate then rotate it slightly **CLOCKWISE** to make it easier to remove as shown in the photo to the right. Slide the inflator out of its mounting while feeding the cut off portion of the wiring harness through the "D-Shaped" hole in the end of the mounting bracket. **NEVER ATTEMPT TO REMOVE THE HARNESS FROM THE INFLATOR!**

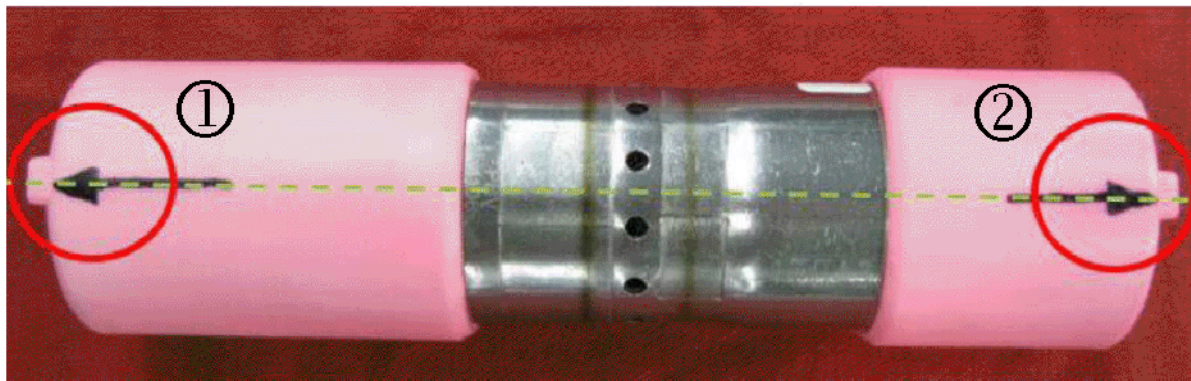
5145856

14. VERY IMPORTANT: Record the 11-digit alpha-numeric serial number for both the removed (Type 1) and 14-digit numeric serial number for the new (Type 2) inflator on the job card hard copy. This information will be required for completion of the Part Return Notice. The new 14-digit numeric serial number is also a requirement for claim entry.

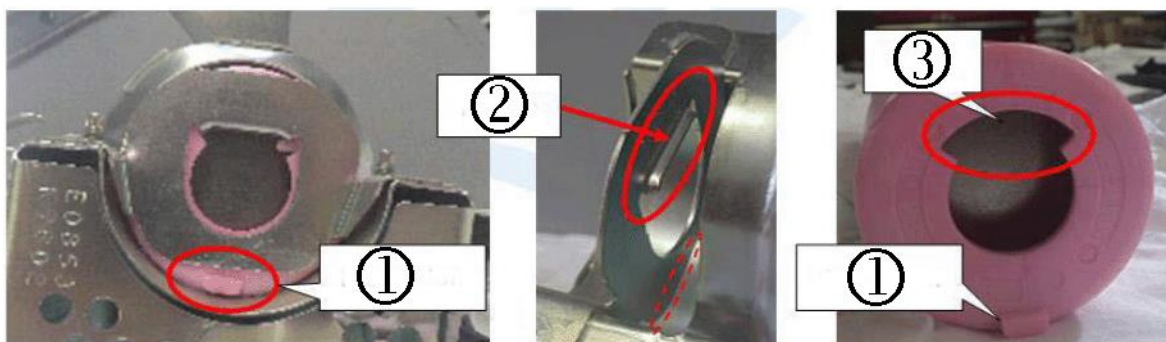
5145858

15. Inspect the new **Type 2** inflator to confirm the locating protrusions on each of the pink-collar portions are aligned as shown below. The “short” collar can be rotated as needed to align it with the protrusion on the “long” collar if necessary.

NOTE: The Type 2 inflator is installed in the opposite direction of the original. This change puts the connector on the other end. The new harness has been extended approximately 2” to compensate.

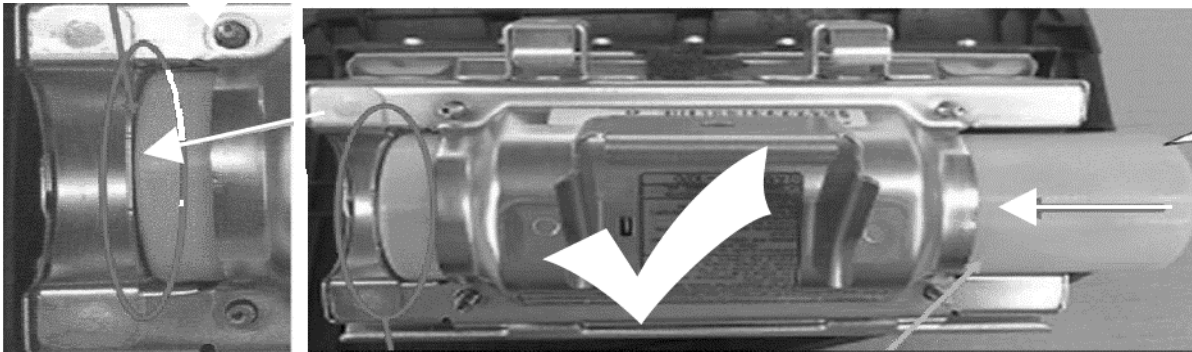
5145863

16. Install the new inflator into the mounting bracket, short collar with the “blank” (no harness connector) end going in first. The protrusion (1) on the short collar will fit in the gap at the bottom of the fixed stopper plate portion. At the same time, the ridge (2) portion of the inflator side of the stopper plate will fit into the “notch” (3) in the end of the collar. When properly installed, the end of the inflator will be seated tight against the mounting bracket with NO gap. DO NOT peel the white harness connection dust cover at this time.

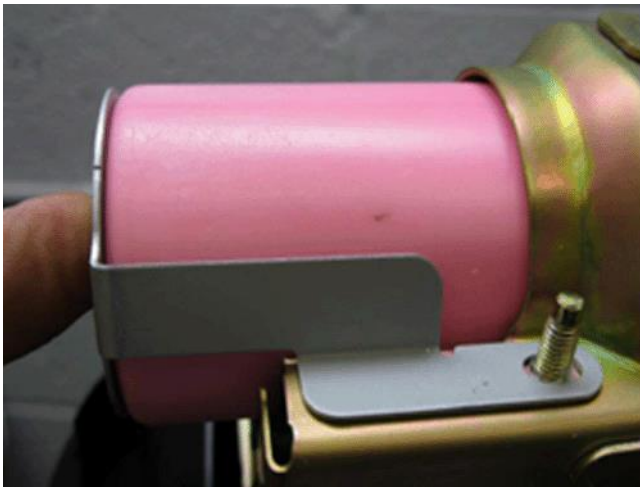
5145864

IMPORTANT: Always hold the stopper plate tight against the inflator as shown above while installing and tightening the **NEW** self-locking nuts. NEVER reuse the original nuts.

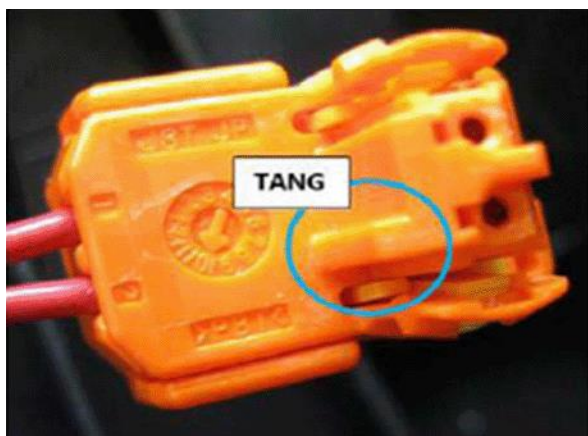
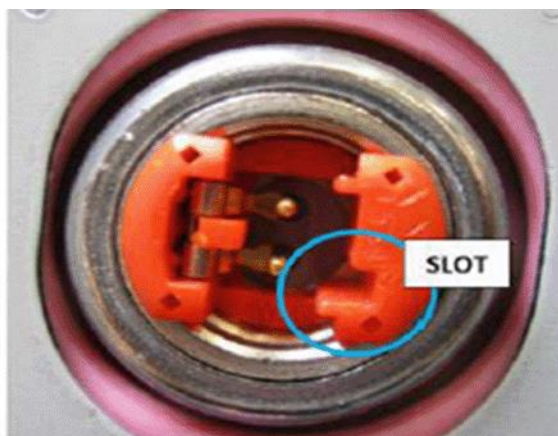
5145867

19. Peel off the white dust cover and **CAREFULLY** align the tang of the new harness connector with the receiving slot in the inflator connector. This assures proper routing of the harness in relation to the air bag assembly mounting brackets.

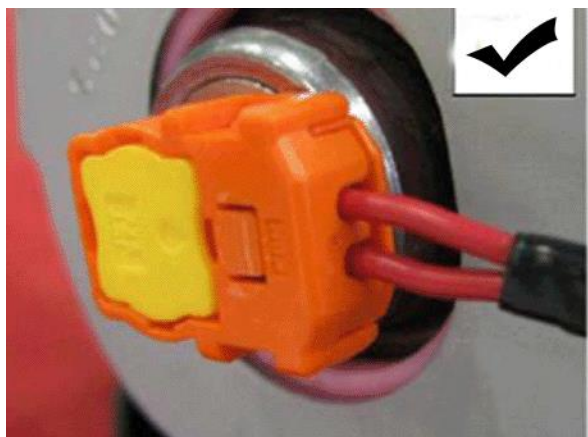
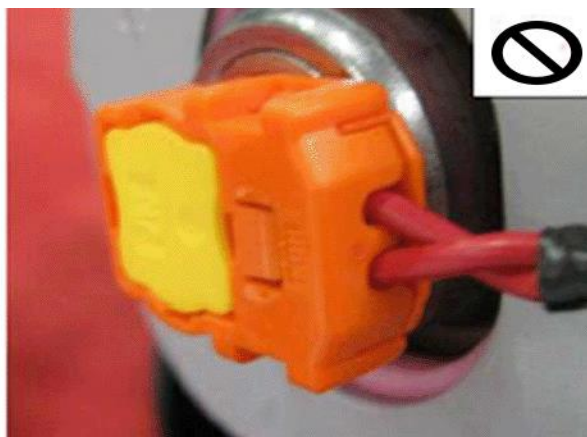
5145870

IMPORTANT: Confirm the harness is not twisted at the inflator connector as shown below.

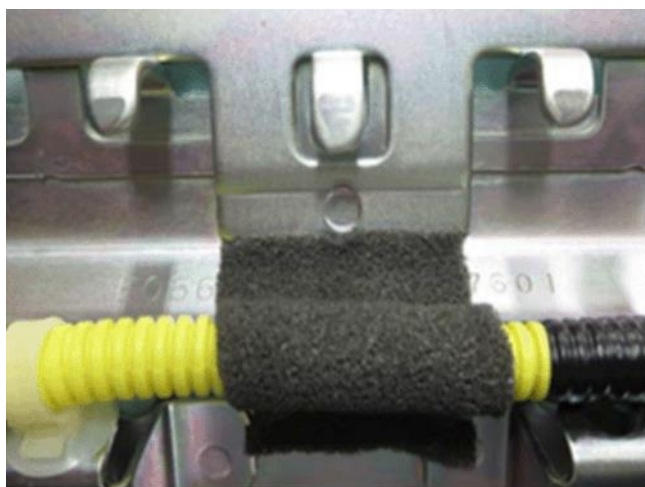
5145871

21. Peel the adhesive backing and install the new Sponge Tape onto the yellow harness tube first then adhere it to the air bag mounting bracket as shown.

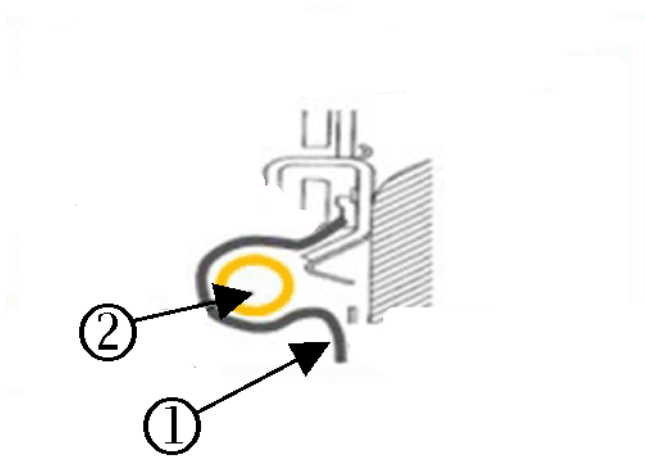
5145875

IMPORTANT: Cross section of the sponge tape installation. The sponge tape (1) must be installed more than half way around the yellow harness tube (2).

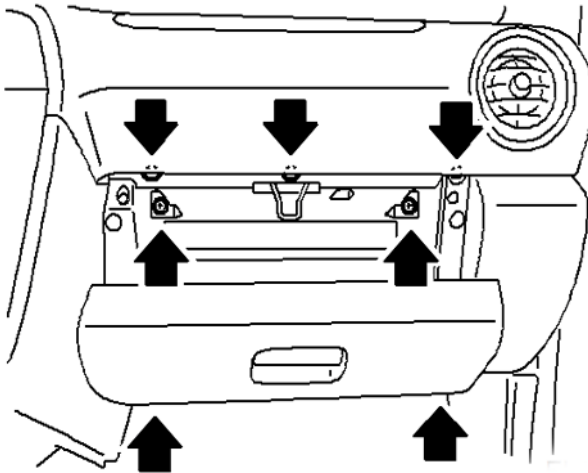
5145835

23. Reconnect the air bag assembly harness connector and attach it to the support beam bracket.

NOTE: Before installing the glove box assembly, reconnect the negative battery cable. Turn the ignition key "ON" and confirm the "AIRBAG" warning light comes on then cycles off properly. Once proper warning light operation is confirmed, reinstall the glove box assembly, while making sure the cord loop for the opening dampener (if equipped) stays connected.

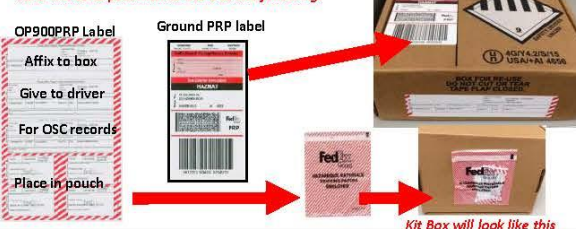
1. Peel off the backing of the FedEx Ground PRP Shipping label and **affix to top of each box to left of the Class 9 label (see below)**
 - Use the scribe line on the box as a guide.
 - The FedEx Ground PRP Shipping label must not touch any portion right of the scribe line.
2. **OP900PRP label is a multiple part label, please see below for further instructions**
2. A single combined shipment of your individually labeled boxes will **be scheduled by XPO (Example: one shipment of 9 boxes)**
3. **Do Not** contact FedEx **unless** you are instructed to by XPO.

XPO will send post mail to the OCS the following:

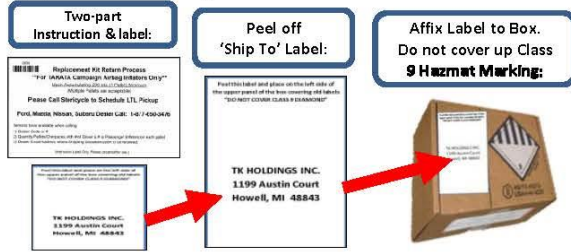
5. LTL Shipping Instructions - Label each box

a) If you do not have labels, please refer to BOX #9.
