Condition	n This recall affects certain 2005 model year Saab 9-2X vehicles which may have had an interim "like-fo			
	like" repair performed under a previous air bag recall using Takata Non-Desiccated Frontal Passenger-			
	side Air Bag Inflators containing Phase Stabilized Ammonium Nitrate for Zone A (HAH). Zone A (HAH)			
	includes states and U.S. territories with the greatest temperature cycling and absolute humidity. It			
	includes: Alabama, California, Florida, Georgia, Hawaii, Louisiana, Mississippi, South Carolina, Texas,			
	Puerto Rico, American Samoa, Guam, the Northern Mariana Islands (Saipan), and the U.S. Virgin			
	Islands. The propellant wafers in some of the subject inflators may degrade over time, which could lead			
	to overaggressive combustion in the event the air bag is activated. Overly aggressive combustion			
	creates excessive internal pressure when the inflator is activated, which may cause the inflator body to

**Correction** Dealers are to replace the front passenger air bag inflator.

## 15048 Front Passenger Air Bag Inflator

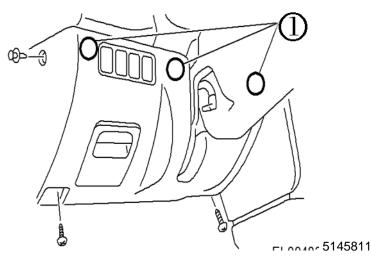
- Air bag System Diagnostic Trouble Code (DTC) read out. Determine if any pre-recall diagnostic trouble codes (DTCs) exist. Record set DTCs if present, on the job card. Notify the vehicle owner of condition, cause and correction recommendation and secure the owner's authorization to proceed with any non-recall related repairs prior to continuing with the recall procedure.
  - 1.1 Remove the lower steering column trim.

- 1.2 Remove 3 philips-head screws, pull the instrument panel lower cover at the clips (1) to remove.
- 1.3 Locate the B79 Check Connector near the OBDII connector.
- 1.4 Disconnect the two connectors to the switches on the left side of the panel to provide additional clearance.

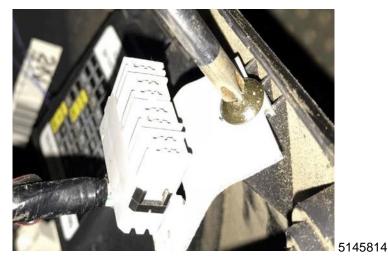
1.5 Carefully rotate the panel counter-clockwise to remove the B79 Check Connector screw. Leave the OBDII connector attached to the panel.

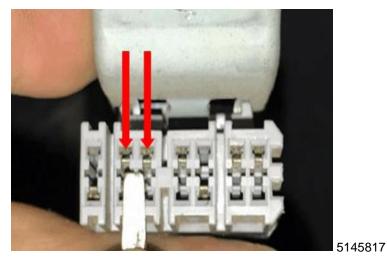
1.2 Locate B79 Check Connector Pins 2 and 3.

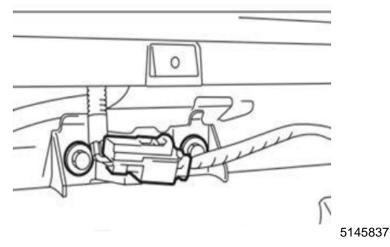
- 4. Disconnect the air bag assembly harness connector from the support beam bracket.
- 5. Remove the 3 retaining bolts and **CAREFULLY** remove the air bag assembly from the vehicle and place it on a clean cloth to protect the dash trim surface portion from damage.

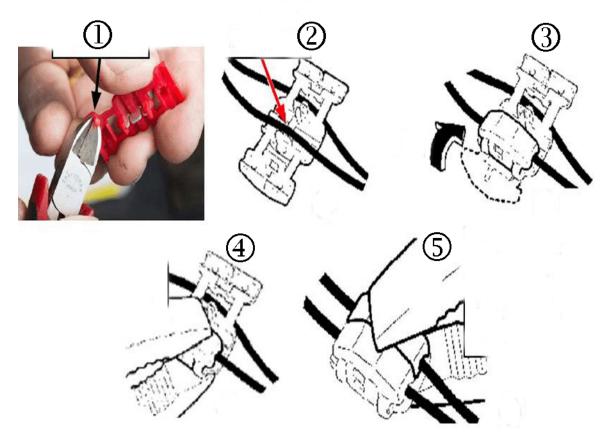
(1) This tab must be cut off.

- (2) Insert 1 wire in the Electro-Tap.
- (3) Fold.
- (4) Crimp closed with pliers.
- (5) Place the other wire in the Electro-Tap, fold then crimp closed with pliers.
- 9. Short the 2 wires together by installing the Electro-Tap connector. The connector creates a short circuit which acts as a safeguard to prevent against static discharge that may deploy the removed inflator. The tab portion of the Electro-Tap connector **MUST** be cut off prior to use to ensure a good short-circuit is made as shown in the illustration below. Follow the sequence below for installing the Electro-Tap connector. Use pliers to squeeze closed the two sections of the connector together, one section at a time.

8. CAREFULLY cut the yellow harness cover enough (approximately 2 inches) to expose the 2 red (or yellow) wires inside and provide enough room to install the Electro-Tap (shorting) connector using a wire cutter or scissor (no knives or razors). TAKE YOUR TIME AND BE CAREFUL TO NOT CUT THE 2 WIRES!

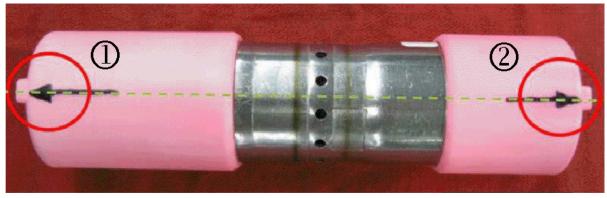
5145856

14. VERY IMPORTANT: Record the **11-digit alpha-numeric serial number for both the removed (Type 1) and 14digit numeric serial number for the new (Type 2) inflator** on the job card hard copy. This information will be required for completion of the Part Return Notice. The new 14-digit numeric serial number is also a requirement for claim entry.

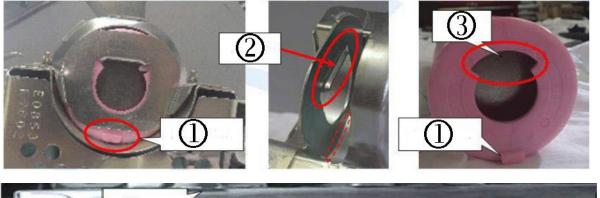
5145858

15. Inspect the new **Type 2** inflator to confirm the locating protrusions on each of the pink-collar portions are aligned as shown below. The "short" collar can be rotated as needed to align it with the protrusion on the "long" collar if necessary.

**NOTE:** The Type 2 inflator is installed in the opposite direction of the original. This change puts the connector on the other end. The new harness has been extended approximately 2" to compensate.

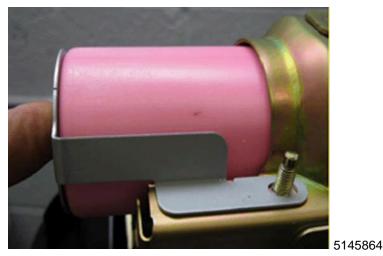
16. Install the new inflator into the mounting bracket, short collar with the "blank" (no harness connector) end going in first. The protrusion (1) on the short collar will fit in the gap at the bottom of the fixed stopper plate portion. At the same time, the ridge (2) portion of the inflator side of the stopper plate will fit into the "notch" (3) in the end of the collar. When properly installed, the end of the inflator will be seated tight against the mounting bracket with NO gap. DO NOT peel the white harness connection dust cover at this time.

**IMPORTANT:** Always hold the stopper plate tight against the inflator as shown above while installing and tightening the NEW self-locking nuts. NEVER reuse the original nuts.

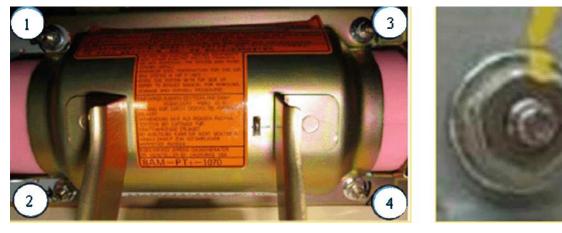
5145865

17. Install the new stopper plate over the harness connector end of the new inflator.

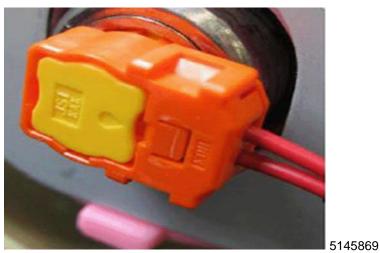
Peel off the white dust cover and CAREFULLY align the tang of the new harness connector with the receiving slot in the inflator connector. This assures proper routing of the harness in relation to the air bag assembly mounting brackets.

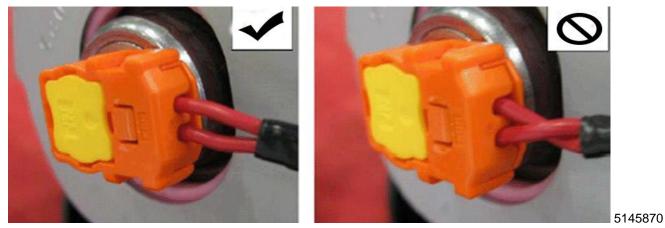
20. Once alignment is confirmed, push down firmly to engage the connector. When fully seated, press down on the yellow tab locking the connector to the inflator.

**IMPORTANT:** Confirm the harness is not twisted at the inflator connector as shown below.
