# Product Safety Recall

## 15049 Front Passenger Air Bag Inflator

**Release Date:** February 2020

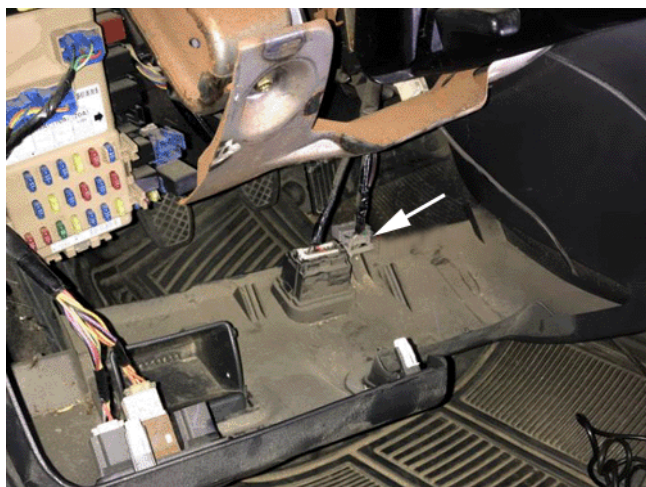
5145813

- 1.2 Remove 3 philips-head screws, pull the instrument panel lower cover at the clips (1) to remove.
  - 1.3 Locate the B79 Check Connector near the OBDII connector.
  - 1.4 Disconnect the two connectors to the switches on the left side of the panel to provide additional clearance.

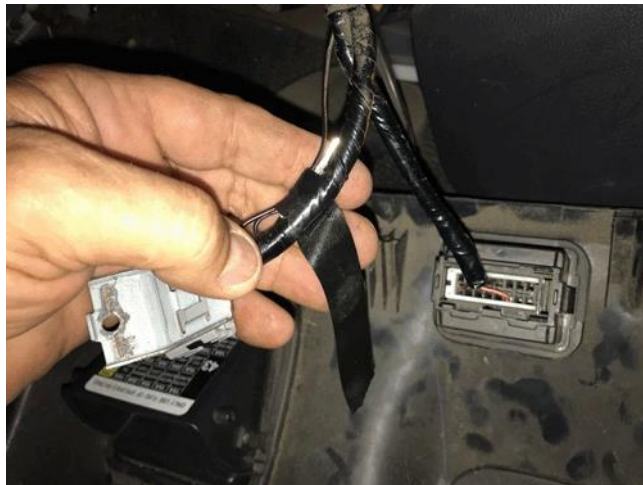
5145816

- 1.5 Carefully rotate the panel counter-clockwise to remove the B79 Check Connector screw. Leave the OBDII connector attached to the panel.

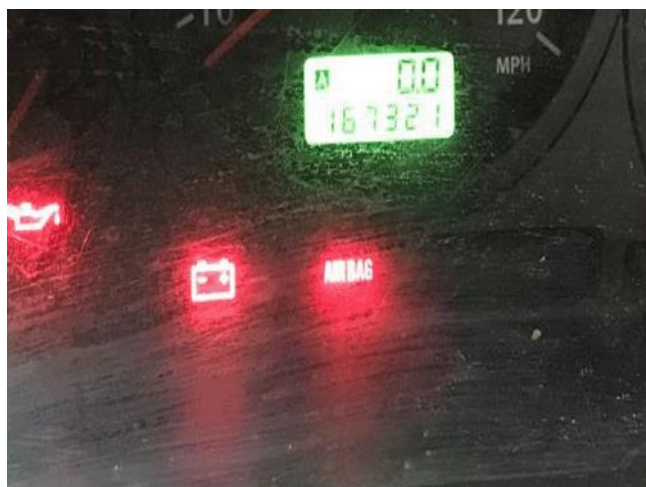
5145828

- 1.4 Watch the “AIRBAG” warning light in the cluster. It will begin to blink.
- 1.5 The long segments (1.2 seconds on) indicates a “ten”, and the short segment (0.3 seconds on) indicates a “one”. The warning light flashes a code corresponding to the fault.
- 1.6 There will be a brief pause approximately 6 seconds long between each DTC (No Light).
- 1.7 Read all codes until they begin to repeat. Write down all the codes.
- 1.8 See **DTC Code Listing chart – Table 1** at bottom of document for DTC code descriptions.

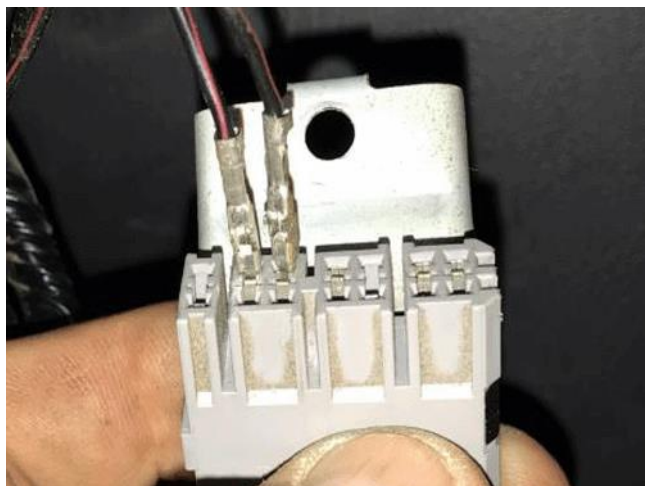
5145830

1. With the first Ground Terminal still connected and while the “AIRBAG” warning light flashes, connect the other Ground Terminal to the B79 Check Connector pin 3.
  - 1.1 Once the fault is repaired and the memory is erased, the warning light will flash one long time (1.2 seconds on) and then returns to the normal flash rate (0.6 sec on).
  - 1.2 If the warning light does not return the normal flash rate (0.6 sec on) this indicates that a fault remains. Once the repair has been made, erase the memory again and confirm that the normal flash rate has returned.
  - 1.3 When the memory has been cleared, disconnect the Ground Terminals from the B79 Check Connector.
  - 1.4 Apply insulating tape around the Ground Terminals and secure them to the harness with tape.
  - 1.5 Reattach the Check Connector to the panel with the Phillips screw.
  - 1.6 Turn the ignition switch off.

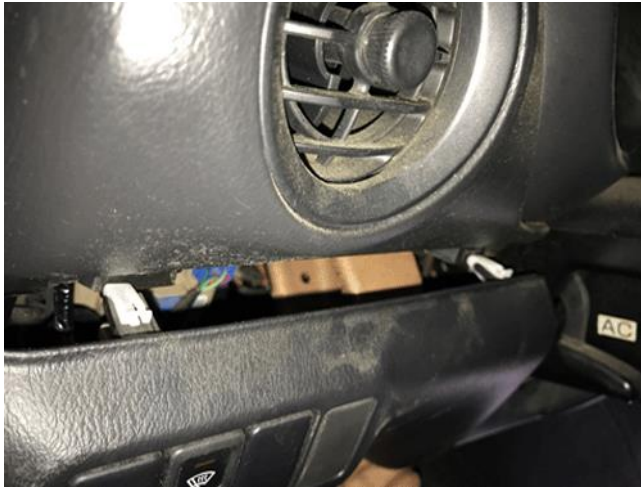
5145832

- 1.7 Rotate panel back to correct orientation.
- 1.8 Carefully line up the 3 upper clips that hold the panel on.

- 1.9 Snap the trim panel back into place.
- 1.10 Reinstall the 3 Phillips screws.
- 1.11 Turn Ignition Switch on.
- 1.12 Verify that the "AIRBAG" warning light comes on for 3 seconds and then goes out.

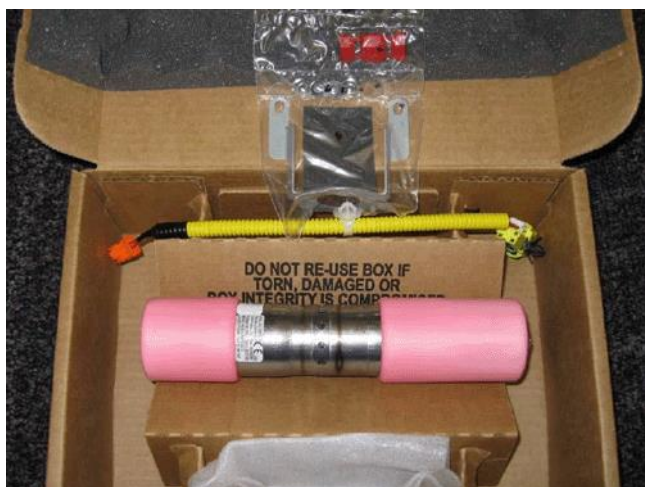
5145838

6. Open the front passenger air bag inflator kit box and confirm all the necessary components are included:

- 4 Self-Locking nuts
- New Type 2 Inflator (pink collars on each end identify it as the replacement part)
- New Inflator Harness
- New Stopper Plate
- Electro-Tap (red shorting crimp connector)
- 1 ½" X 2 ¼" piece of self-adhesive Sponge Tape
- Shipping Documentation and Instructions

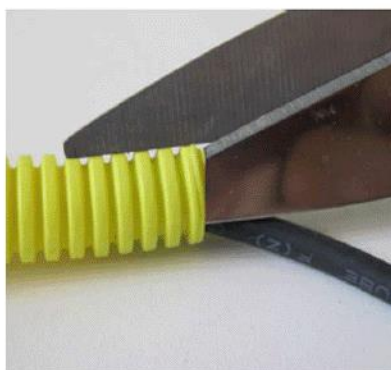
5145843

8. CAREFULLY cut the yellow harness cover enough (approximately 2 inches) to expose the 2 red (or yellow) wires inside and provide enough room to install the Electro-Tap (shorting) connector using a wire cutter or scissor (no knives or razors). TAKE YOUR TIME AND BE CAREFUL TO NOT CUT THE 2 WIRES!

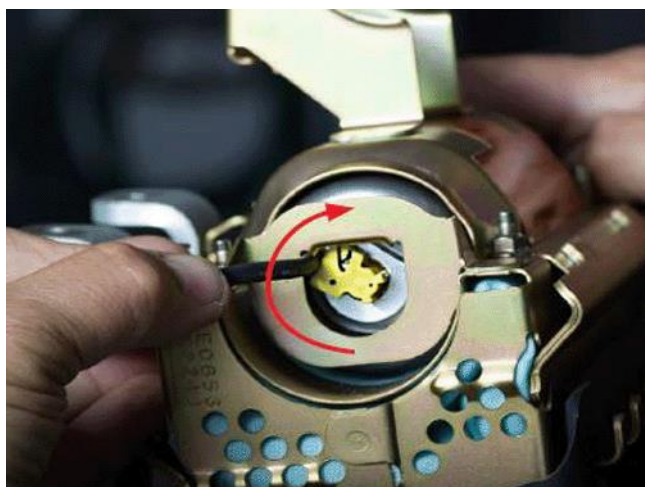
5145849

12. With the stopper plate removed and the other 2 self-locking nuts loosened, unseat the inflator off the mounting bracket end plate then rotate it slightly **CLOCKWISE** to make it easier to remove as shown in the photo to the right. Slide the inflator out of its mounting while feeding the cut off portion of the wiring harness through the "D-Shaped" hole in the end of the mounting bracket. **NEVER ATTEMPT TO REMOVE THE HARNESS FROM THE INFLATOR!**

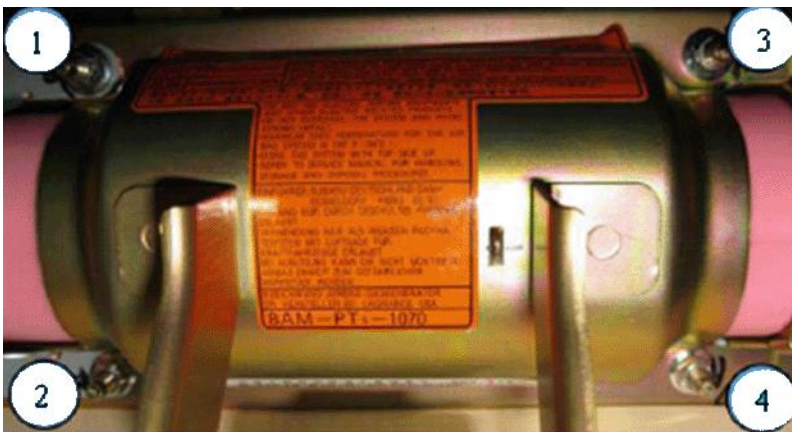
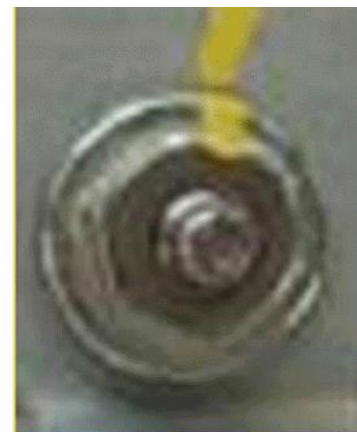
5145865

17. Install the new stopper plate over the harness connector end of the new inflator.

18. Remove the 2 nuts still installed on the mounting bracket and replace them with 2 **NEW** self-locking nuts. Once all 4 **NEW** nuts are in place, torque to 31-38-inch pounds in the new sequence shown below. Use a marker to mark the nuts after torquing indicating they have been fully tightened.

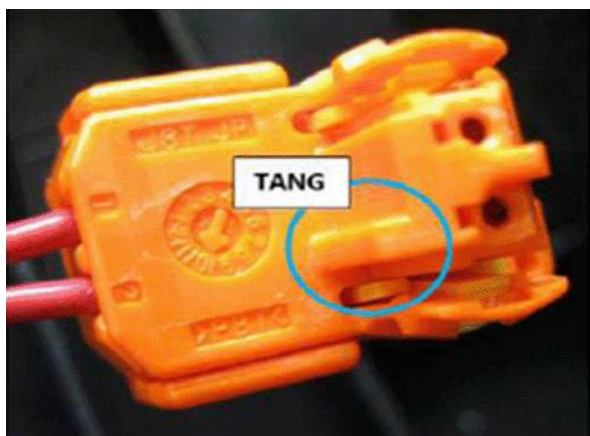
5145867

19. Peel off the white dust cover and **CAREFULLY** align the tang of the new harness connector with the receiving slot in the inflator connector. This assures proper routing of the harness in relation to the air bag assembly mounting brackets.

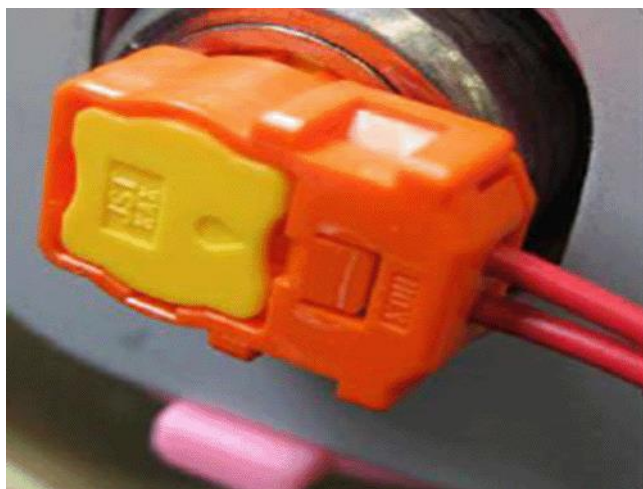
5145869

20. Once alignment is confirmed, push down firmly to engage the connector. When fully seated, press down on the yellow tab locking the connector to the inflator.

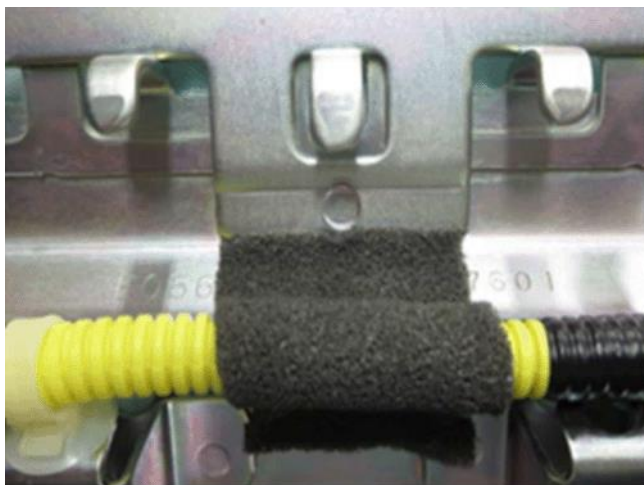
5145871

21. Peel the adhesive backing and install the new Sponge Tape onto the yellow harness tube first then adhere it to the air bag mounting bracket as shown.
