**TECHNICAL INSTRUCTIONS  
FOR  
SAFETY RECALL 20TA06  
POTENTIAL VEHICLE STALL WHILE DRIVING  
CERTAIN 2020 MODEL YEAR HIGHLANDER**

### **UPDATE 3/24/2020**

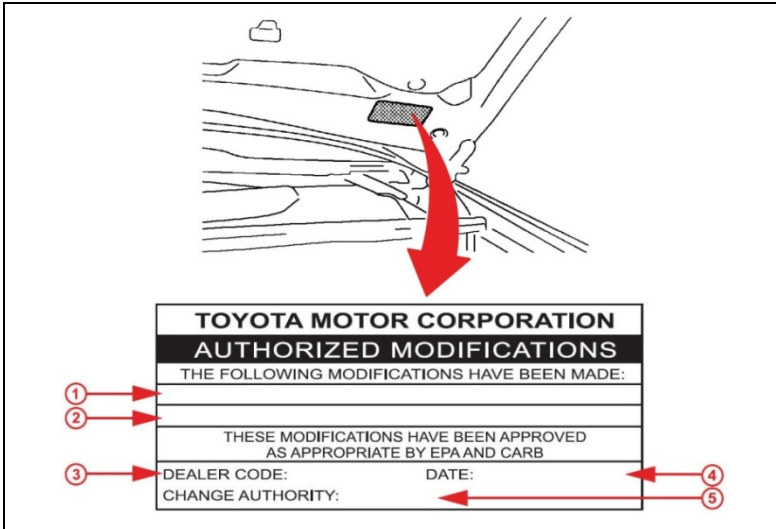
## 6. ATTACH THE AUTHORIZED VEHICLE MODIFICATION LABEL

- a. Fill out the label.
- b. Affix the label to the under-side of the hood.

1	ECM P/N
2	New Calibration ID
3	Dealer Code
4	Date Completed
5	Campaign Code (20TA06)

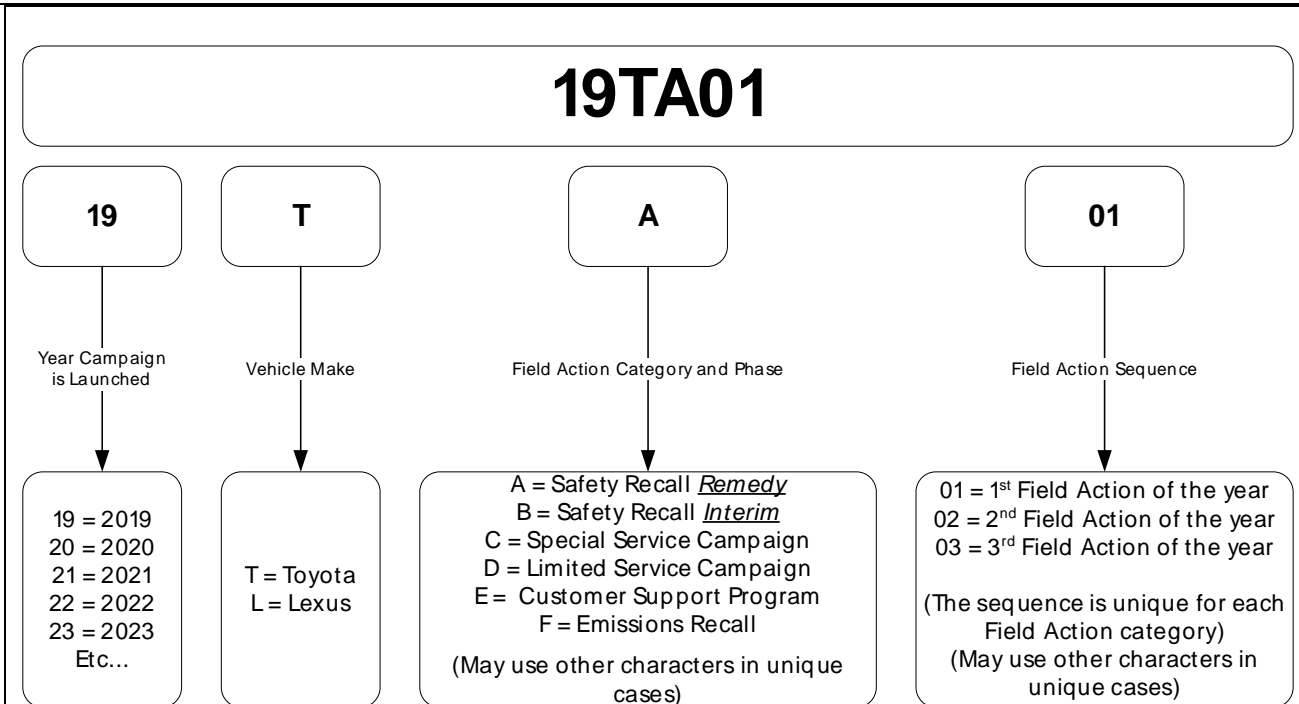
#### A. CAMPAIGN DESIGNATION DECORDER

Examples:

19TA01 = Launched in 2019, Toyota, Safety Recall Remedy Phase, 1<sup>st</sup> Safety Recall Launched in 2019  
 20TC02 = Launched in 2020, Special Service Campaign, 2<sup>nd</sup> Special Service Campaign Launched in 2020  
 21TE05 = Launched in 2021, Customer Support Program, 5<sup>th</sup> Customer Support Program Launched in 2021
