TECHNICAL INSTRUCTIONS
FOR
SAFETY RECALL 20TA06
POTENTIAL VEHICLE STALL WHILE DRIVING
CERTAIN 2020 MODEL YEAR HIGHLANDER

I. OPERATION FLOW CHART

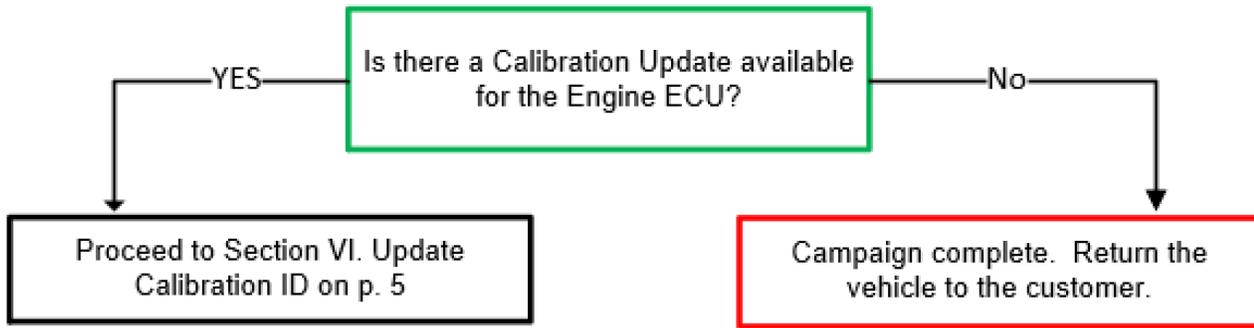
2. DETERMINE CALIBRATION UPDATE STATUS

- Locate the Update column for the Engine ECU in the Stored Data tab.
- Determine the status of an available update; indicated by a YES or NO.

Campaign Status: **Yes**
PERMANENT: **NO**

System	SB	RoB	Calibration	Update
Radar Cruise2	-	-	-	-
Engine	-	-	896630735000	Yes
Transmission	-	-	896650706000	Yes
Radar Cruise1	-	-	-	-
Parking Assist Camera	-	-	867B02D167 867B12D004	No No
ABS/VSC/TRAC/EPB	-	-	F152607140	No
EMPS	-	-	8965B41080	No

Note: If the Engine ECU already has the updated Calibration ID, the campaign is complete. No further action is required. Submit the warranty claim using op code FB0001 to complete this vehicle.

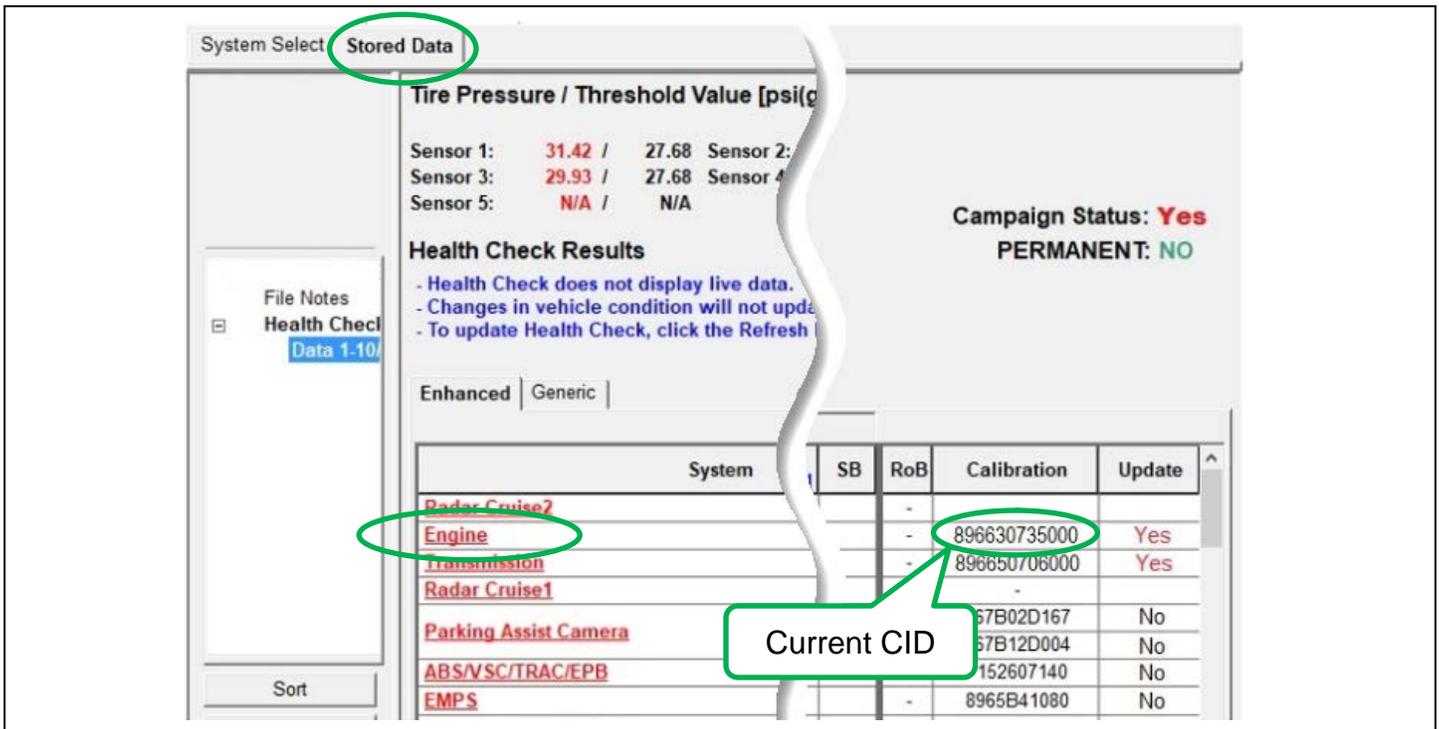
a. Identify the current Calibration ID for the Engine ECU on the Stored Data tab.

System	SB	RoB	Calibration	Update
Radar Cruise2	-	-	-	-
Engine	-	-	896630735000	Yes
Transmission	-	-	896650708000	Yes
Radar Cruise1	-	-	-	-
Parking Assist Camera	-	-	57B02D167	No
ABS/VSC/TRAC/EPB	-	-	57B12D004	No
EMPS	-	-	152607140	No
	-	-	8965B41080	No

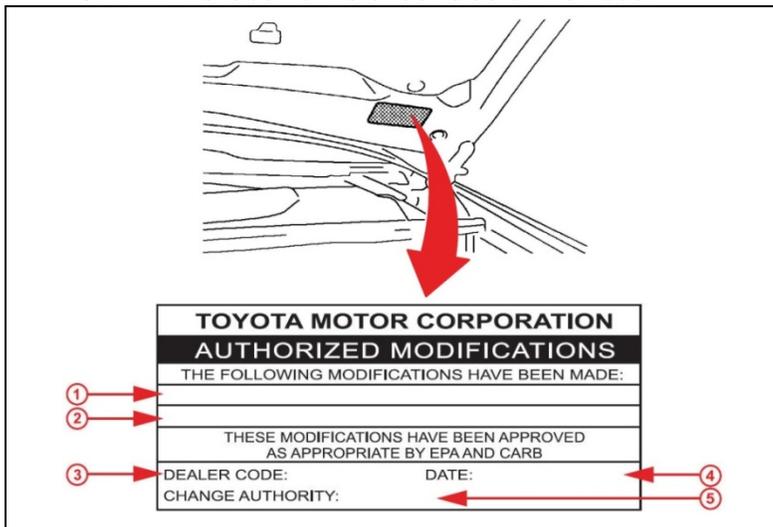
6. ATTACH THE AUTHORIZED VEHICLE MODIFICATION LABEL

- a. Fill out the label.
- b. Affix the label to the under-side of the hood.

1	ECM P/N
2	New Calibration ID
3	Dealer Code
4	Date Completed
5	Campaign Code (20TA06)

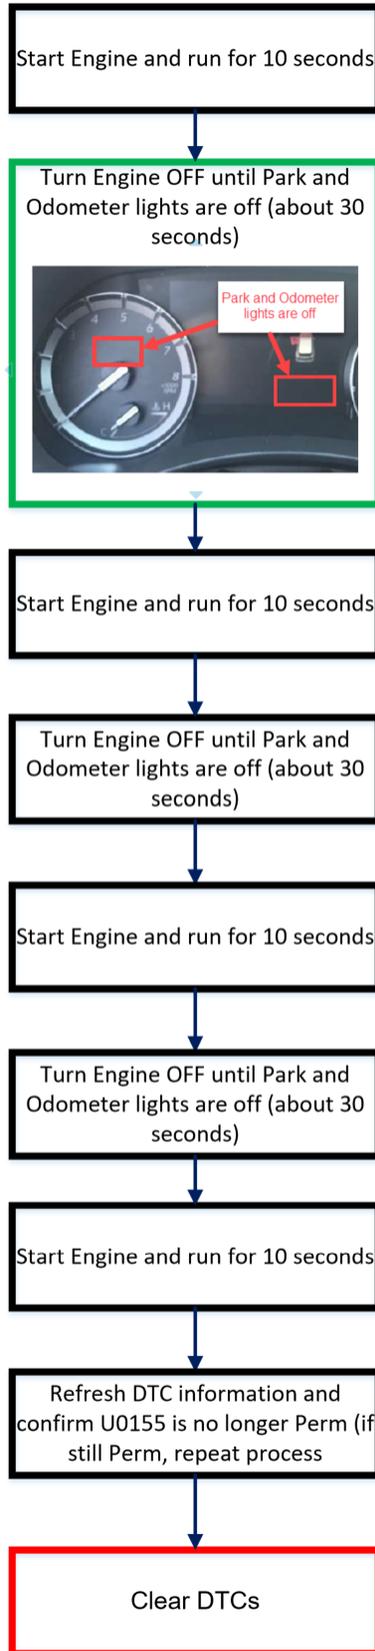
b. Follow the steps below to clear DTC U0155

NOTE: If DTC U0155 is found under the Generic tab follow the procedure in the Appendix Section B for instructions
