May 2020  
FL846AB  
NHTSA #20V-176  
Transport Canada #2020-123

## Subject: Meritor MX EVO 120 Front Drive Axles

**Models Affected: Specific Model Year 2019-2020 Freightliner 108SD and Business Class M2 vehicles manufactured May 3, 2018, through January 30, 2019, and equipped with certain Meritor MX 120 EVO front drive steer axles.**

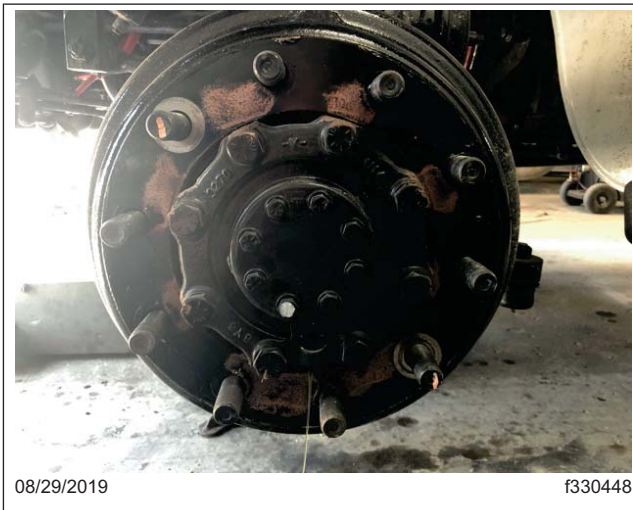
6. Remove the oil fill/drain plug. See [Fig. 1](#).
7. Remove the bolts and washer that connect the hub cover to the drive flange. See [Fig. 2](#).

**Fig. 1, Oil Fill/Drain Plug Removed**

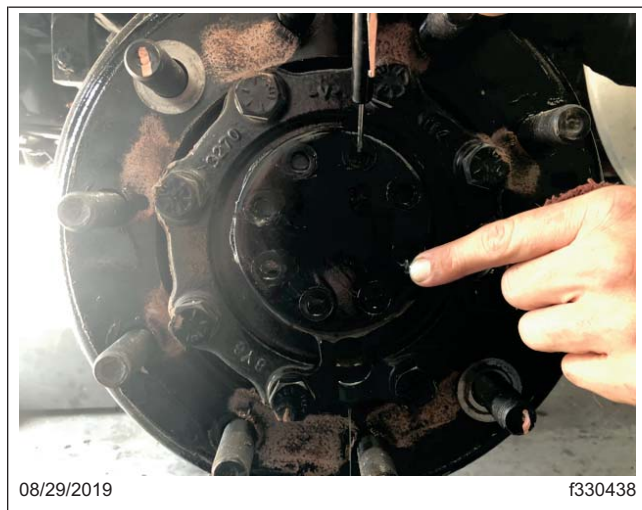
**Fig. 2, Hub Cover Bolts Removed**

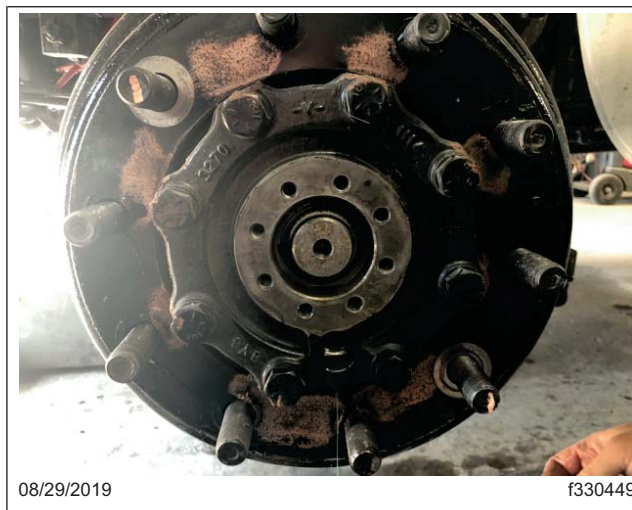
8. Remove the hub cover, using a light hammer, by gently tapping the axle. See [Fig. 3](#).

**Fig. 3, Hub Cover Removed**

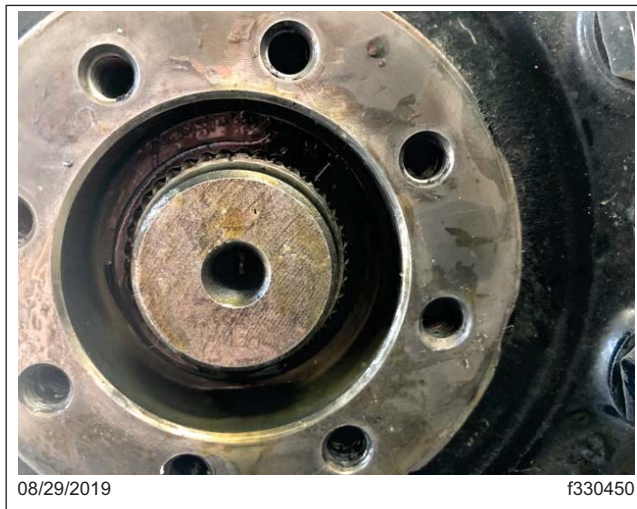
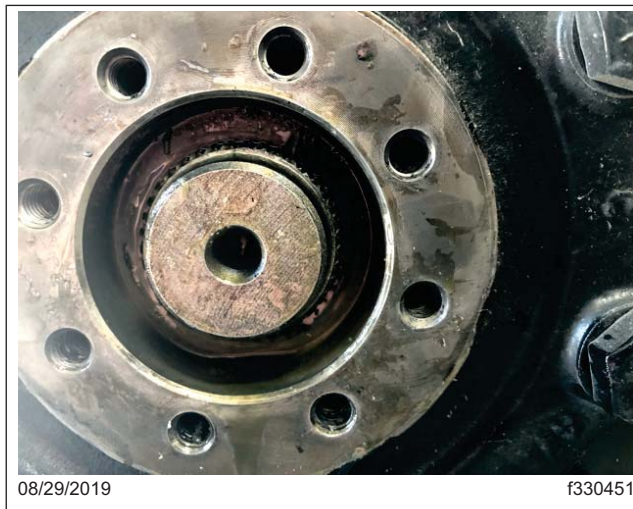
9. Remove the snap ring from the end of the axle shaft. See [Fig. 4](#). and [Fig. 5](#).

**Fig. 4, Axle Shaft with Snap Ring**

**Fig. 5, Snap Ring Removed from Axle Shaft**

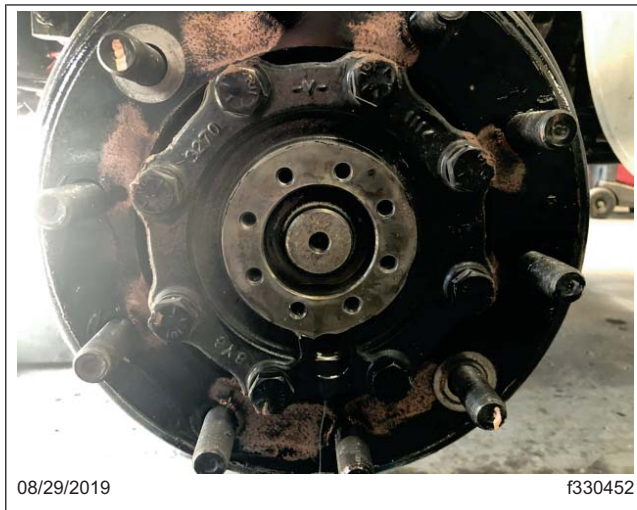
10. Remove the eight flange bolts that connect the drive flange to the wheel hub. See [Fig. 6.](#) and [Fig. 7.](#)

**Fig. 6, Flange Bolts Connecting the Drive Flange to the Wheel Hub**

**Fig. 7, Flange Bolts that connect the Drive Flange to the Wheel Hub Removed**

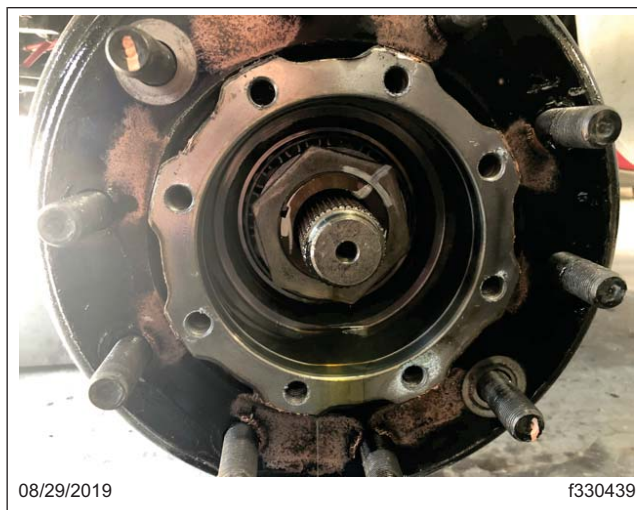
11. Remove the drive flange from the hub. If necessary, use a puller to remove the drive flange. See [Fig. 8.](#)

**Fig. 8, Drive Flange from the Hub Removed**

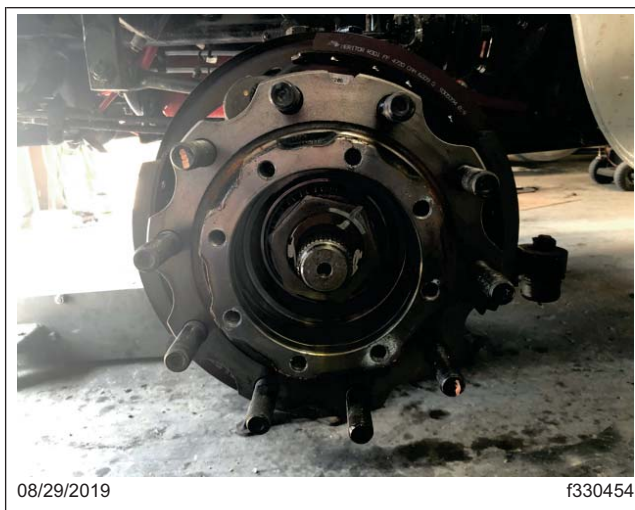
12. Remove the brake drum. See [Fig. 9.](#)

**Fig. 9, Brake Drum Removed**

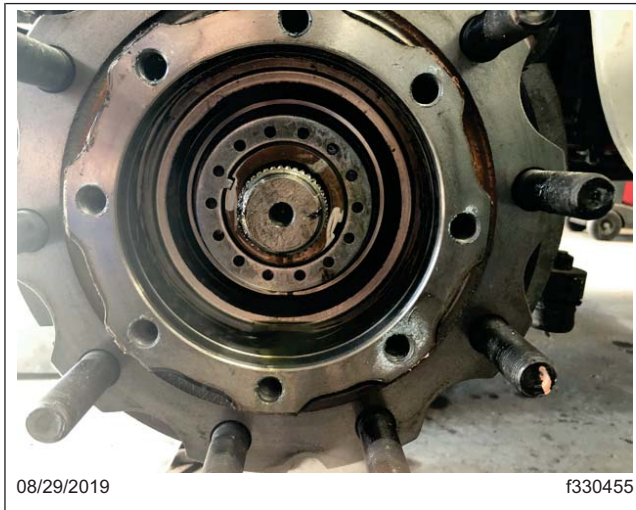
13. Remove the outer spindle nut. See [Fig. 10](#).

**Fig. 10, Outer Spindle Nut Removed**

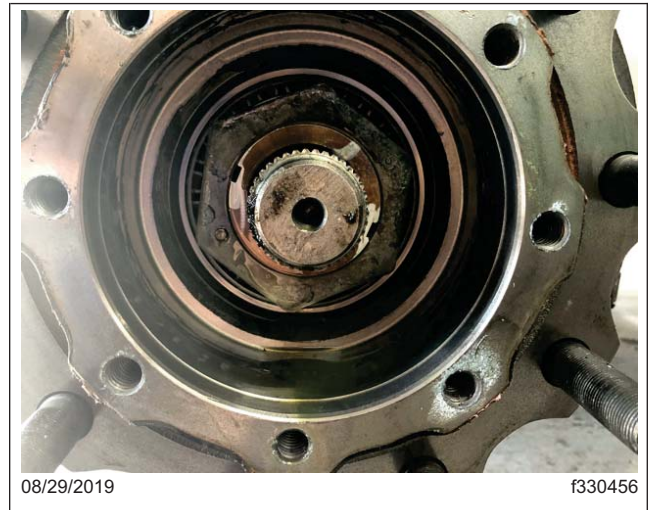
14. Remove the lock ring. See [Fig. 11](#).

**Fig. 11, Lock Ring Removed**

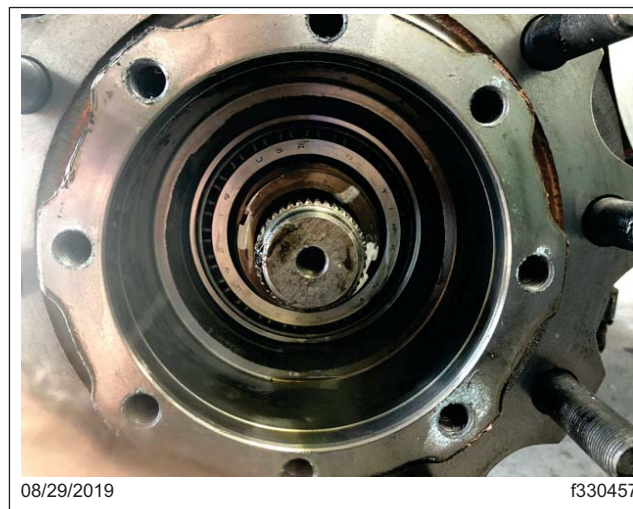
15. Remove the inner spindle nut. See [Fig. 12](#).

**Fig. 12, Inner Spindle Nut Removed**

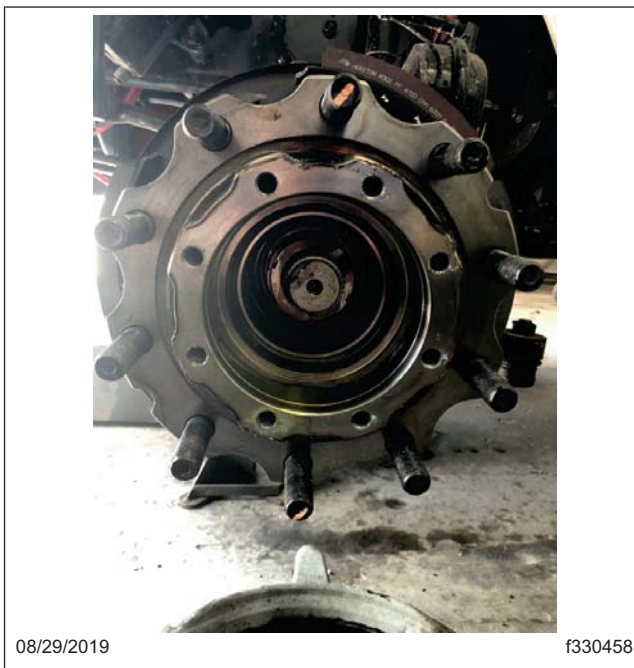
16. Remove the outer bearing. See [Fig. 13](#).

**Fig. 13, Outer Bearing Removed**

- Be careful not to let the outer wheel bearing drop from the axle spindle. Dropping the bearing can warp the cage or damage the rollers, ruining the bearing. Use care when working with the hubs. To prevent damage to the tone wheel, do not drop the hub, or lay it down in a way that would damage the tone wheel.
- Do not spin bearing rollers at any time. Dirt or grit can scratch the roller surface and cause rapid wear of the bearing assembly. Treat used bearings as carefully as new ones.

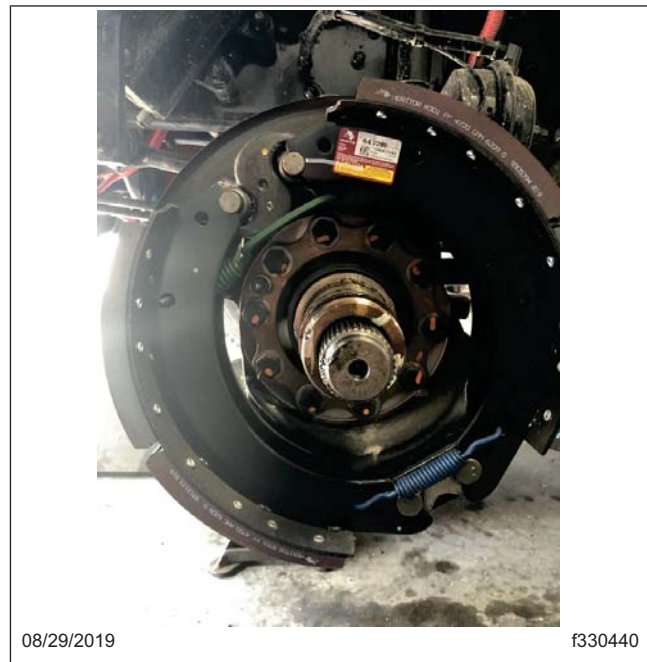
17. Remove the hub and inner bearing. See [Fig. 14](#).

**Fig. 14, Hub and Inner Bearing Removed**

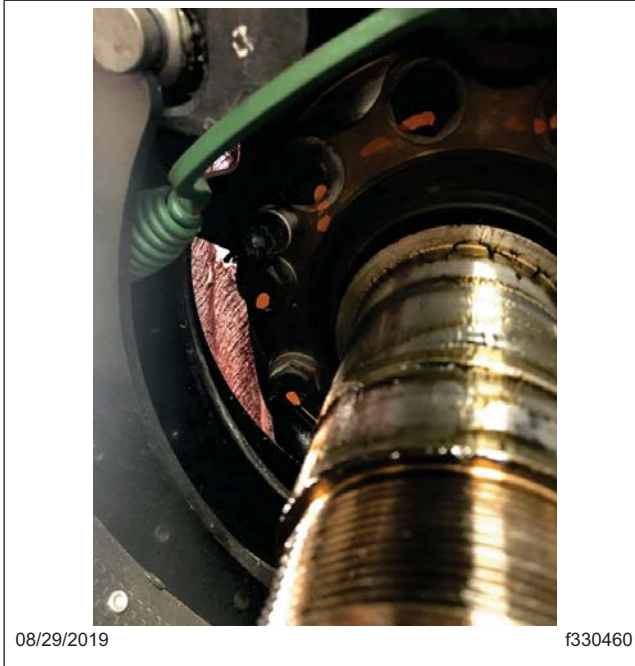
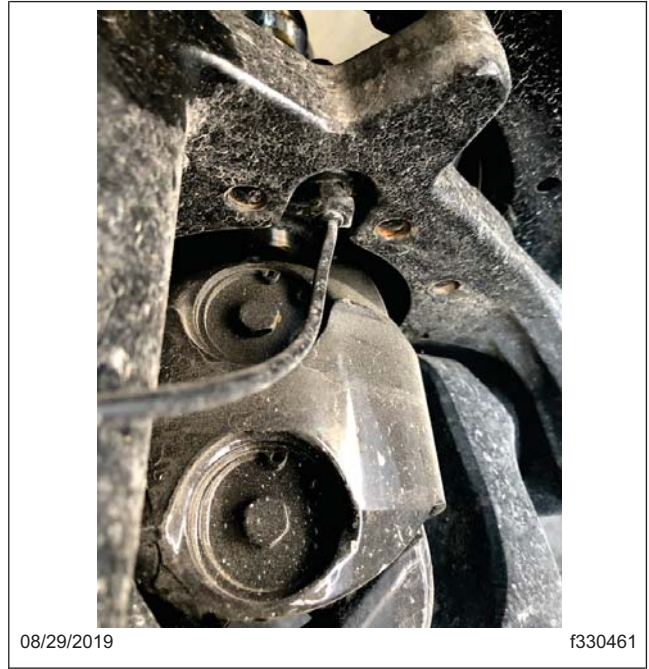
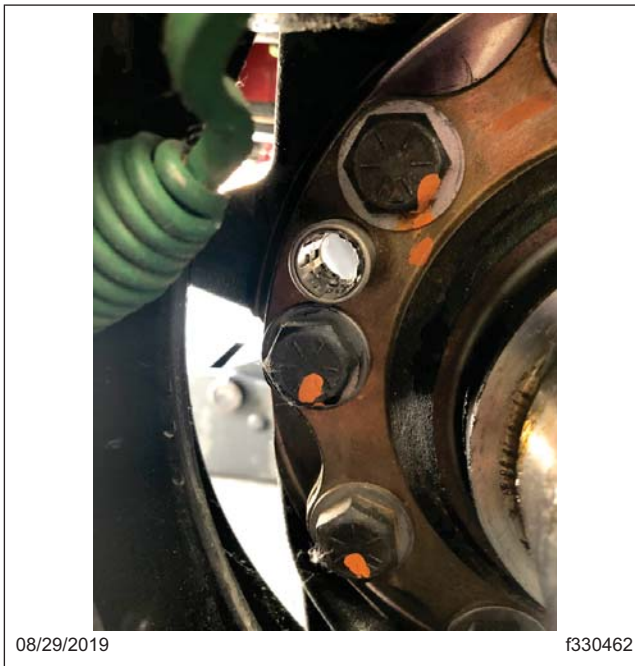
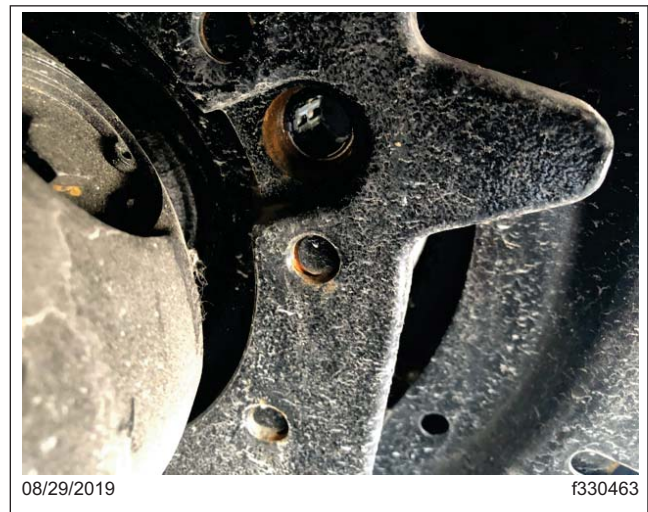
18. Remove the ABS sensor. See [Fig. 15](#), [Fig. 16](#), [Fig. 17](#) and [Fig. 18](#).

**Fig. 15, Removal of ABS Sensor**

**Fig. 16, Removal of ABS Sensor**

**Fig. 17, Removal of ABS Sensor**

**Fig. 18, ABS Sensor Removed**

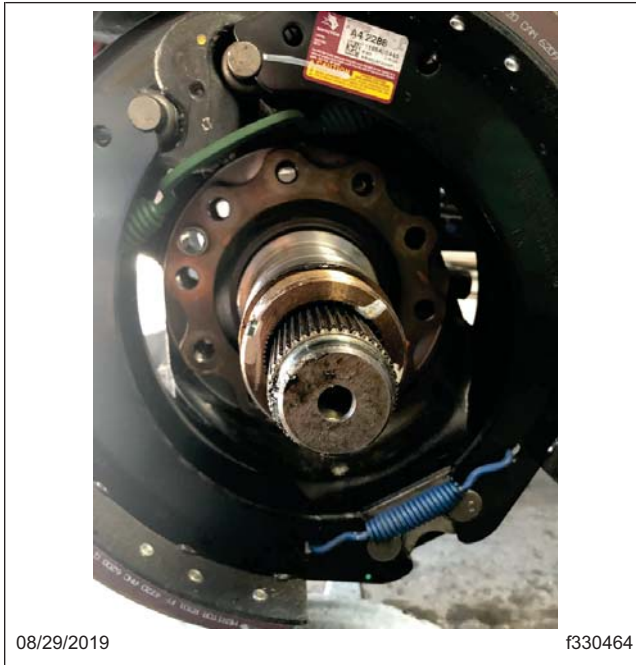
19. Remove ten spindle mounting flange bolts. See [Fig. 19](#).

**Fig. 19, Mounting Flange Bolt Removed**

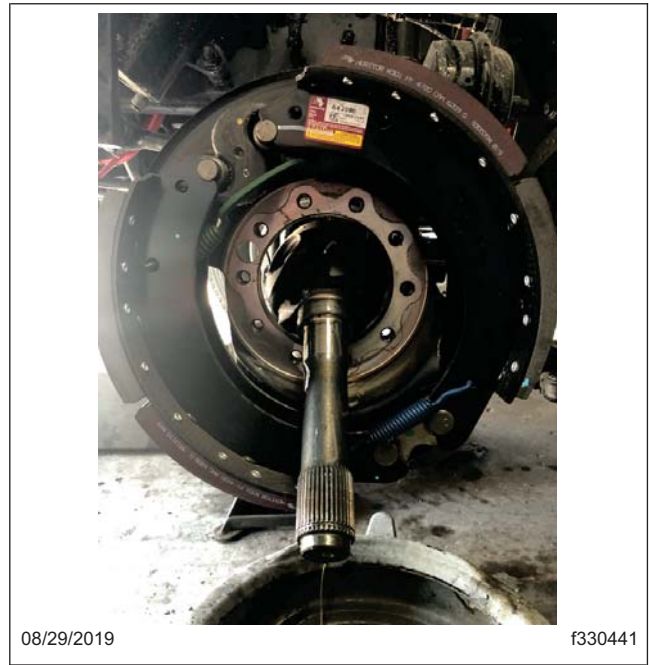
20. Remove the spindle from the assembly. See [Fig. 20](#).

**Fig. 20, Spindle from the Assembly Removed**

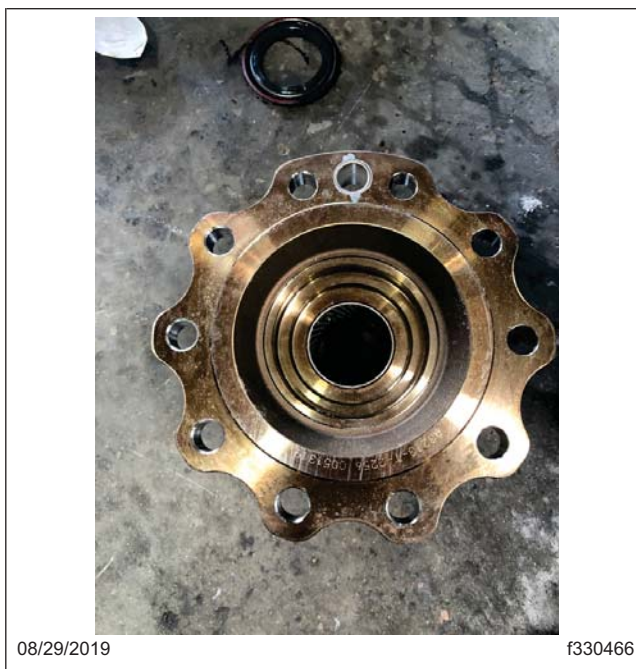
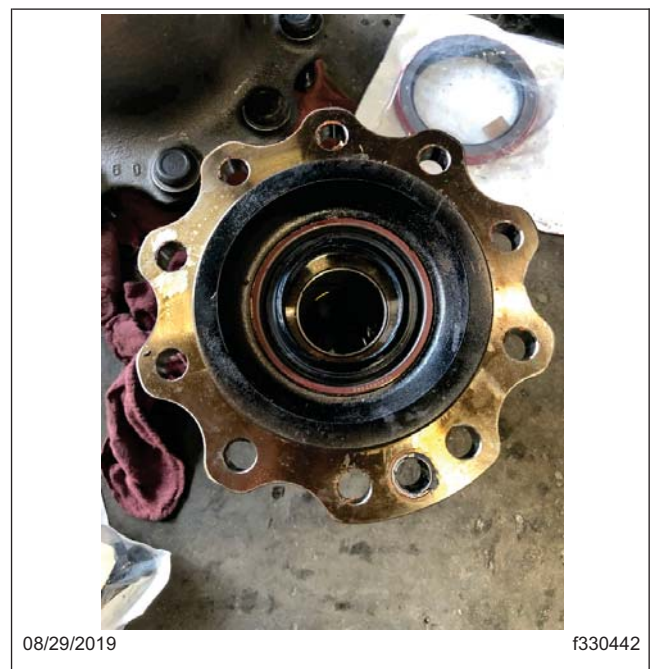
21. Install the spindle seal. See [Fig. 21](#). and [Fig. 22](#).

**Fig. 21, Installing Spindle Seal**

**Fig. 22, Spindle Seal Installed**

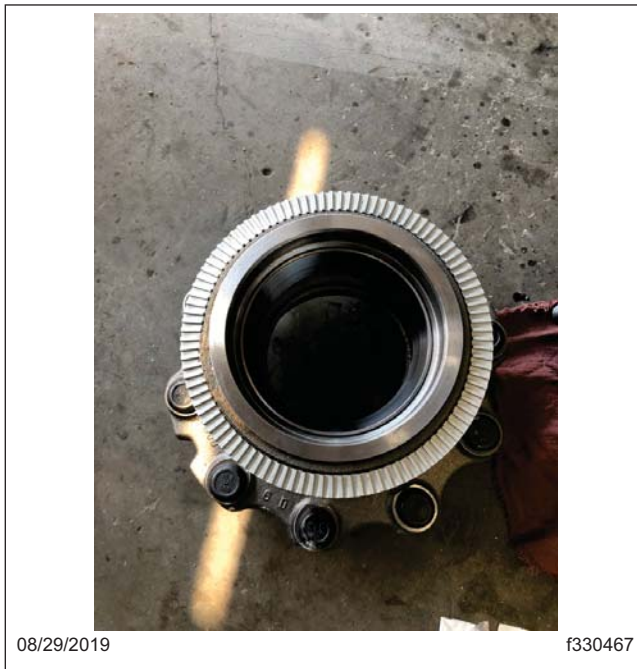
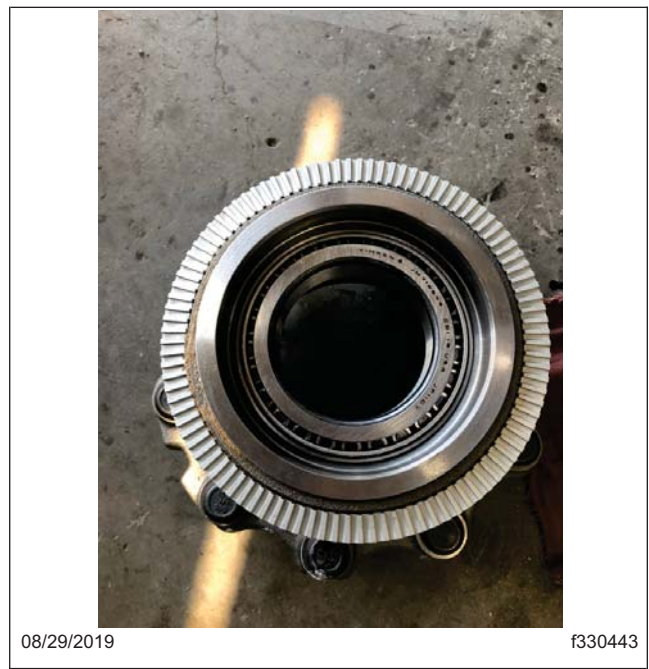
22. Lubricate the new inner wheel bearing from the parts kit by dipping it in oil and slowly working the rollers in oil. See [Fig. 23](#), and [Fig. 24](#).

Fig. 23, Lubricating the New Inner Wheel Bearing

Fig. 24, New Inner Wheel Bearing Lubricated

Ensure that both bearing assemblies are coated with fresh oil. Use only fresh oil on the bearing assemblies; old oil could be contaminated with dirt or water (both are corrosives) and could cause damage to both wheel bearing assemblies and the wheel hub.

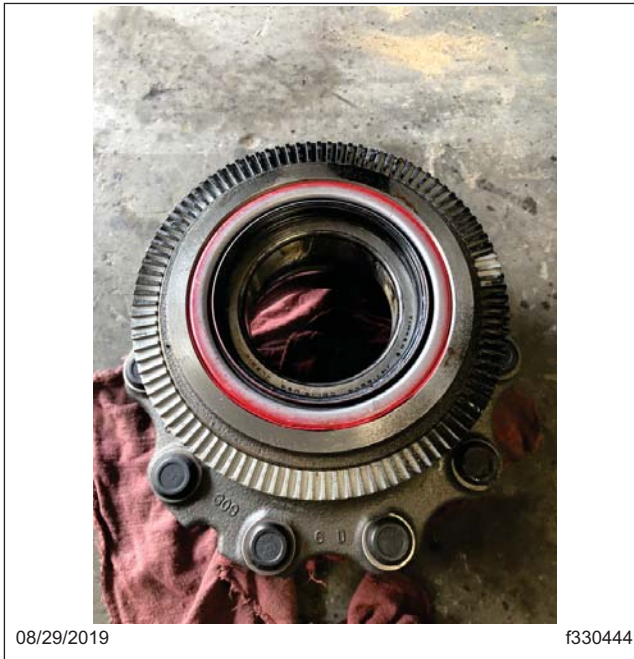
23. Install a lubricated new inner wheel bearing into the hub.
24. Using the hub seal installation tool install the hub seal into the hub bore. Do not force or hit the seal after it has reached the bottom of the bore, which can damage the seal. See [Fig. 25](#).
25. Install the spindle and fasten one bolt.
26. Install the remaining nine spindle bolts and then torque all 10 of them to 180 lbf-ft (244 N·m). See [Fig. 26](#).

**Fig. 25, Hub Seal Installed**

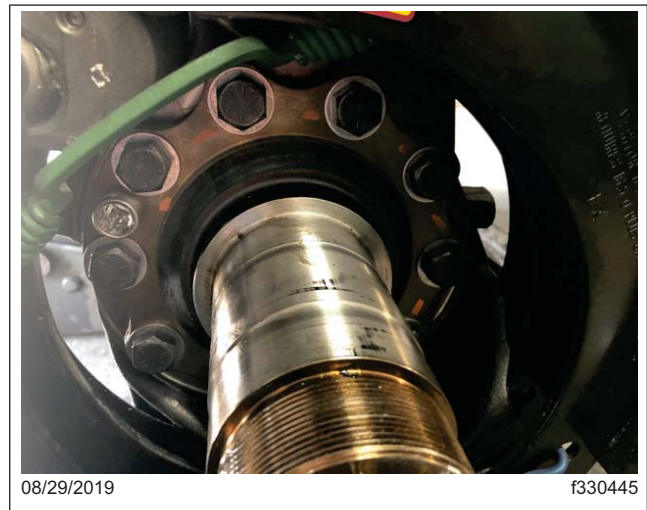
**Fig. 26, Installing the Spindle Bolts**

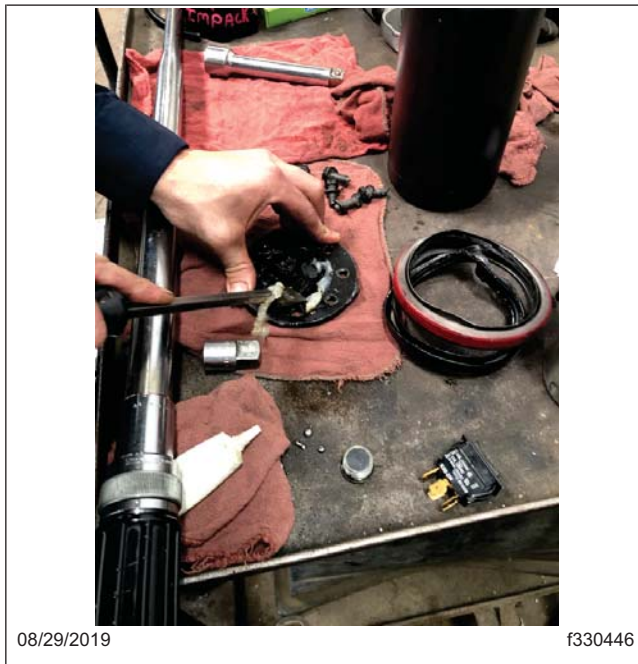
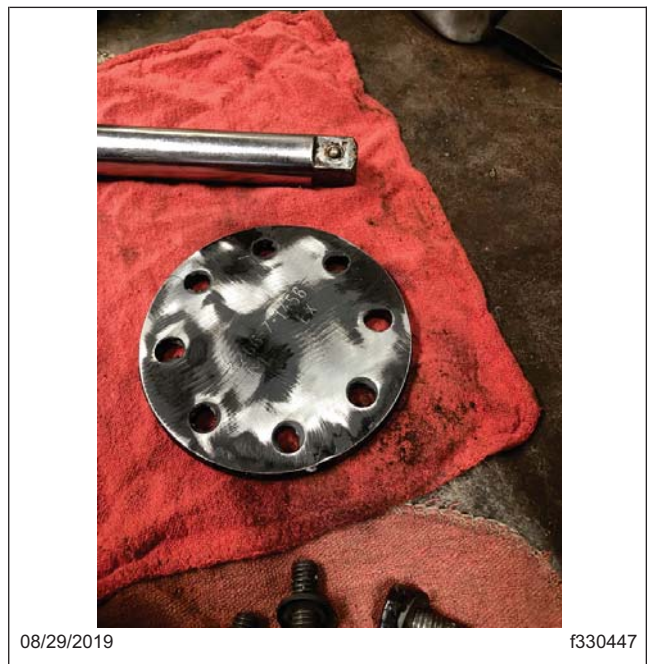
34. Check the resulting end play with a dial indicator. The end play must be between 0.001 and 0.005 inch (0.03 and 0.13 mm). If the end play is not within the specified value, follow the below procedure.
  - Remove the jam nut and locking device, and back off or tighten the inner adjusting nut.
  - Install the locking device and jam nut.
  - Measure the end play. If the end play is not within 0.001 and 0.005 inch (0.03 and 0.13 mm), repeat the adjustment procedure until the correct end play is achieved.
35. Install the new O-ring on the drive flange.
36. Install the drive flange onto the hub with one bolt at first, then install all the remaining flange bolts.
37. Install the snap ring onto the end of the axle shaft. Ensure the snap ring is positioned in the groove at the end of the axle shaft.
38. Clean the hub cover. See [Fig. 27.](#) and [Fig. 28.](#)

Fig. 27, Cleaning the Hub Cover

Fig. 28, Hub Cover Cleaned
