June 2020  
FL852AB  
NHTSA #20V-281  
Transport Canada #2020-217

## Subject: Western Star Ground Circuit Splice Pack

**Models Affected: Specific Model Year 2019-2021 Western Star 4700 and 5700 model vehicles manufactured October 24, 2018, through May 6, 2020.**

The ground circuit splice pack, located in the engine compartment near the frame rail on the driver's side, will be replaced.

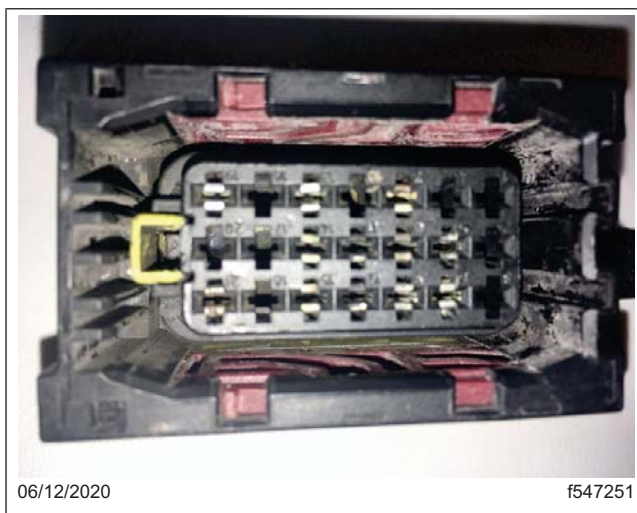
**Fig. 12, MCM Connector**

16. Remove the tie straps and harness wrap to access the terminals wiring, and remove the connector back shell cover.
17. Release the secondary terminal lock using the tool DKIOCHA17002-1 by moving the yellow lock away from the terminals until a slight click is heard or felt. See [Fig. 12](#) and [Fig. 13](#)

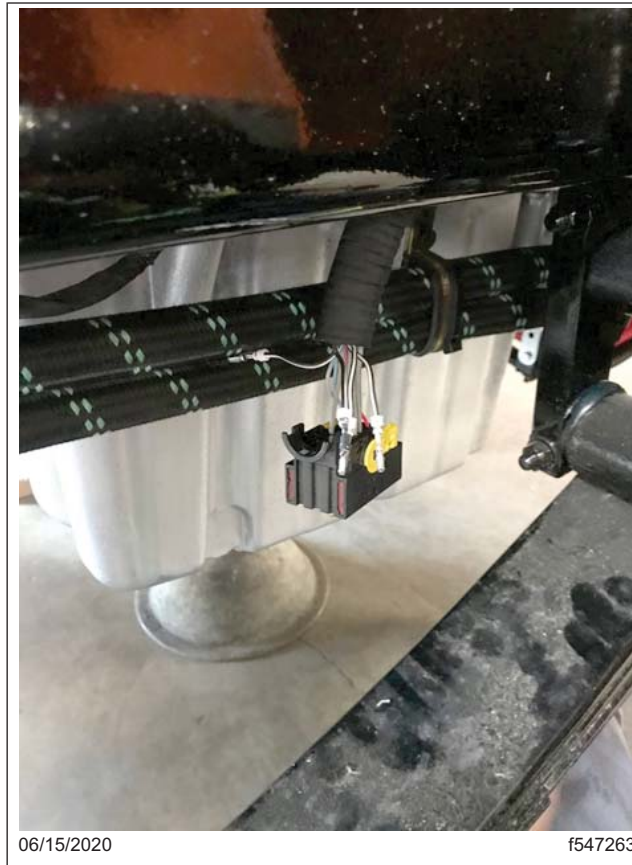
**Fig. 14, GNDE Wires Extraction**

18. Using the tool DKOCHA17002-8, extract the four GNDE wires from the connector cavities 5, 6, 8, and 9.  
See [Fig. 10](#) and [Fig. 14](#).

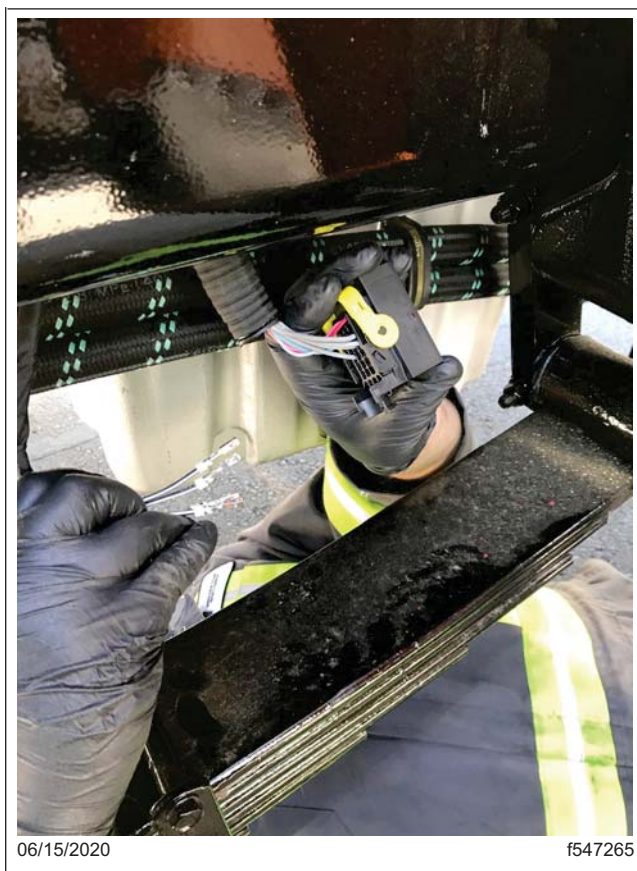
**Fig. 18, MCM 21-Pin with New Terminals**

- 20.4 Route the new overlay harness to MCM 21-pin connector, insert the four GNDE wires into the MCM 21-pin connector cavities 5, 6, 8, and 9. Install MCM 21-pin back shell cover. Move the yellow secondary terminal lock to the lock position by moving it toward the terminals. Secure, wrap, and seal the 21-pin connector to the harness with electrical tape. Install the 21-pin connector into the MCM and secure with the lever-lock. See [Fig. 18](#) and [Fig. 19](#).
- 20.5 Wrap all the exposed wiring with appropriate harness wrap and electrical tape. Route and secure the new overlay harness along the existing harness using tie straps and electrical tape. Check that all connectors and overlay harness connectors are secured.
