Dealer Service Instructions for:

## **Safety Recall W47 / NHTSA 20V-343**

### **PTU Input Spline**

**2014-2017 (KL) Jeep® Cherokee**

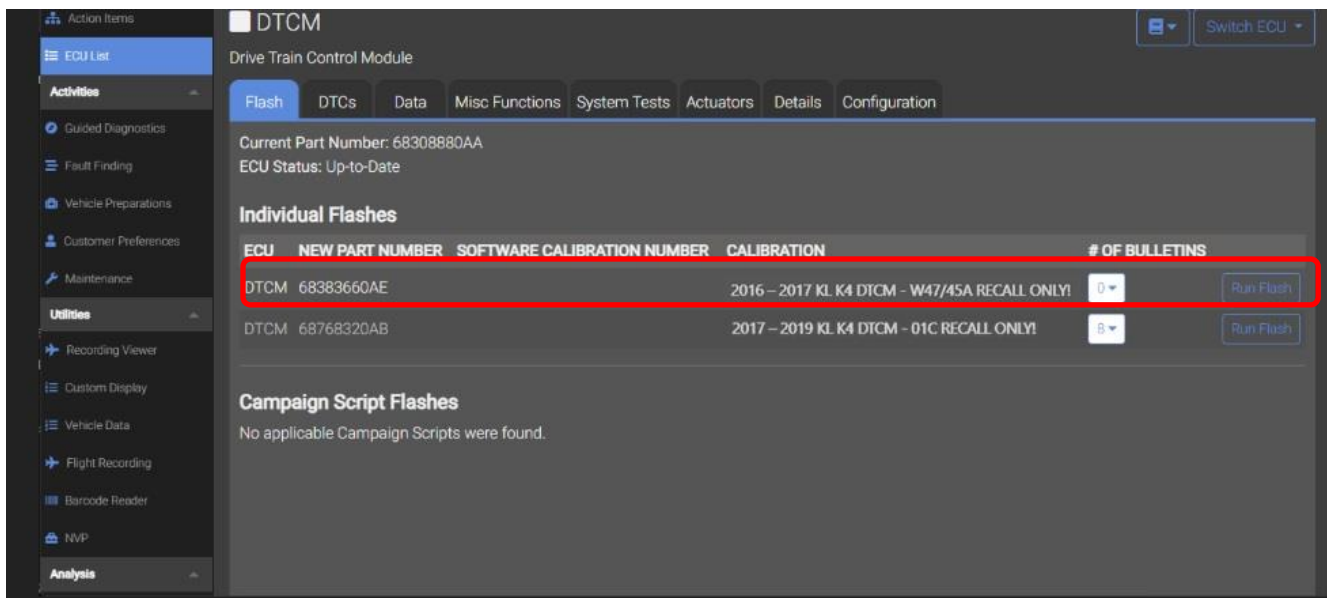
**Figure 1 – Select Part Number for 2016-2017 Models**

- From the DTCM tab, select the W47/45A DTCM flash part number (For 2016-2017 models, see Figure 1).

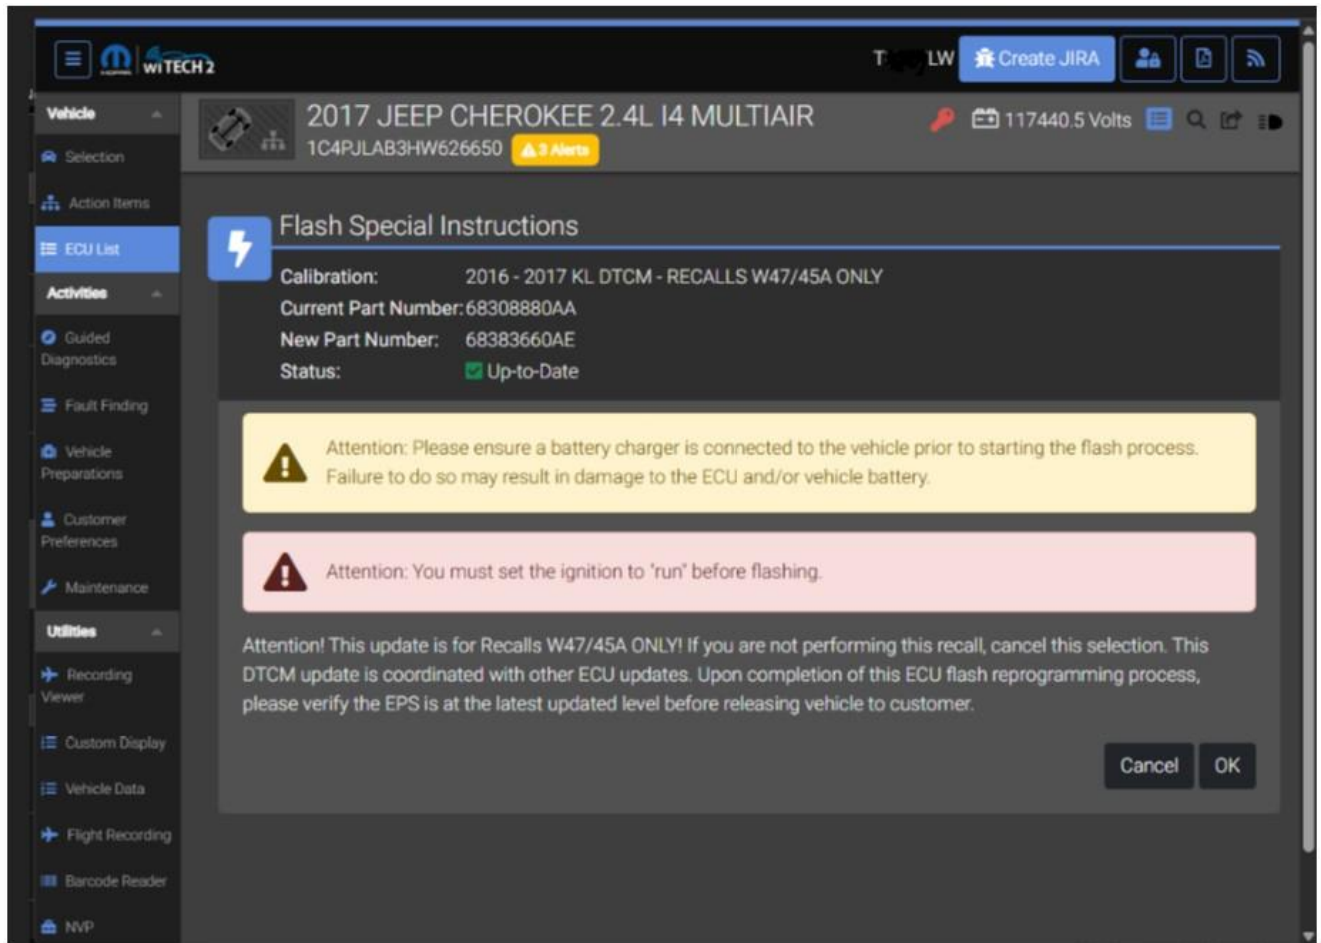
Figure 2 – Flash Special Instructions

- Read the flash special instructions page. Select “OK” to continue (Figure 2).
