Compliance Recalls

Code: 91BB & 91BC

Subject Rear Camera Software

Release Date December 04, 2020

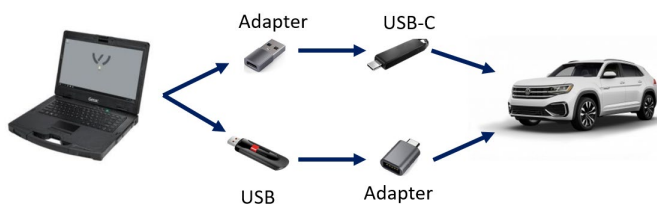
- The MIB3 system uses a USB-C input.
- If the software is downloaded onto a USB drive, a USB to USB-C adapter will be required.
- If the software is downloaded onto a USB-C drive, a USB-C to USB adapter will be required since the VAS tester does not have a USB-C drive.

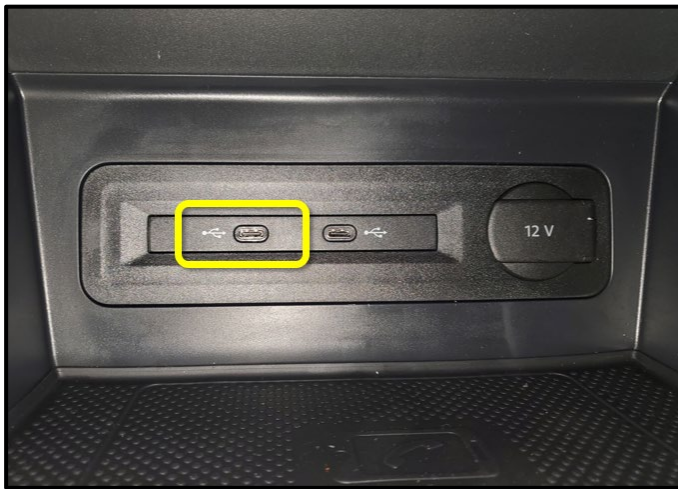
- Insert the USB drive in port 1 of the USB connection in front center console storage compartment.

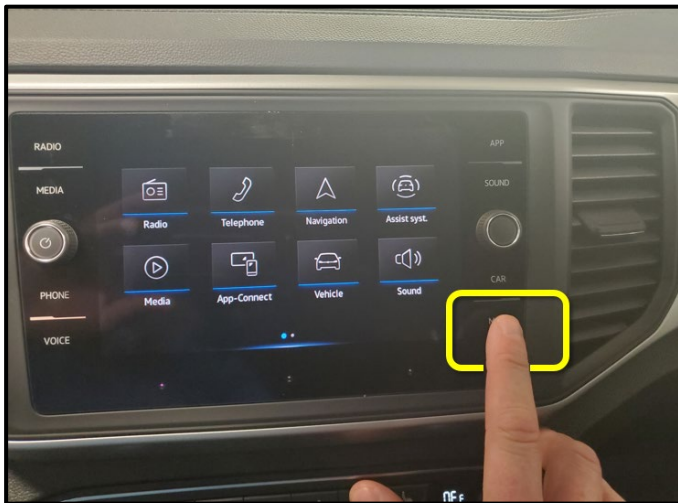
- Press and hold the "MENU" button located on the Radio for 5 seconds, wait until service mode is available.

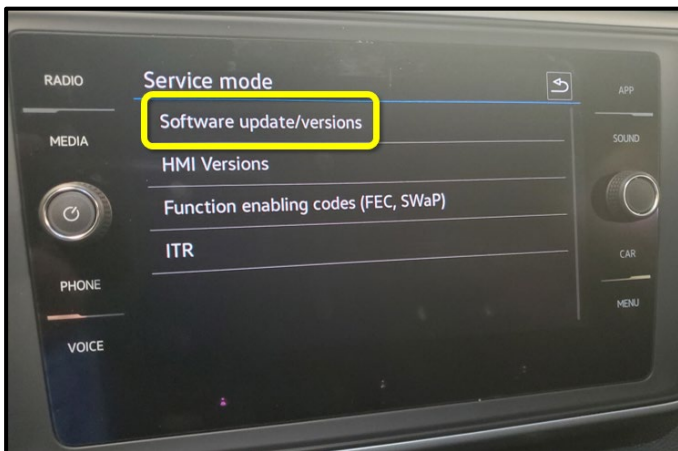
- Select the option "Software Update/Versions."

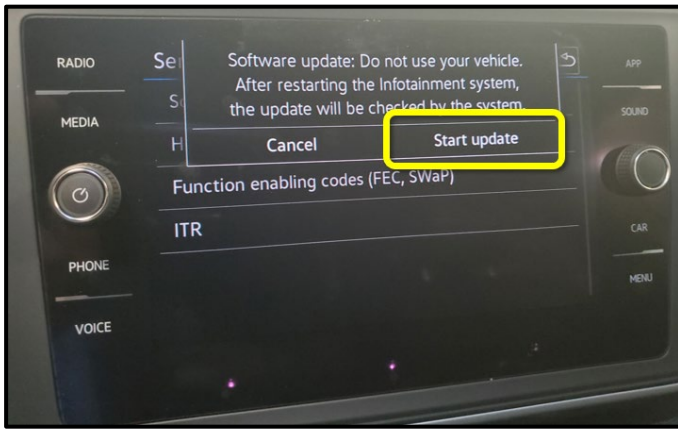
- Select "Start update."

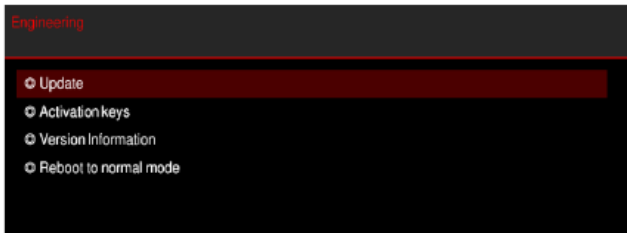
- Select Update.

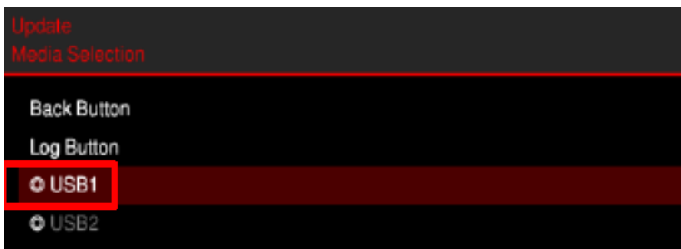
- Select the option USB 1.

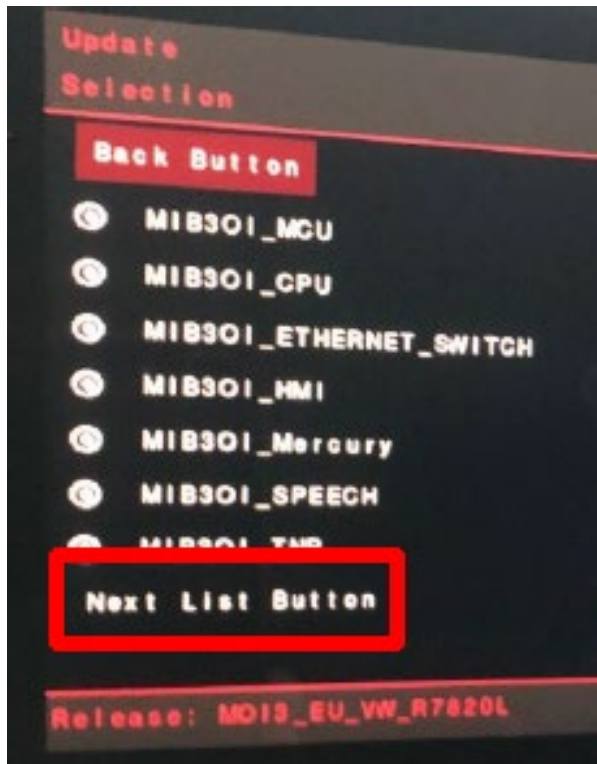
- Select next list button option.

If "N/A" is shown next to the file names on this screen, a software patch is required prior to completing the software update. See Appendix A for instructions on installing the patch.

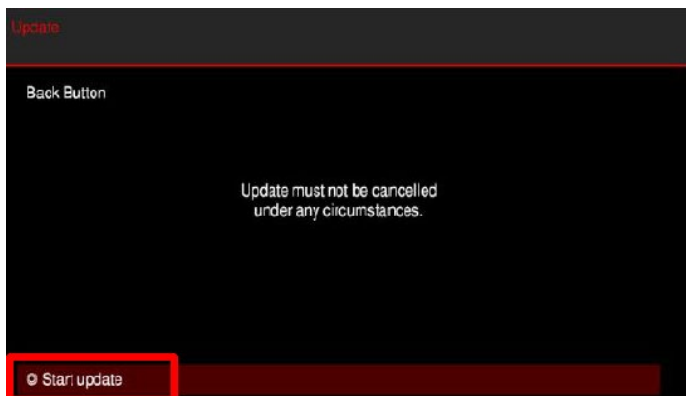
- Select "Start Update."

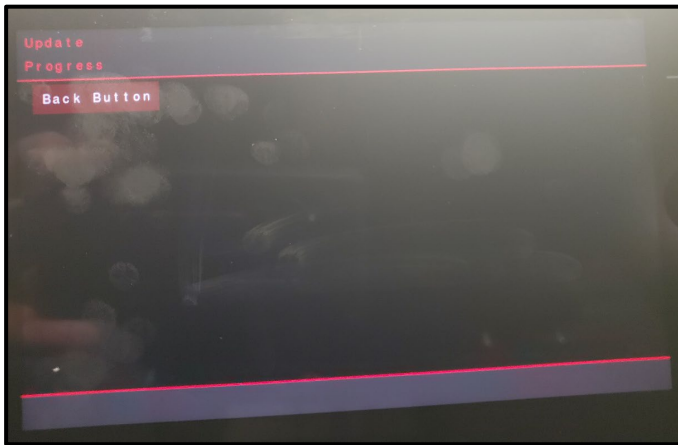
NOTE
 After starting the update, this screen will appear and remain for up to 5 minutes.

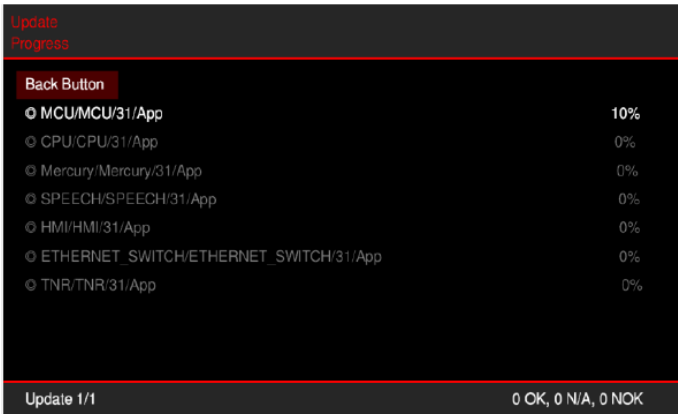
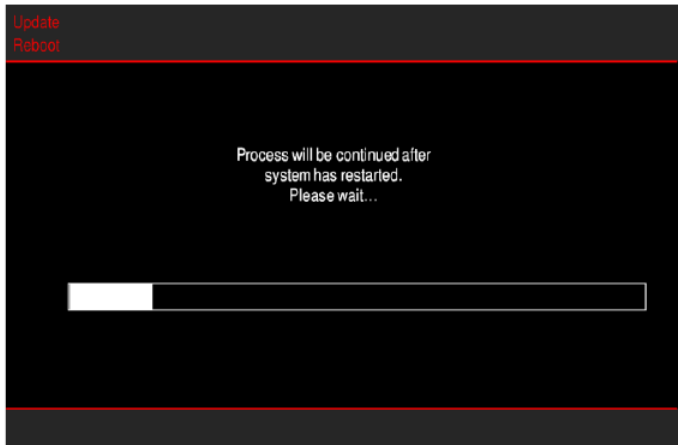
- Software Update progress screens shown here.

NOTE
 The screen may go blank a few times during the update.

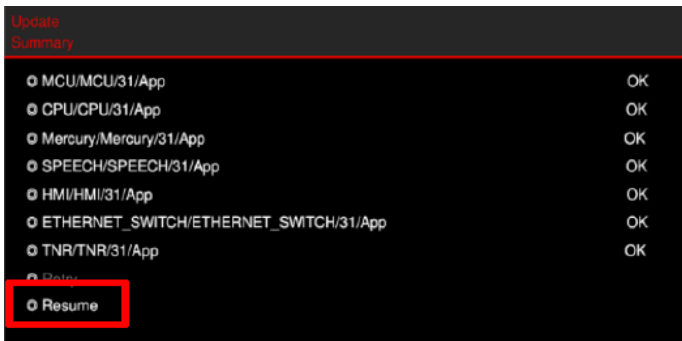
- When the Update Summary screen appears, select “Resume.”

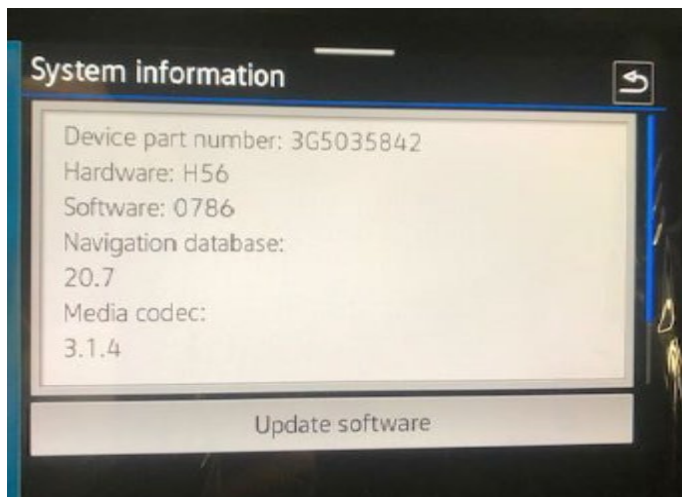
- When the completed update screen appears, select, “OK.”

- If the software version did not change to 0786, refer to Appendix A for instructions on loading a software patch.
- The 91BB/91BC software update will have to be performed again after the patch is installed.

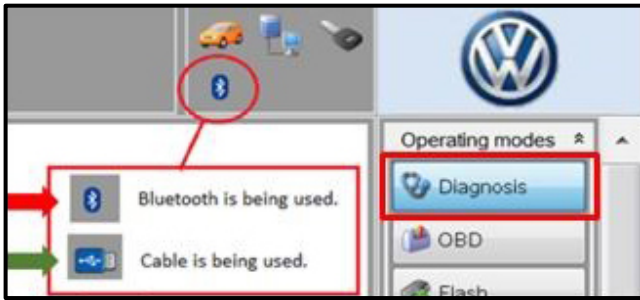
- Confirm that scan tool is communicating with the diagnostic head by USB <Green Arrow>.
 - If the Bluetooth symbol is shown <Red Arrow> then disconnect the diagnostic head from the vehicle and reconnect the USB cable to the diagnostic head and then reattach to the vehicle.
- Upon ODIS startup, verify the “Diagnosis” operating mode is selected <as shown>.

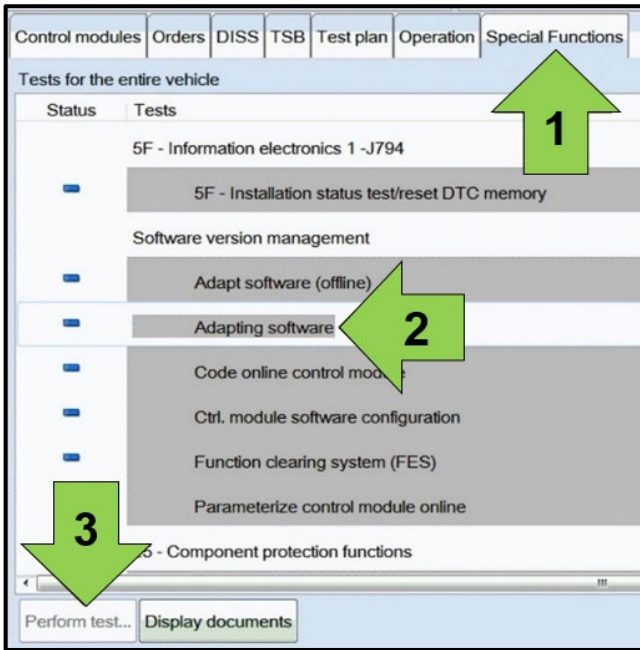
- Once the GFF scan is complete, select “Special functions” <arrow 1>, then “Adapting software” <arrow 2>, then select “Perform test” <arrow 3>.

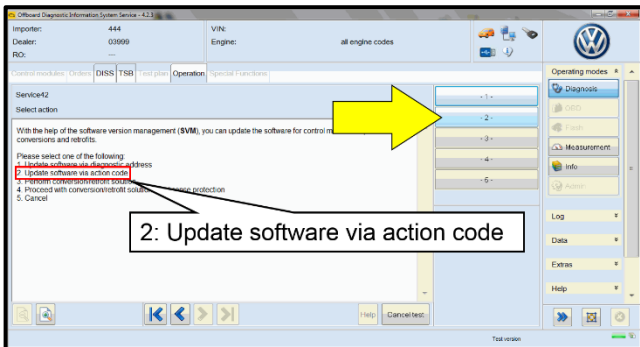
- Select the correct option to “Update software via action code” OR “Software update via measured code”.

NOTE
The different options to perform the SVM operation may vary based on model.

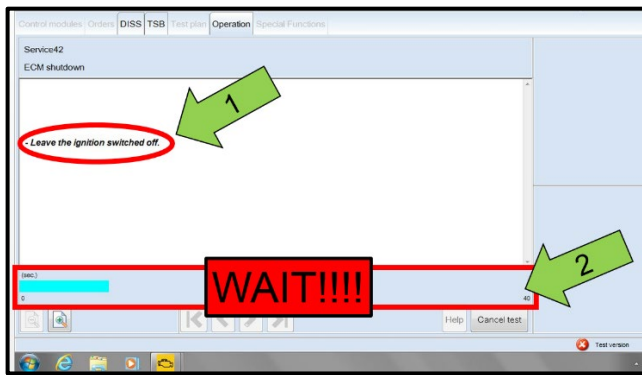
- It is **IMPERATIVE** that **ALL** of the ignition cycle on/off delay requests are fulfilled in their entirety during this flash process <arrow 1>.
- Failing to wait for the ignition on/off timing cycle to complete (progress bar and countdown timer <arrow 2>) before cycling the ignition on/off **MAY** damage a control module.
- Damage to control modules as a result of failing to wait the specified time displayed by the progress bar and countdown timer <arrow 2> are **NOT** covered under this action.

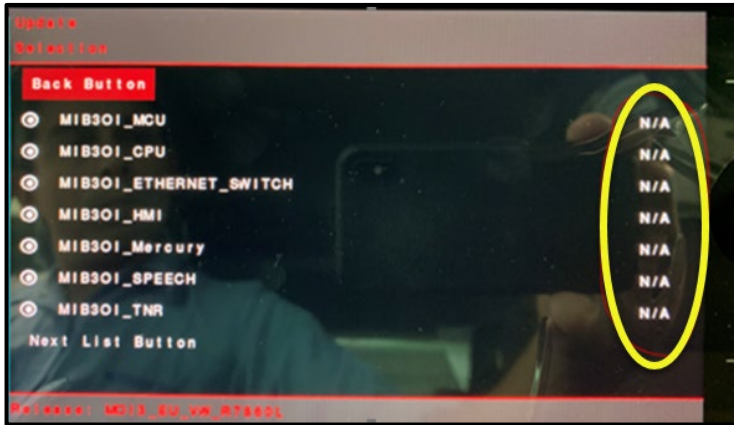
- If the software version did not change to 0786 after the software update or N/A is listed in the Update screen, a software patch may resolve the concern.
- The 91BB/91BC software update will have to be performed again after the patch is installed.

- This patch software must be downloaded onto a separate USB device (USB Type A 2.0 or higher, or USB-C).
- The USB device must be formatted prior to downloading the patch software.
- Formatting the USB device will erase all files currently on the device.
- To format the USB device:
 - Locate the USB device in Windows File Explorer.
 - Right click on the drive.
 - Select "Format."

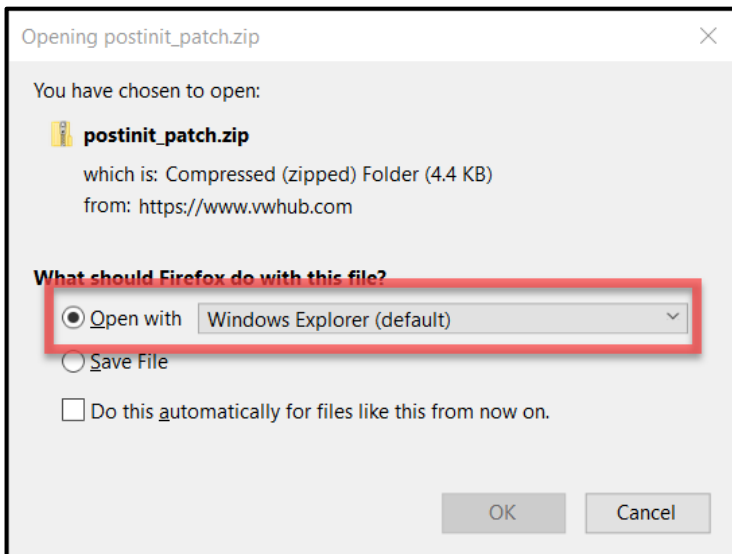
- Open the “*postinit_patch.zip*” folder.
