# Product Safety Recall

## N202311160 Drivers May Overlook Open Hood Alerts

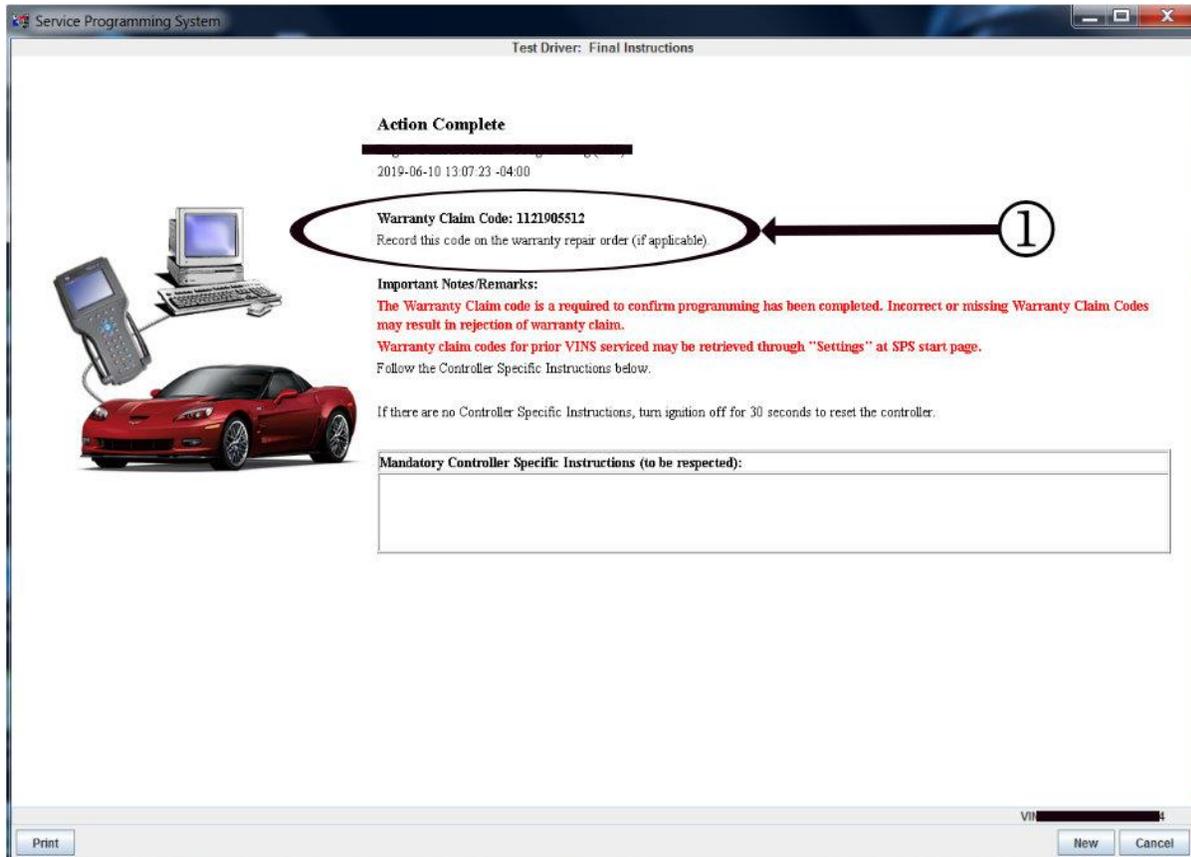
5431209

**Important:** To avoid warranty transaction rejections, you MUST record the warranty claim code provided on the Warranty Claim Code (WCC) screen shown above on the job card. Refer to callout 1 above for the location of the WCC on the screen.

**Important:** If the Same Calibration/Software Warning is noted on the TLC or SPS Summary screen, select OK and follow screen instructions. After a successful programming event, the WCC is located in the Service Programming System dialogue box of the SPS Summary screen. No further action is required. Refer to the Warranty section of the bulletin.
