# Product Safety Recall

## N202311730 High Voltage Battery May Melt or Burn

**Release Date:** April 2021

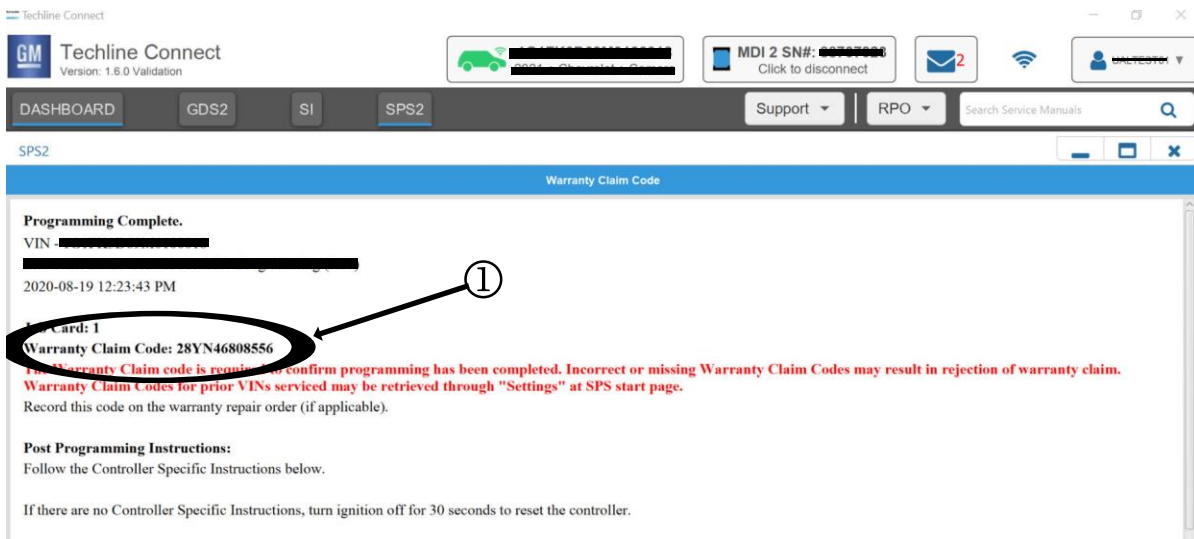
5644478

1. Reprogram the K114B Hybrid/EV Powertrain Control Module 2. Refer to *K114B Hybrid/EV Powertrain Control Module 2: Programming and Setup* in SI.
