Product Safety Recall

N202311731 High Voltage Battery May Melt or Burn

Release Date: April 2021

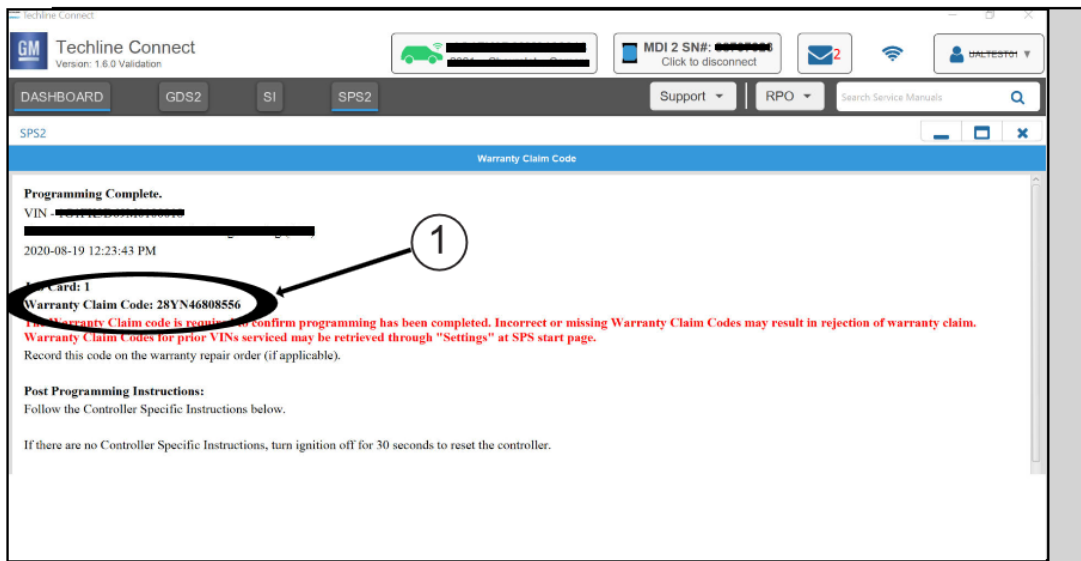
2. Reprogram the K9 Body Control Module. Refer to *K9 Body Control Module Programming and Setup* in SI.

Note: The screenshots above are an example of module programming and may not be indicative of the specific module that is being programmed. Module selection and VIN information have been blacked out.

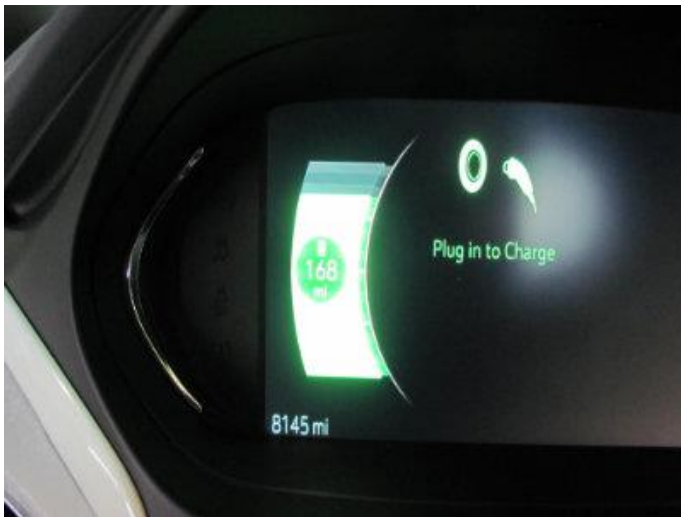
- If any DTCs are set, store any Freeze Frame/Failure Records and go to Diagnostic Trouble Code (DTC) List – Vehicle in Si. Return to this procedure after DTC repair.
 - If no DTCs are set, go to Step 2.
2. Vehicle ON, use GDS2 to view Specific DTC status:
- From Module Diagnostics, select Hybrid Powertrain Control Module 2.
 - Select Diagnostic Trouble Codes folder
 - Select Specific DTC
 - Ensure the following DTCs have Ran and Passed this ignition: DTC P0BBB.
 - If the DTCs have ran and passed proceed to Step 3
 - If the DTCs have failed go to Diagnostic Trouble Code (DTC) List – Vehicle
 - If DTC P0BBB is not supported an error has occurred during programming, repeat Procedure 3: Software Flashing Procedure.
