EQUIPMENT RECALL 21TH01 (Interim Notice)

Potentially Defective Power Steering Gear Service Replacement Assemblies

**Potentially Defective Power Steering Gear Service Replacement Assemblies
Dealer Parts Inventory Inspection Procedure**

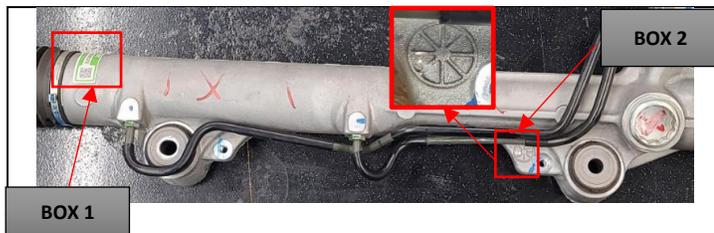
1. CONFIRM PART NUMBER IS IN PARTS LIST

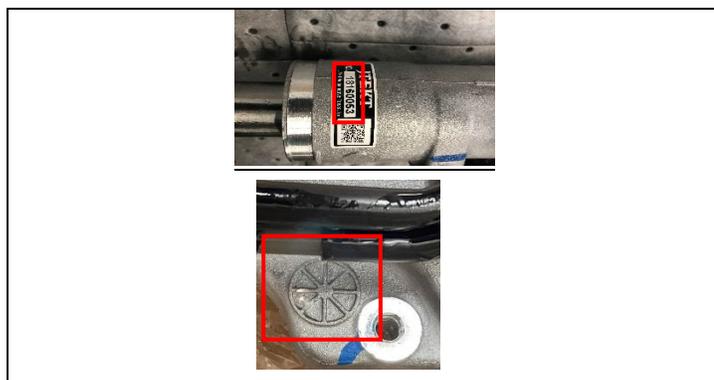
- 2. REMOVE STEERING GEAR FROM BOX AND PREPARE PART FOR INSPECTION**
- 3. IDENTIFY THE SERIAL NUMBER (BOX 1) AND MACHINE ID MARK (BOX 2) LOCATION**

- 4. IDENTIFY SERIAL NUMBER**
 - a. TAKE A PHOTO OF THE SERIAL NUMBER**
- 5. IDENTIFY MACHINE ID MARK**
 - a. TAKE A PHOTO OF THE MACHINE ID Mark**
