March 2021
FL872A
NHTSA #21V-007
Transport Canada #2021-007

Subject: Cascadia Bridgestone Steer Tire Failures

Models Affected: Specific Model Year 2020-2022 Freightliner Cascadia model vehicles, manufactured February 5, 2019, through January 6, 2021, equipped with Bridgestone R284, R268, or R283S ECOPIA steer axle tires, in conjunction with a specific air dam.

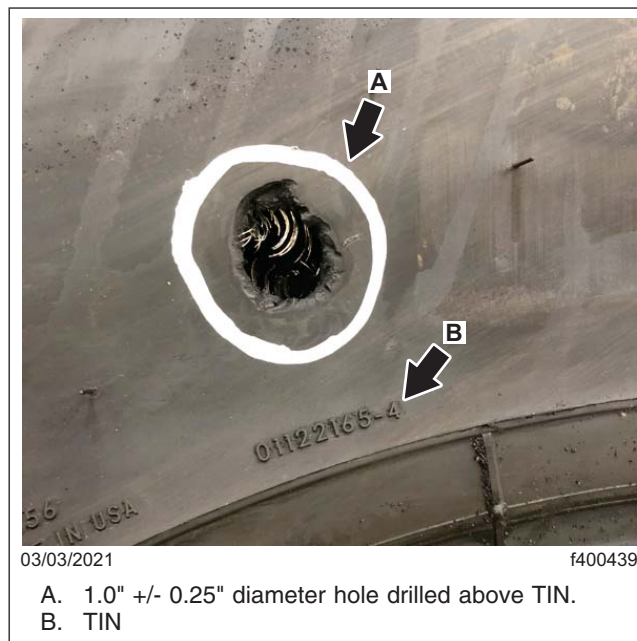
Fig. 7, Hole Drilled Above the TIN

2. Drill a 1.0" +/- 0.25" diameter hole above the TIN as shown in [Fig. 7](#).

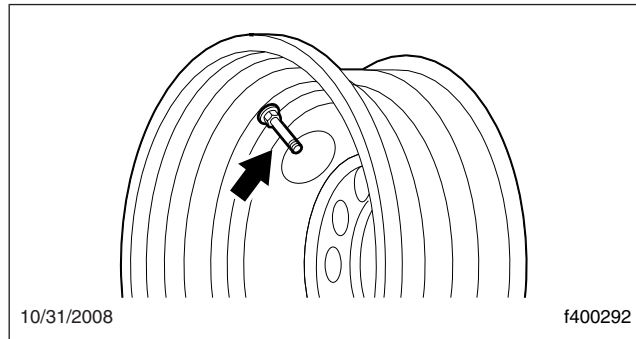
Fig. 9, Valve Stem Installation

1. Remove the old valve stem, and install a new valve stem in the wheel.
 - 1.1 Place the valve stem, with a rubber washer, through the valve hole from the tire side of the wheel.
 - 1.2 Screw the valve nut onto the stem from the opposite side. Make sure the rubber bushing and metal collar or nut are centered and fit snugly in the valve hole. See [Fig. 9](#).
 - 1.3 Tighten the nut securely.
