March 2021
FL872A
NHTSA #21V-007
Transport Canada #2021-007
(Revised Notice)

Subject: Cascadia Bridgestone Steer Tire Failures

Models Affected: Specific Model Year 2020-2022 Freightliner Cascadia model vehicles, manufactured February 5, 2019, through January 6, 2021, equipped with Bridgestone R284, R268, or R283S ECOPIA steer axle tires, in conjunction with a specific air dam.

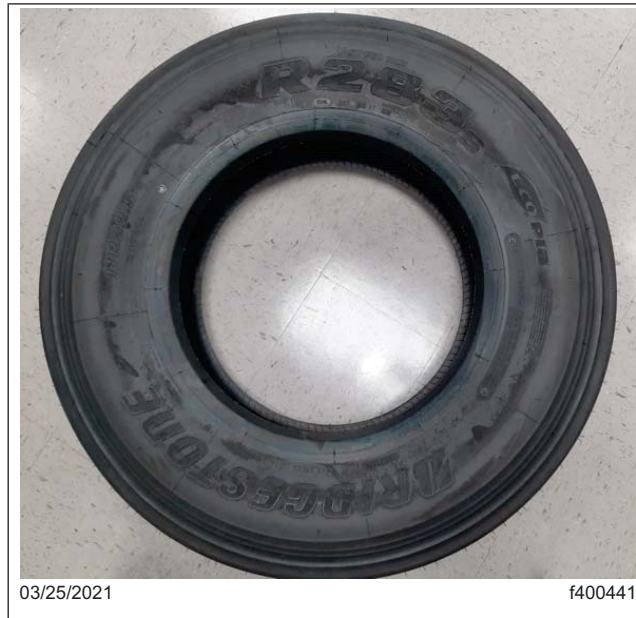
Fig. 6, Bridgestone R283S Tire

1. Locate the DOT Tire Identification Number (TIN) on each tire. See [Fig. 6](#), [Fig. 7](#) and [Fig. 8](#).

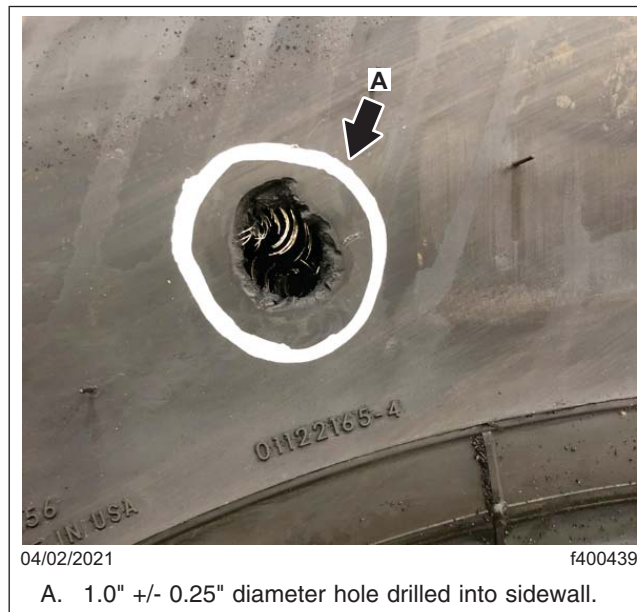
Fig. 9, Hole Drilled

2. Drill a 1.0" +/- 0.25" diameter hole into the sidewall of the tire as shown in **Fig. 9**.

A. 1.0" +/- 0.25" diameter hole drilled into sidewall.
