**SUBJECT:** **NEW VEHICLE DEMONSTRATION / DELIVERY HOLD**  
**Compliance Recall 21C23 – Supplement #1**  
Certain 2021 Model Year Bronco  
Front Passenger Air Bag Replacement

## CERTAIN 2021 MODEL YEAR BRONCO VEHICLES — FRONT PASSENGER AIR BAG REPLACEMENT

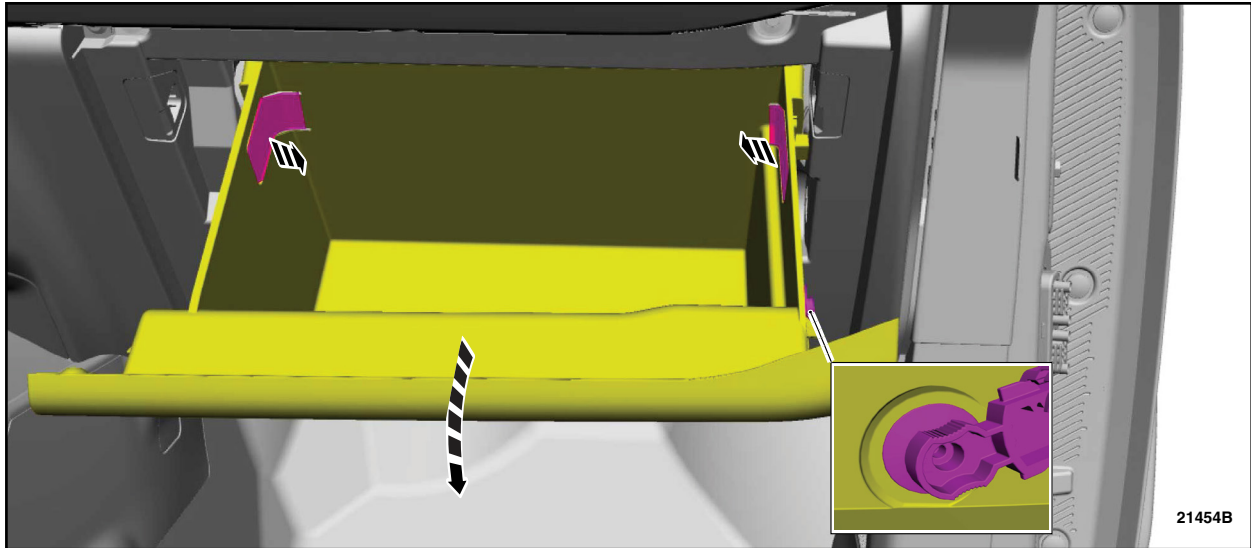
**FIGURE 2**

3. Open the glove compartment, remove the dampener, and release the stop tabs and fully lower the glove box. See Figure 2.

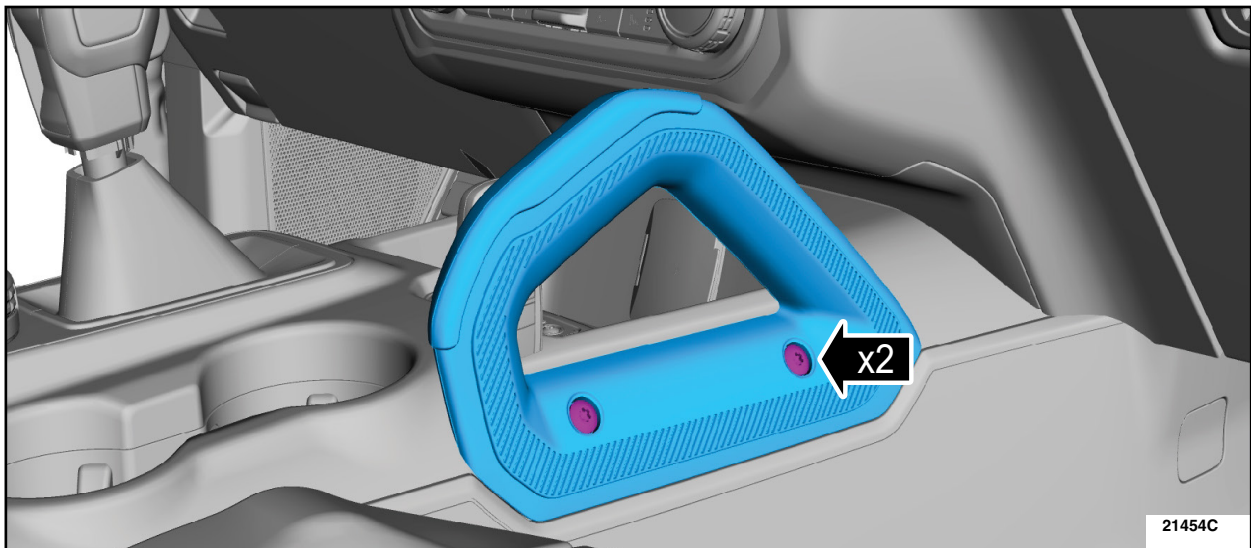
**FIGURE 3**

4. If equipped remove the screws and the console handle. See Figure 3.

- Torque 48 lb.in (5.4 Nm).
