SIB 34 02 21

## RECALL 21V-062: INTEGRATED BRAKE SYSTEM

Replace the IB.

Replace the IB as per REP 34 51 601.

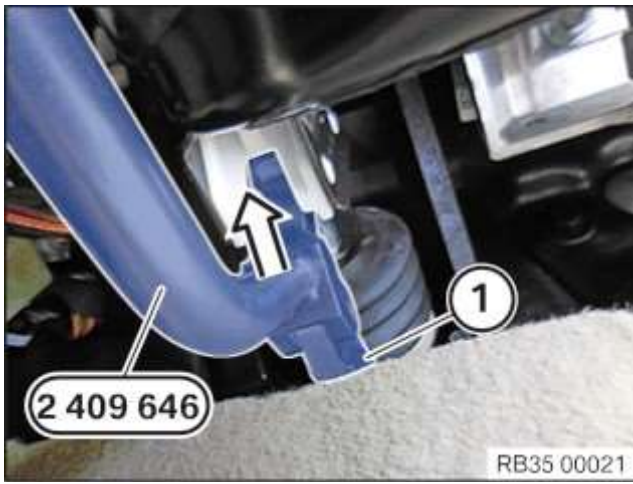
- Press the special tool **2 409 646** in the direction of the arrow and lever the brake pedal off the brake booster.

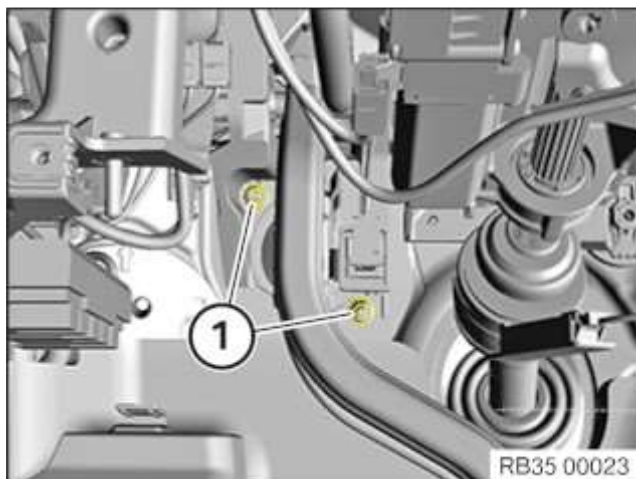
- Renew nuts.
- Place and tighten nuts (1).

M8	1 x retighten to the hydraulic unit after 10 min	Tightening torque	22 Nm
----	--	-------------------	-------

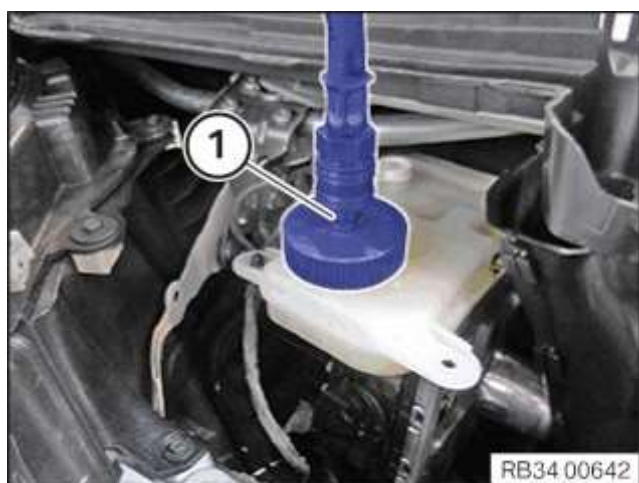
- Connect the bleeder unit (1) to the brake fluid expansion tank and switch it on.

- **Do not exceed the filling pressure of 2 bar.**

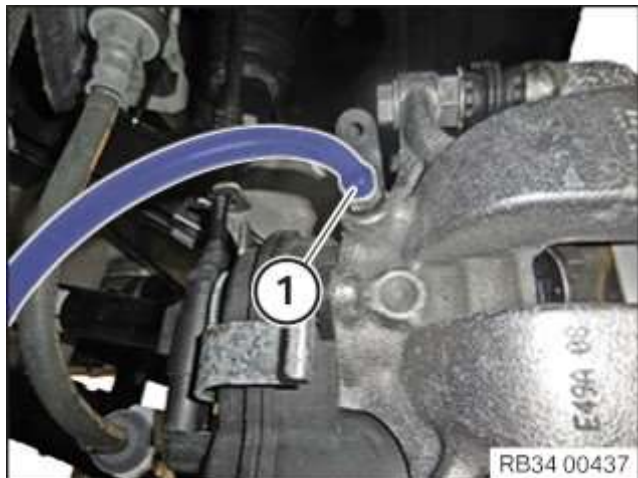
- **Start flushing at the rear right.**
- Connect the vent hose with the collecting vessel to the vent valve (1) on rear right brake caliper.
- Open the vent valve (1) and purge it until clear, bubble-free brake fluid emerges.
- Close vent valve.

Vent valve	Tightening torque	10 Nm
------------	-------------------	-------

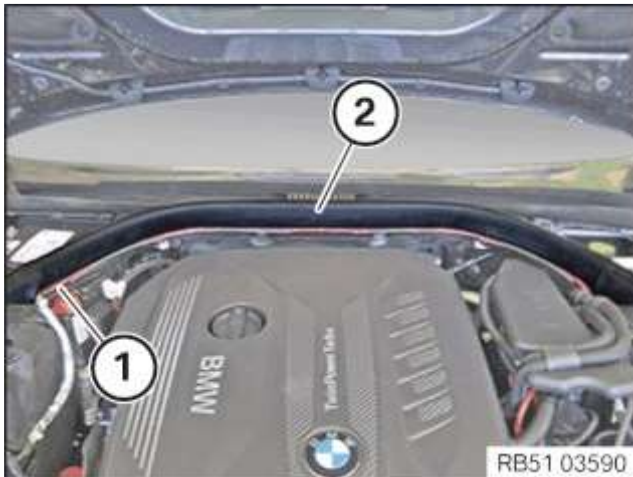
### 22–Install the seal for the bonnet

- Press the rear bonnet seal (2) into the guide.
- Feed in cable (1) into the brackets.
- Check that the rear bonnet seal (2) and the cable (1) are seated correctly.
