# Compliance Recall

## Code: 69BV

<b>Subject</b>	<b>Airbag Control Module Programming</b>																			
<b>Release Date</b>	February 25, 2021																			
<b>Affected Vehicles</b>

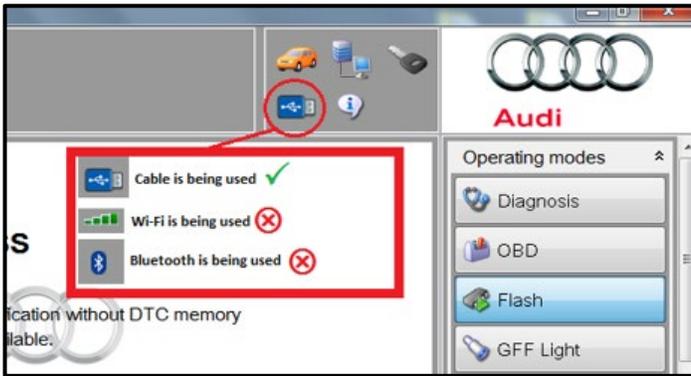
- Confirm that scan tool is communicating with the diagnostic head by USB cable.
  - If the Bluetooth or WiFi symbol is shown, then disconnect the diagnostic head from the vehicle and reconnect the USB cable to the diagnostic head and then reattach to the vehicle.

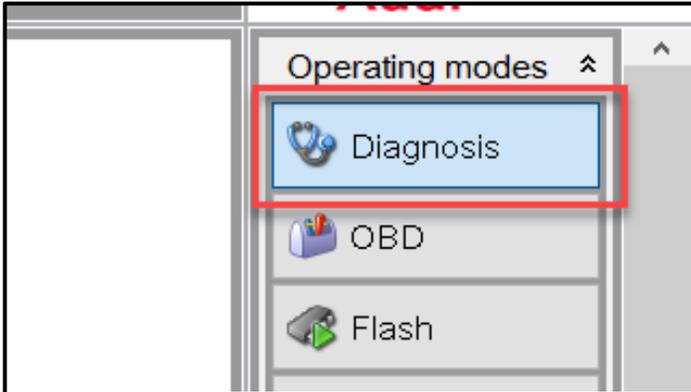
- From the home screen of the scan tool highlight “Diagnosis” and perform a full GFF diagnostic scan.
- Follow the on-screen prompts.

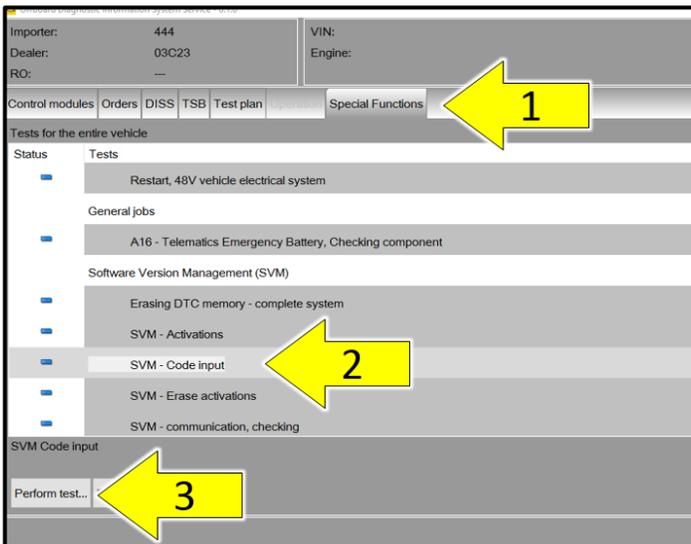
- After the diagnostic scan is complete:
  - Select the “Special Functions” tab <1>.
  - Select “SVM Code Input” <2>.
  - Select “Perform test...” <3>.
- Follow the on screen prompts.

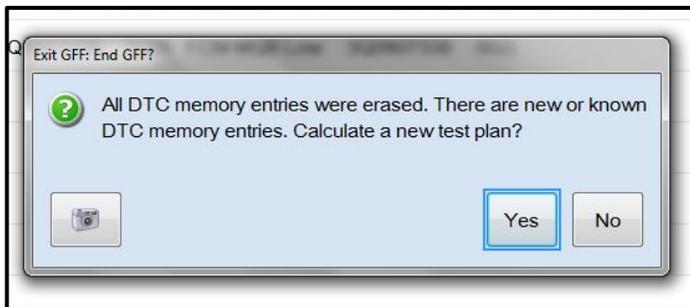
- Static fault "*B159B00, Start-up not ended ; static*" may set during the update, which will turn on the airbag light in the instrument cluster.
- When exiting Guided Fault Finding, ODIS will provide a prompt (as shown) if faults are set.
- Select "Yes" and test plans will be automatically populated.

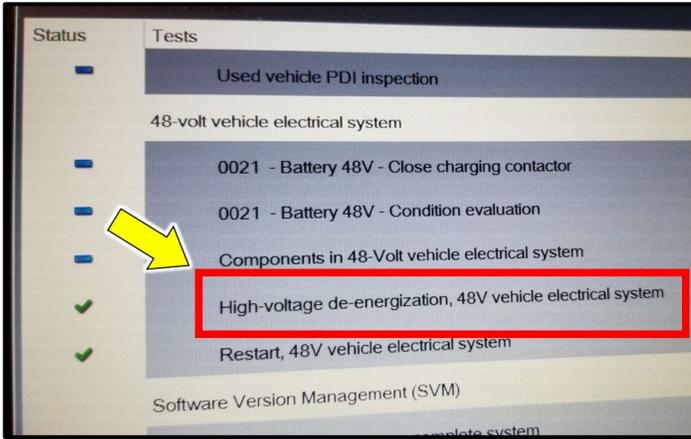
**NOTE**  
 The test plan populated will require the 12V battery to be disconnected.

- For vehicles with a 48V battery system, the high-voltage system will need to be de-energized prior to disconnecting the 12V battery.
- The test plan for de-energization <arrow> can be found under the Special Functions tab.

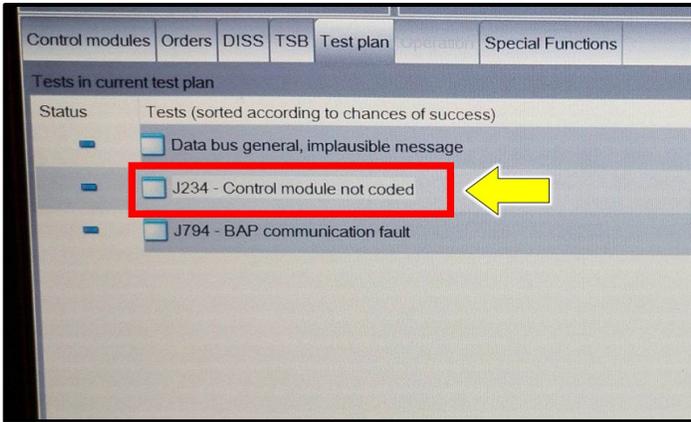
- Perform the test plan "J234 – Control module not coded" <arrow>.
- Follow the on-screen prompts.

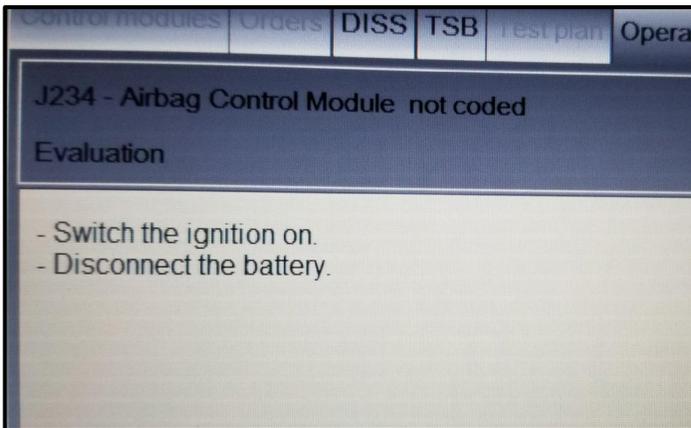
- The test plan requires the 12V battery negative terminal to be disconnected with the ignition switched **ON**.
- After disconnecting the 12V battery negative terminal for a moment, it can be reconnected.
- Torque the battery terminal nut to 6 Nm.

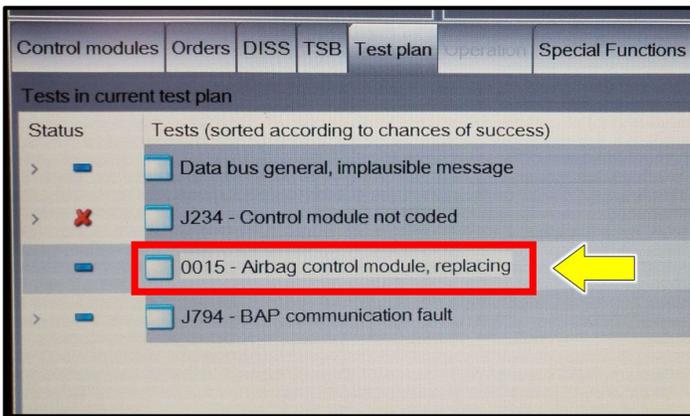
- Upon completion of the test plan “J234 – Control module not coded”, the “Airbag control module, replacing” test plan <arrow> will be populated.
- Start the test plan and follow the on-screen prompts.

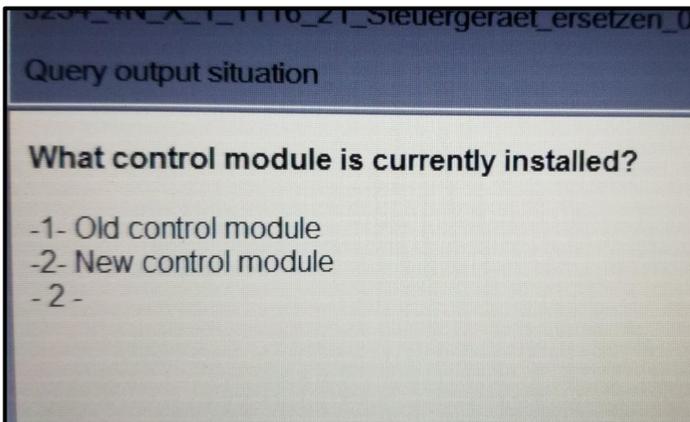
- When asked what control module is currently installed, select that a **NEW** control module is currently installed.

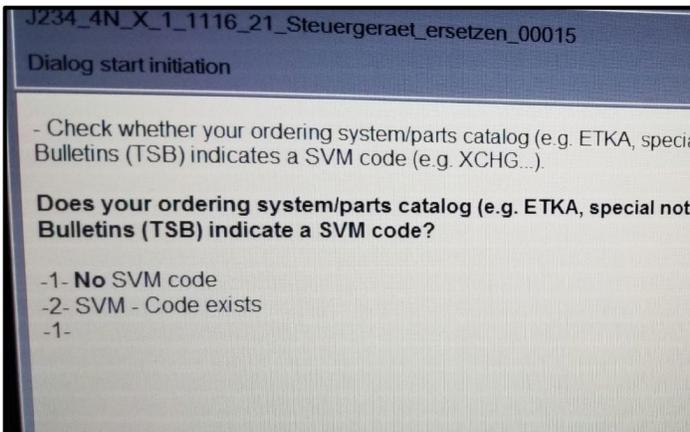
- When asked if any TSB's indicate a SVM code, select that there is **NO** SVM code.
