Safety Recall

Code: 69BY

Subject Passenger Occupant Detection System (PODS)

REVISION SUMMARY Updated PODS programming and troubleshooting steps

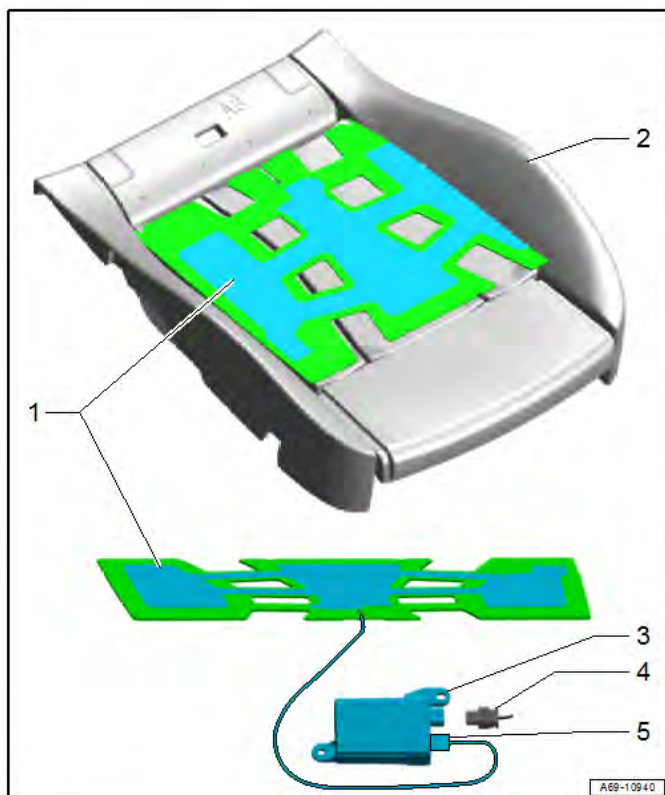
Repair Overview

- Replace PODS sensor mat.
- Program existing PODS ECU.
- Perform PODS Basic Settings.

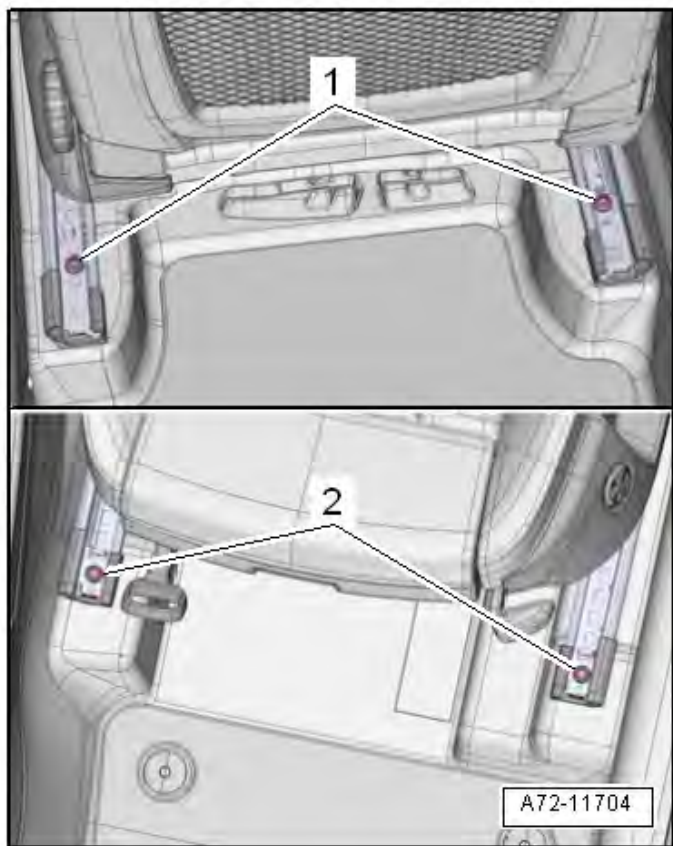
Unbolt seat:

- Push the headrest into the lowest position.
- Move the front seat all the way to the rear and then into its lowest position.
- Remove seat bolt covers.
- Remove front bolts <2> from the seat rail.
- Move the front seat all the way forward and up.
- Remove the rear bolts <1> from the seat rail.

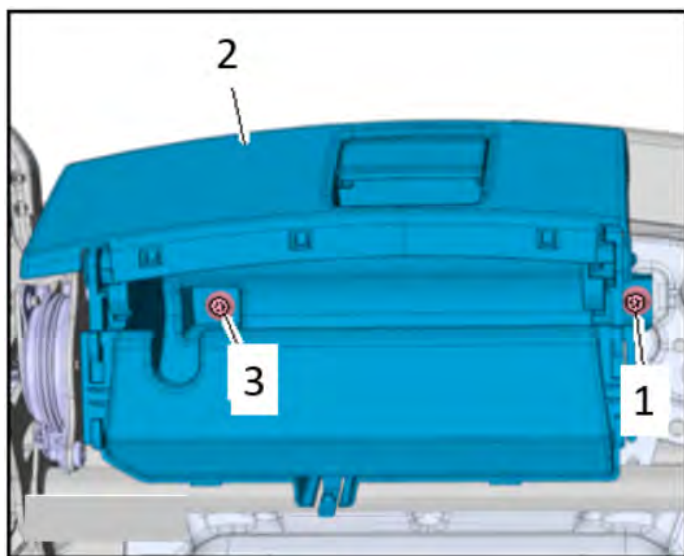
Remove storage compartment (if equipped):

- Handle the customer's property with care.
- Remove the bolts <1 and 3>.

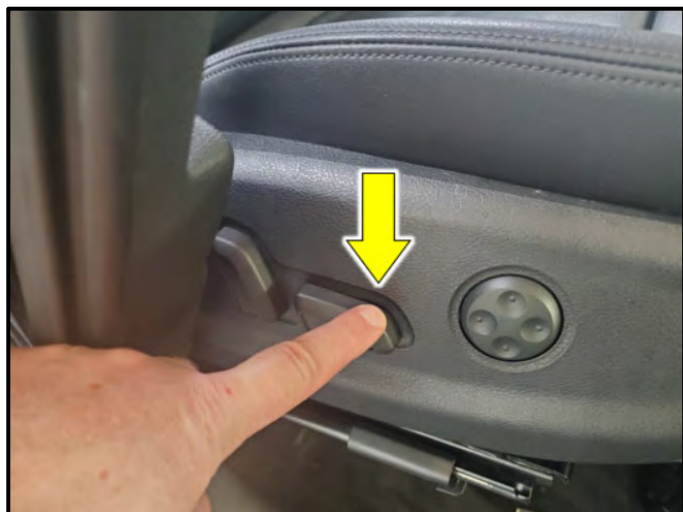
- Press down on the seat bottom tilt adjustment.

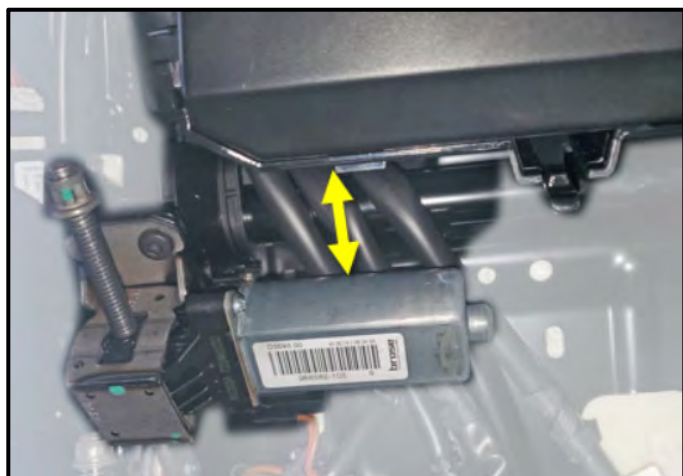
Moving the front tilt adjustment position to its lowest position will provide the necessary clearance to allow removal of the storage compartment.

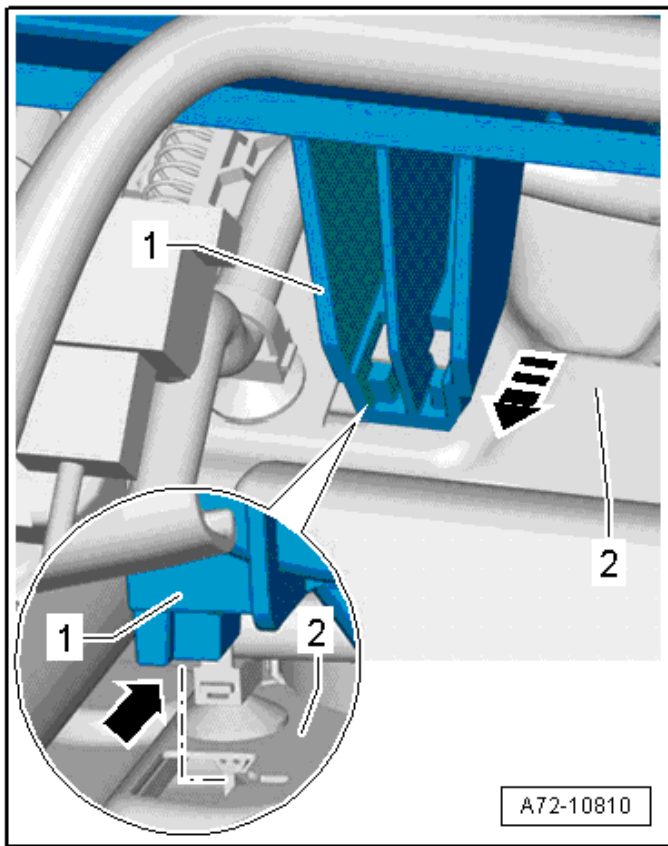
- Push the storage compartment rearward <1> in the direction of the <arrow> and disengage the retainer <lower arrow> from the upper seat frame <2>.
- Remove the storage compartment from the seat pan upper frame.
- Unclip the Passenger Occupant Detection System Control Module -J706-.

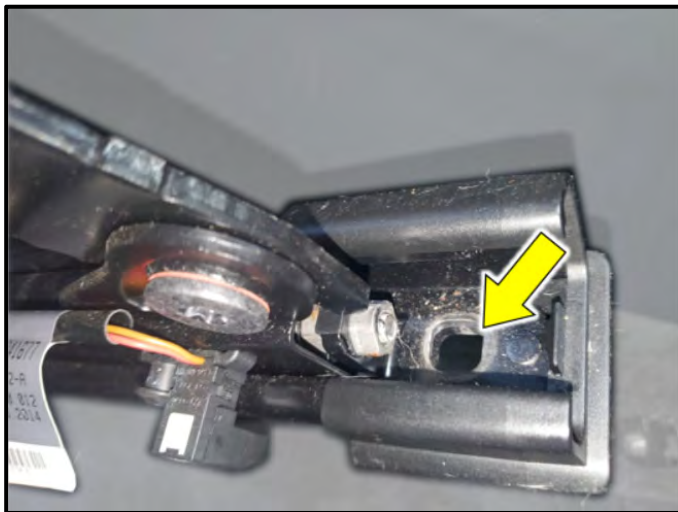
Position seat for removal:

- Move seat to its highest position.
- Move seat toward the rear so the front hole <arrow> for the seat frame bolt can be accessed (as shown).
- Ensure the rear holes for the seat frame bolts can also be accessed.

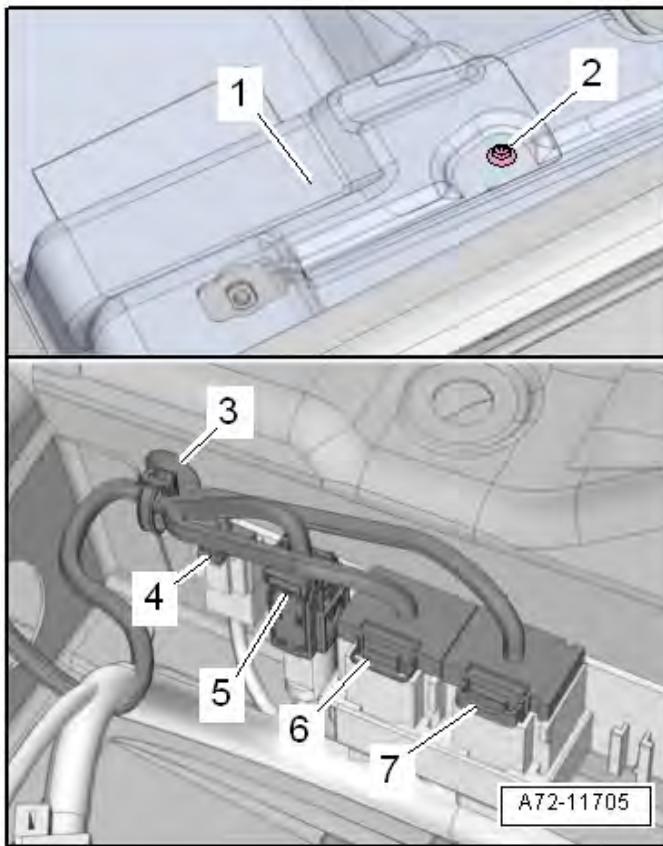
Disconnect connectors:

- Remove the expanding clip <2> and fold up the section of the carpet <1>.
- Unclip the cable holder <3>.

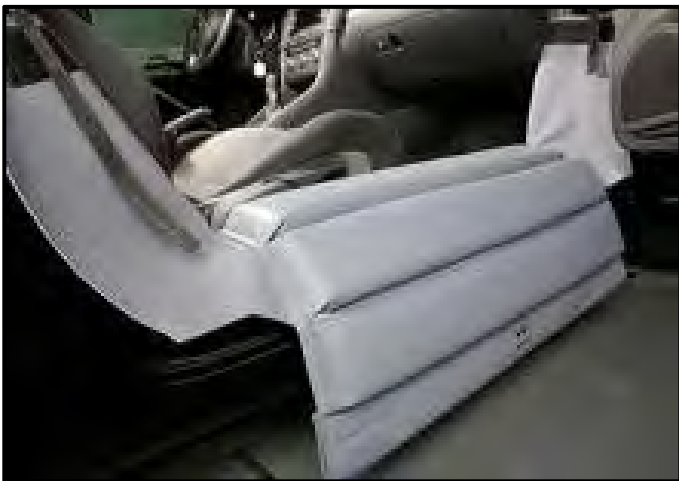
Install -VAS871001-:

- To protect the sill panel before removing the front seat, install the Universal Vehicle Protector -VAS871001- <as shown>.
- Carefully remove the front seat from the vehicle.

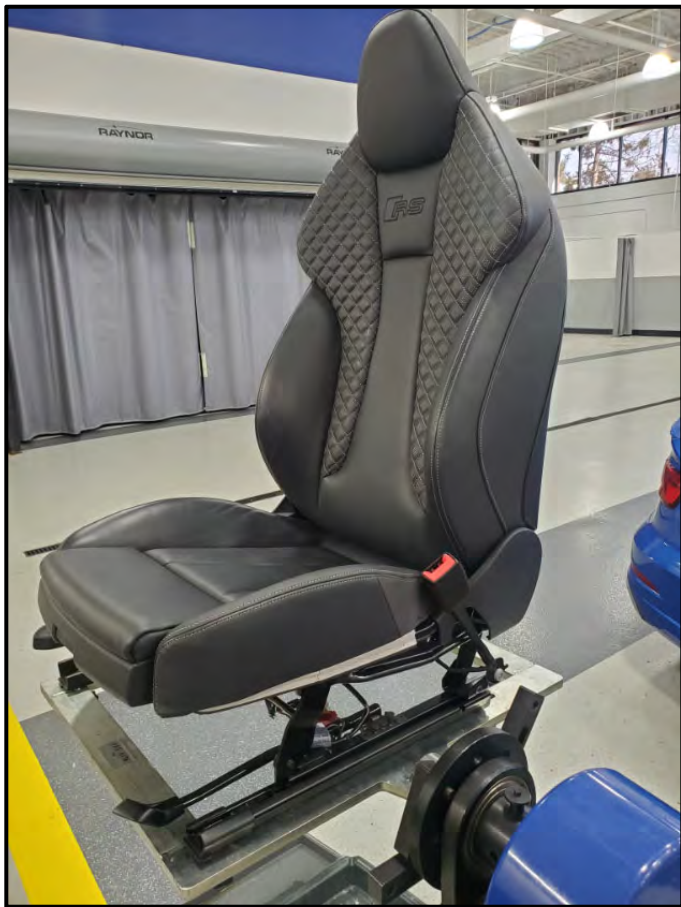
Attach seat to -VAS6136-:

- Attach the Seat Repair Fixture -VAS6136- to the Engine and Transmission Holder -VAS6095-.
- Fasten the front seat onto the Seat Repair Fixture -VAS6136-.

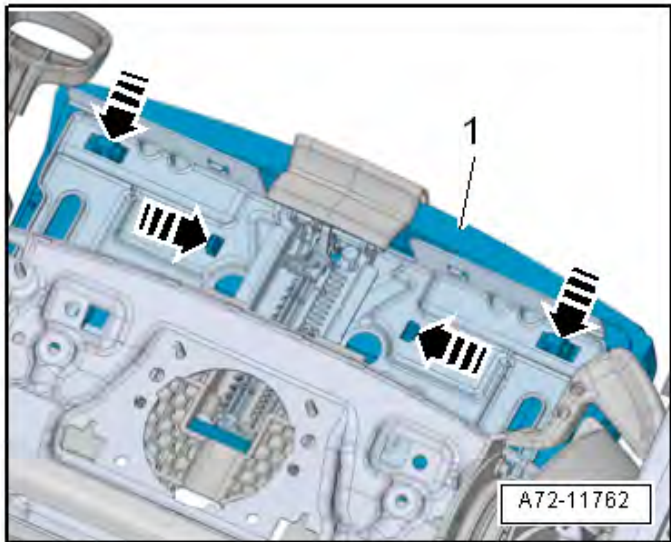
Disengage seat depth adjuster cushion (if equipped):

- Release the retaining tabs <arrow> on the support using the -3409- from the seat depth adjuster.
- Remove the support <1> with seat depth adjustment cushion and cover upward.

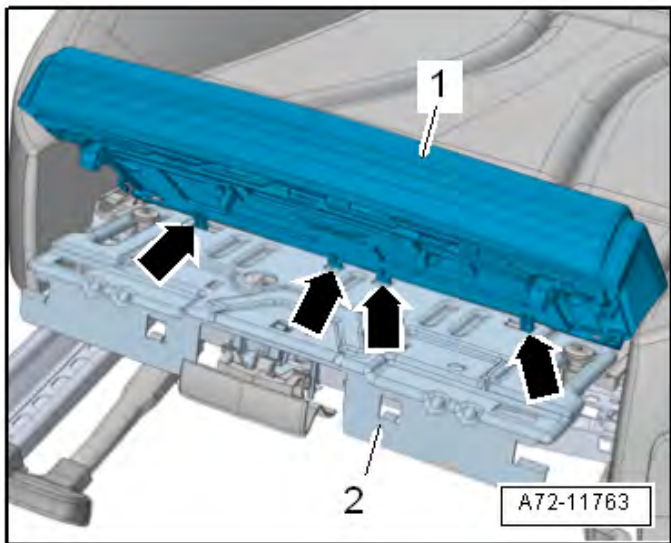
- Disengage the tabs <arrows> from the seat depth adjuster <2> and move the support with cushion and cover upward.
- Remove the support <1> with cushion and cover for the seat depth adjuster upward and forward at the same time.

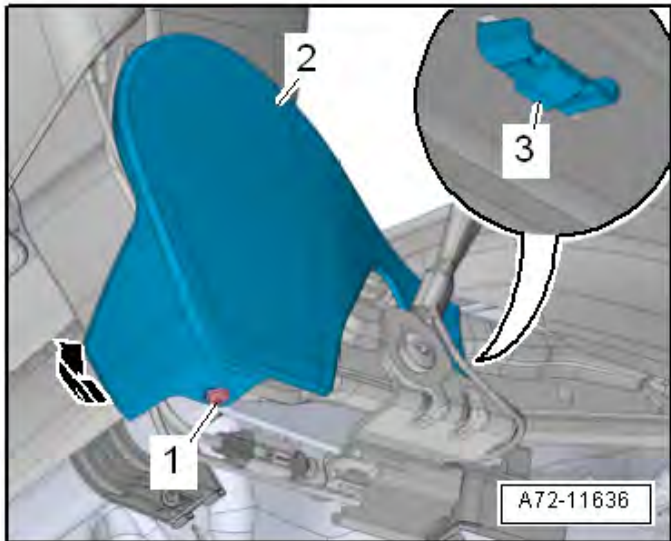
Remove tunnel side seat trim:

- Remove the expanding rivet <1> from the seat side trim on the tunnel side.
- Disengage the front seat side trim <2> from the seat pan, to do this release the retaining tab <3> and pull the seat side trim outward.
- Disengage the seat side trim on the tunnel side from the backrest hinge in direction of <arrow> and remove.

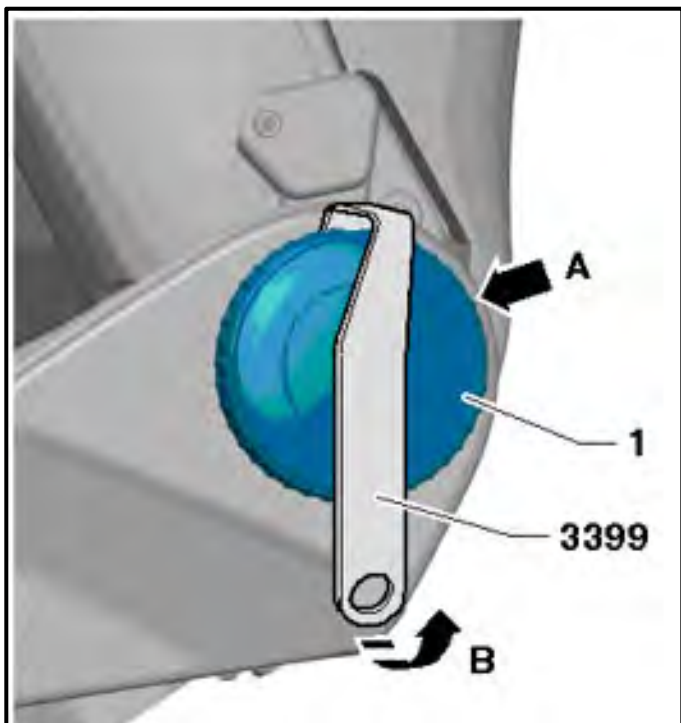
Remove backrest adjustment hand wheel (MANUAL seats):

- Turn the seat back adjustment wheel <1> until one catch is visible from behind <arrow A>. Use a flashlight if necessary.
- Using the Assembly Tool -3399-, carefully pry the adjustment wheel off the seat <direction of arrow B>.
- Turn the seat back adjustment wheel 120° further and repeat the process.
- Remove the seat back adjustment wheel.

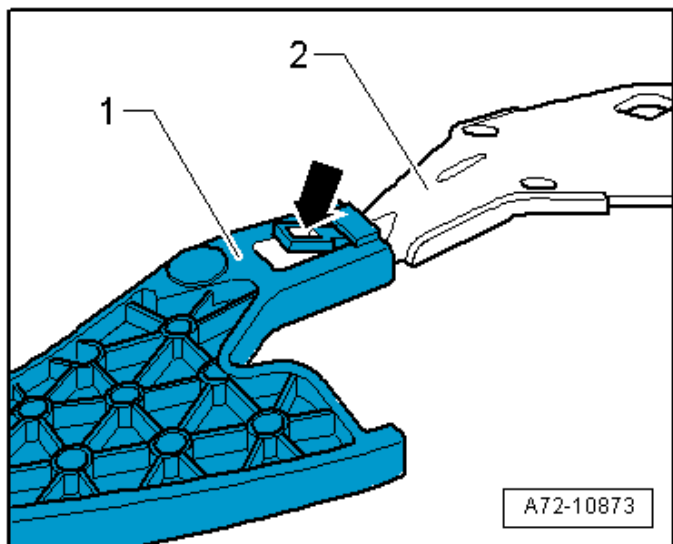
Remove seat height adjuster handle (MANUAL seats):

Remove the seat height adjustment handle <1> as described, do not drive it off the lever <2>.

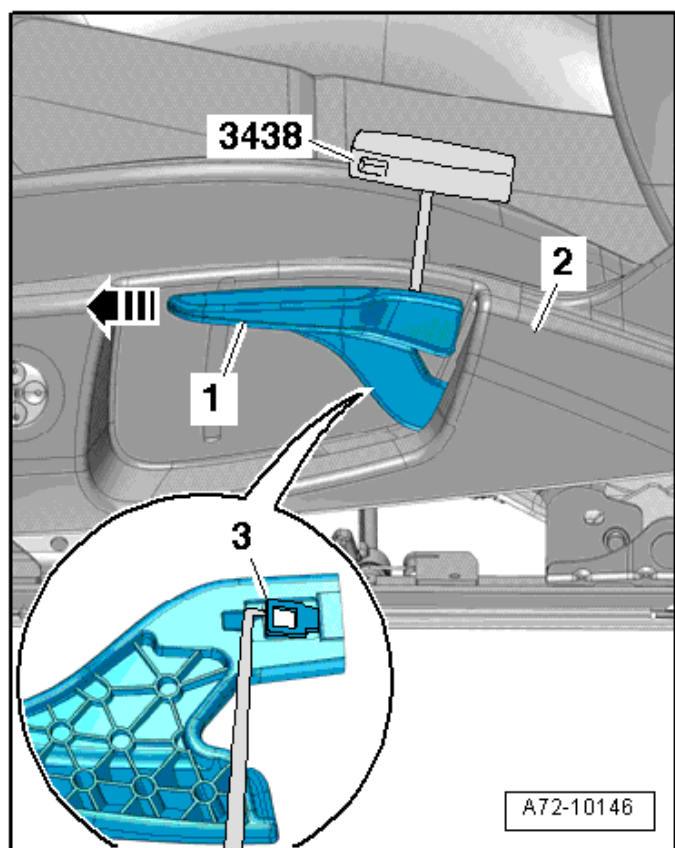
- Pull the seat height adjustment handle <1> slightly upward and hold in this position.
- Remove the seat height adjustment handle as far as possible from the front seat.
- Guide the -3438- between the seat height adjustment handle and seat side trim <2>.
- Release the tab <3> with the -3438- and at the same time remove the seat height adjustment handle in the direction of the <arrow> from the lever.

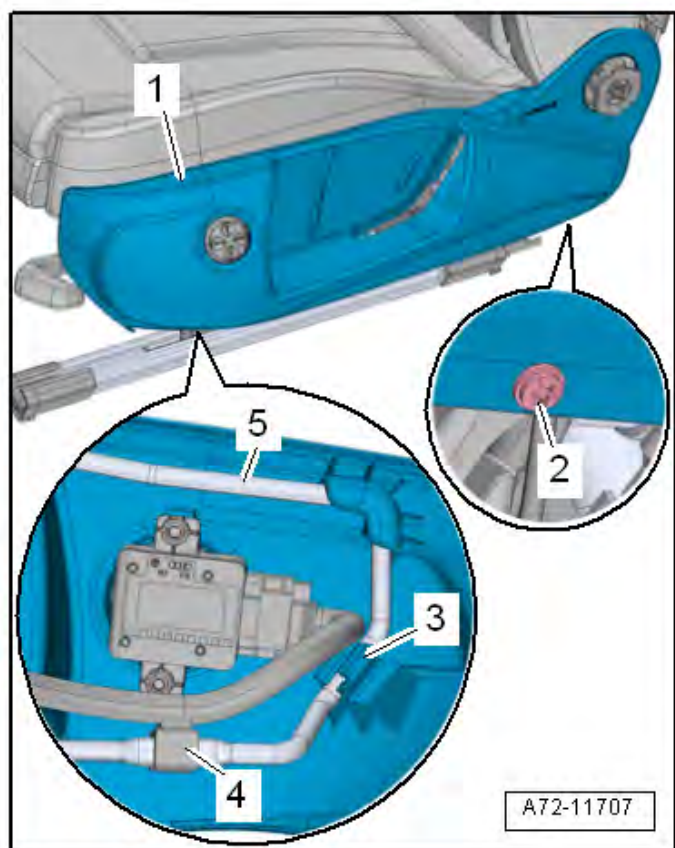
Remove side trim and bracket on sill side (MANUAL seat):

- Remove the expanding rivet <2> from the seat side trim.
- Open the clip <3> with a screwdriver.
- Disengage the rear seat trim on side sill side <1> from the backrest hinge and the seat pan.
- Slightly lift the front seat side sill trim, unclip from the bracket <5> and remove forward.
- Equipment versions with lumbar support: unclip the cable holder <4> and disconnect the connector from the lumbar support adjustment switch.

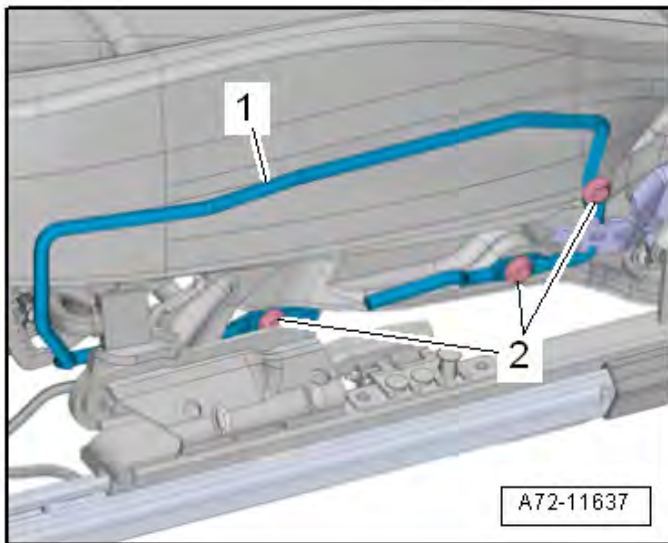
- Remove the bolts <2> and remove the bracket <1>.

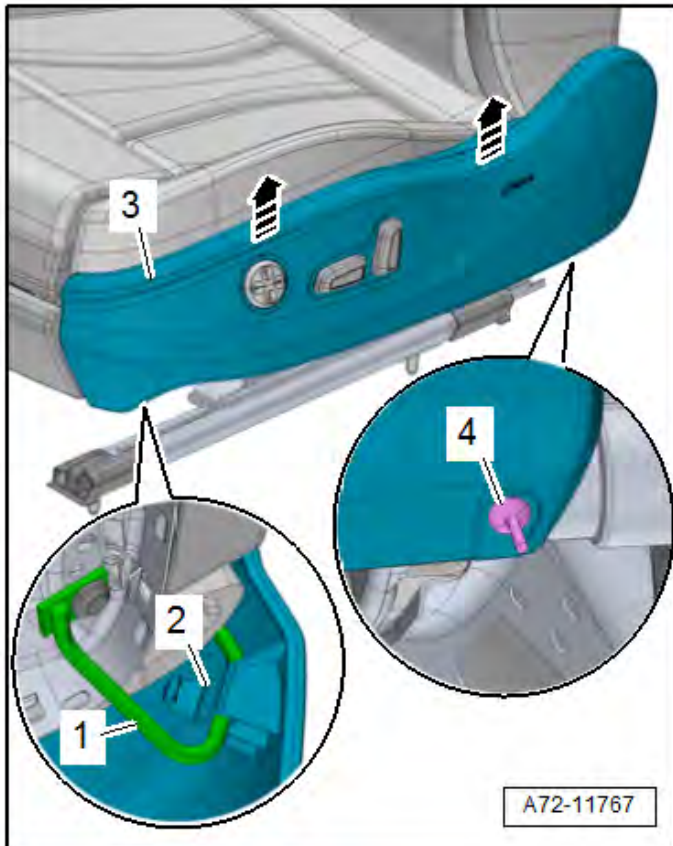
Remove side trim and bracket on sill side (POWER seat):

- Remove the expanding rivet <4> from the seat side trim.
- Open the clip <2> with a screwdriver.
- Disengage the seat side sill trim <3> from the backrest hinge and seat frame.
- Slightly lift the front seat side trim, and unclip from the bracket <1>.
- Slightly lift the rear seat side trim, disengage from the bracket <arrows> and remove forward.

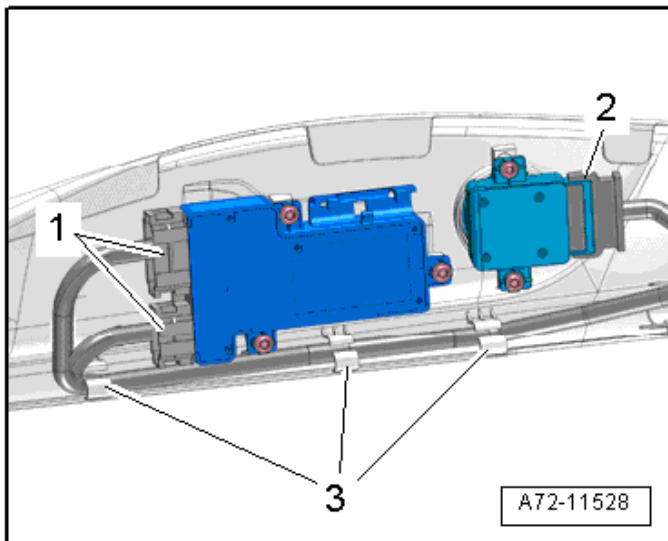
- Disconnect the connectors:
 - 1 - Driver Seat Adjustment Control Head -E470-/ Front Passenger Seat Adjustment Control Head -E471-.
 - 2 - Driver Seat Lumbar Support Adjustment Switch -E176-/ Front Passenger Seat Lumbar Support Adjustment Switch -E177-.
- Free up electrical wire on the bracket <3>.
- Remove the seat side trim.

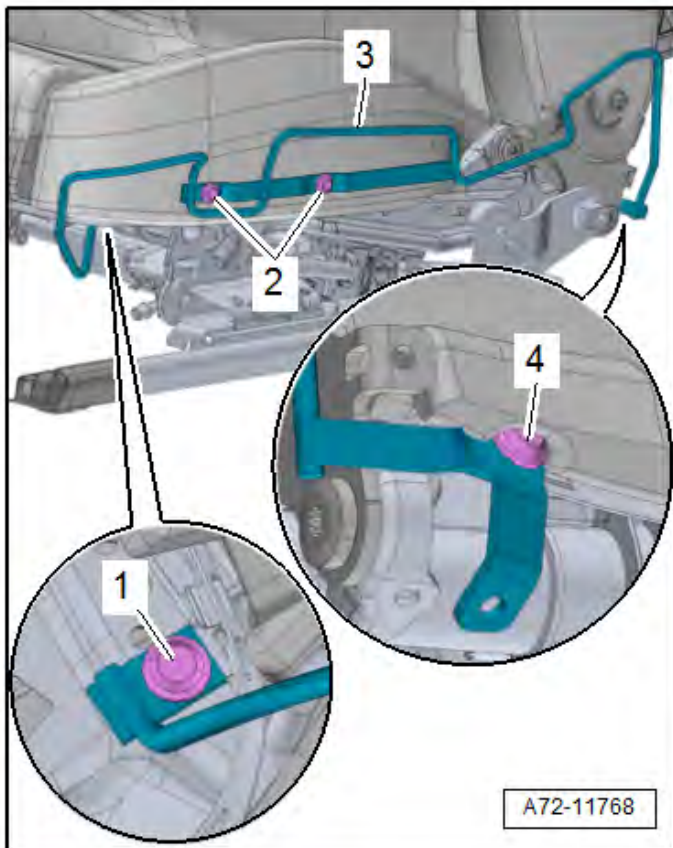
- Remove the bolts <1, 2, and 4> and remove the bracket <3>.

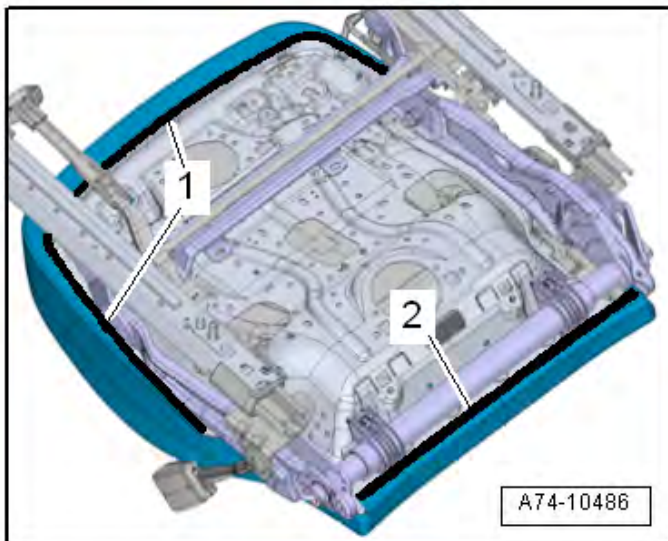
Detach seat cushion from seat pan (STANDARD seats):

- Detach the molding <1> from the seat cover in the front and side areas using the -3370-.
- Detach the molding <2> of the cover in the rear area using the -3370-.

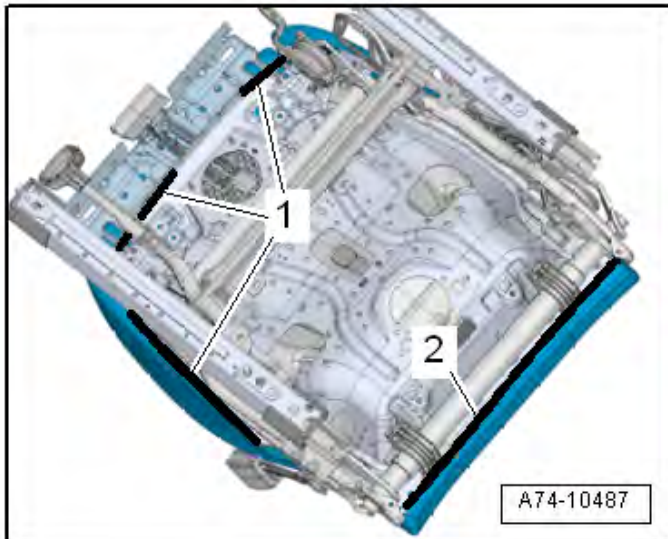
Detach seat cushion from seat pan (SPORT/SUPER-SPORT seats):

- Disengage the molding <1> on the side, and the molding <2> in the area of the rear cover using the -3370-.

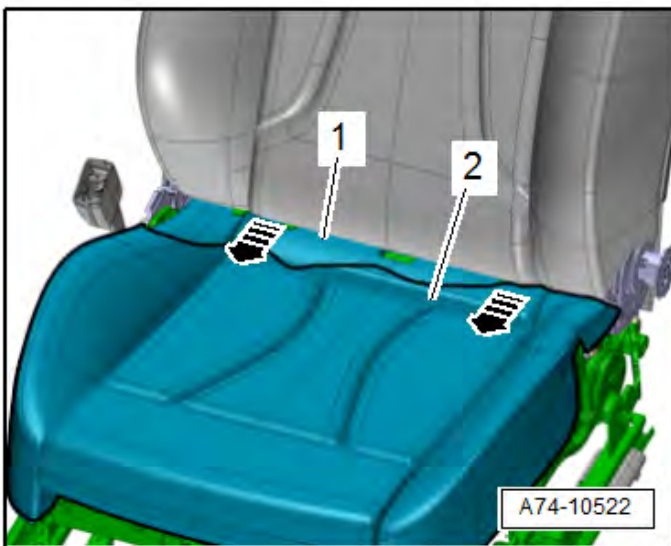
- Carefully disengage the cushion <1> with cover <2> at the rear of the seat pan <arrows>.
- Remove the cover and cushion from the seat pan, while doing so if necessary free up the seat heating wiring harness.

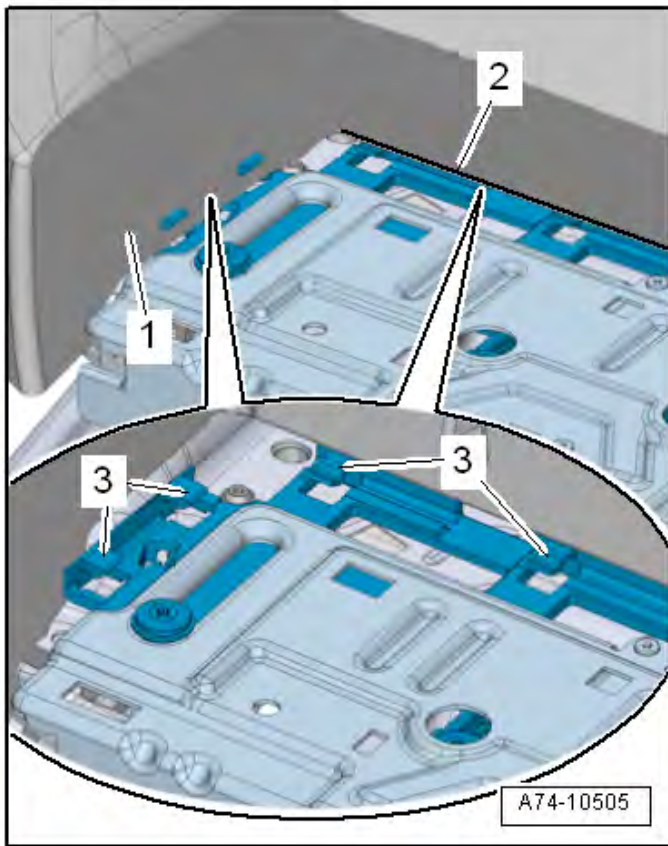
Disengage seat covering from seat depth adjuster:

- Disengage the cushion <1> at the sides from the tabs <3>.

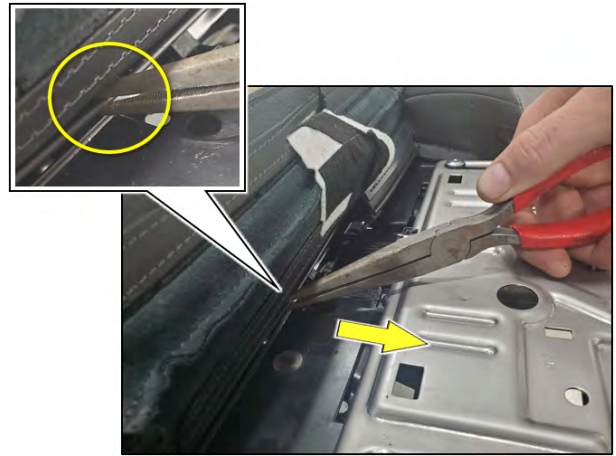
- Proceed very carefully when clipping and unclipping.
- Using pliers to carefully grasp the plastic edge of the seat cover molding (circle) and gently pulling the molding out of the tabs <3> in the direction of <arrow>, will prevent damage to the tabs <3>.

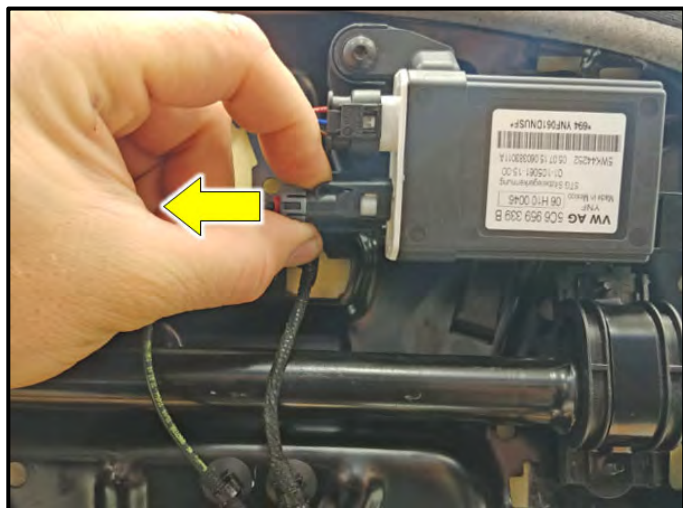
The connector must be removed exactly parallel with the PODS ECU. The center pin in the PODS ECU is fragile and must not be bent during removal. A damaged center pin will cause PODS faults. Damage to PODS ECU is not covered under this action.

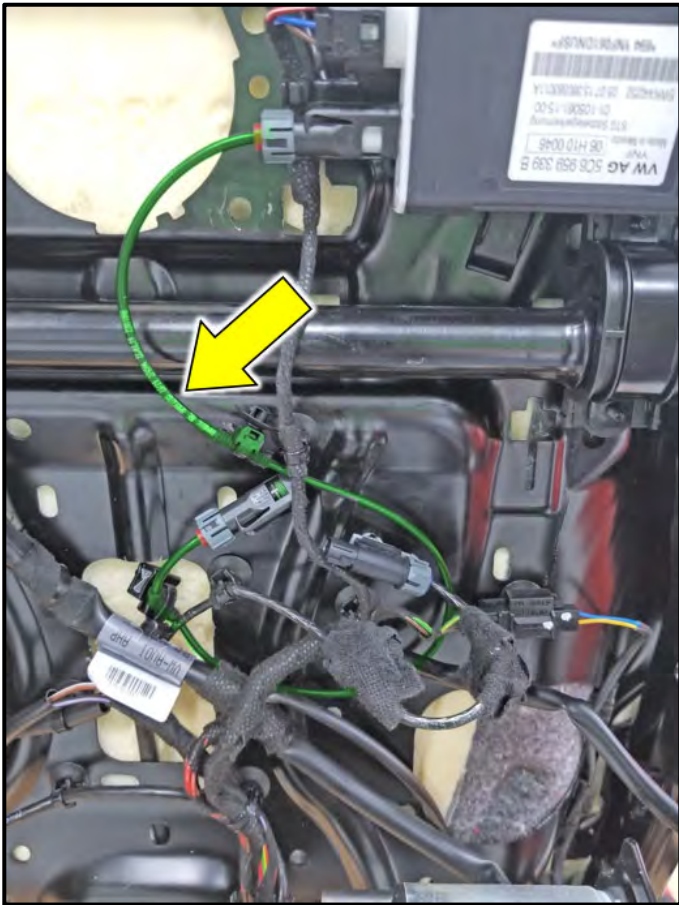
- If present, disconnect and discard 69Z4 PODS repair wiring harness <arrow>.

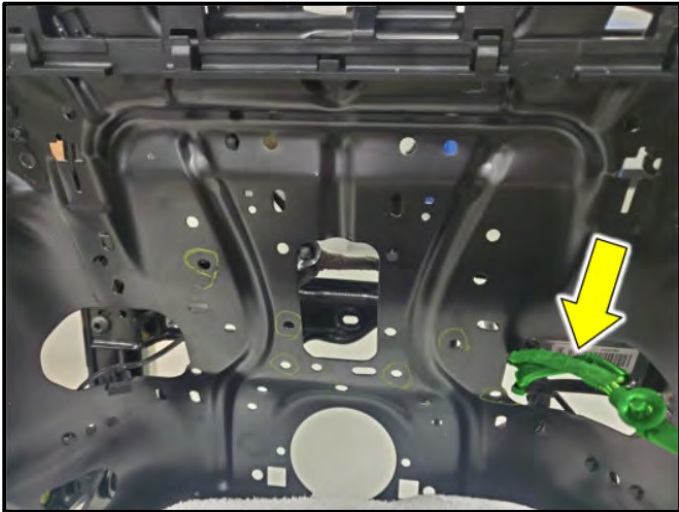
- Unclip the seat wiring harness and disconnect connectors as needed to gain enough slack in the wiring harness.
- Mark the location of each wiring harness clip that is removed.
- When reinstalling the wiring harness, the harness must be routed in the same location.
- There should be enough slack in the seat wiring harness <arrow> so the work on the seat bottom can be performed without putting any strain on the seat wiring harness.

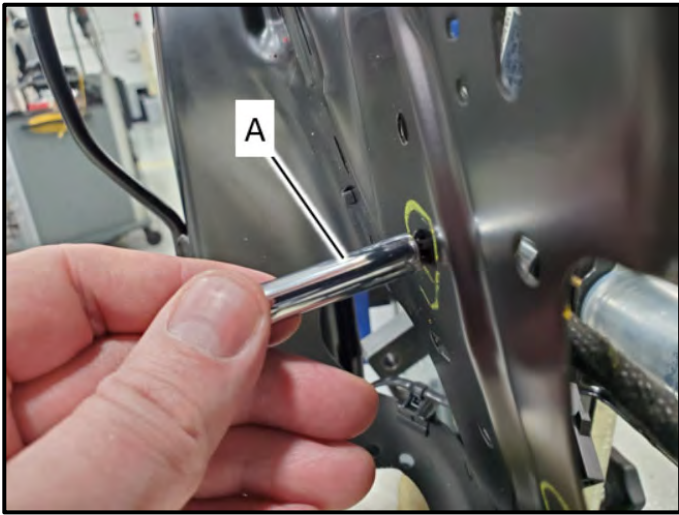
- To prevent damage to the clips, use a 6 mm, 6-point socket <A> and press it over the locking tabs from the seat cushion side of the seat pan.
- If access is not available, use needle nose pliers to compress the locking tabs.

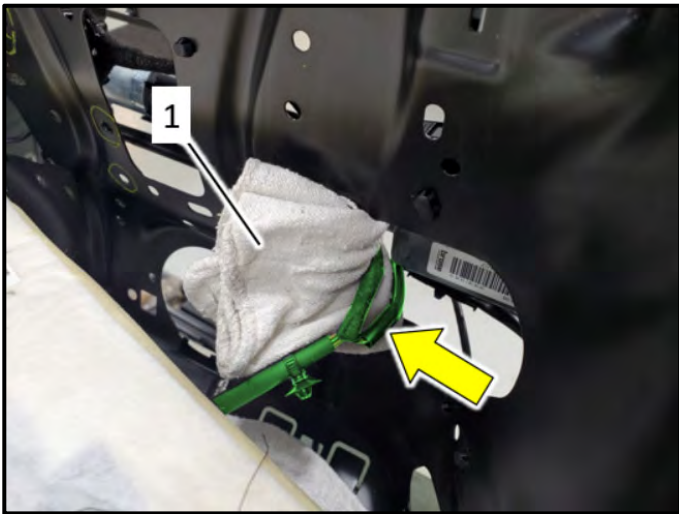
- Place a protective cloth <1> between the seat pan openings and wiring harness <arrow> to prevent damage to the seat wiring harness.

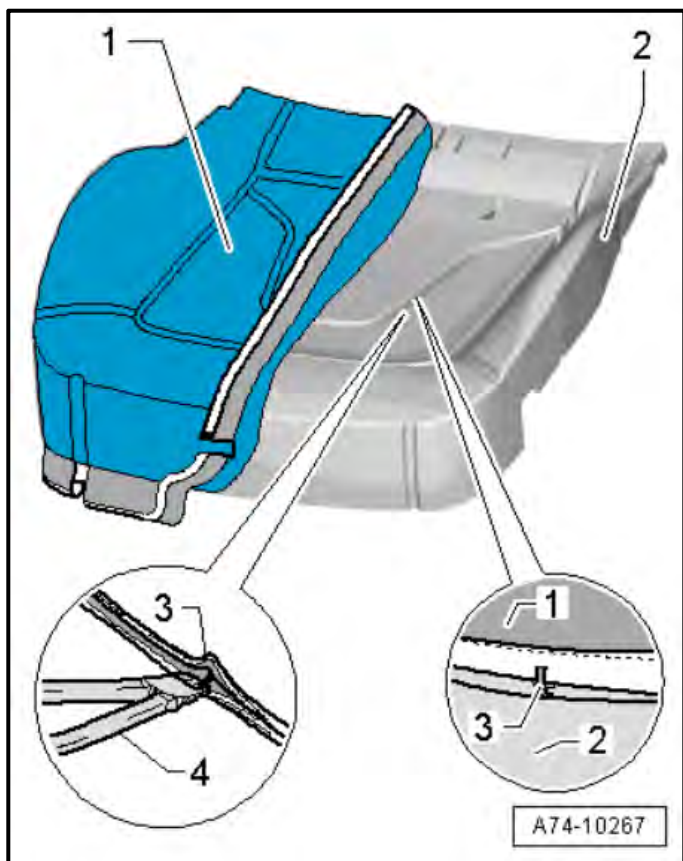
Separating seat cover and cushion (STANDARD seats):

- Remove seat cover <1> in the rear and side from the seat cushion <2> and cut upholstery clips <3> using pliers <4>.

The seat cover will have approximately 24 upholstery clips installed. While cutting these clips, some fragments may remain attached to the seat cover and cushion. **ALL** fragments of the old clips **MUST** be removed from the seat cover and cushion prior to reassembling the seat.

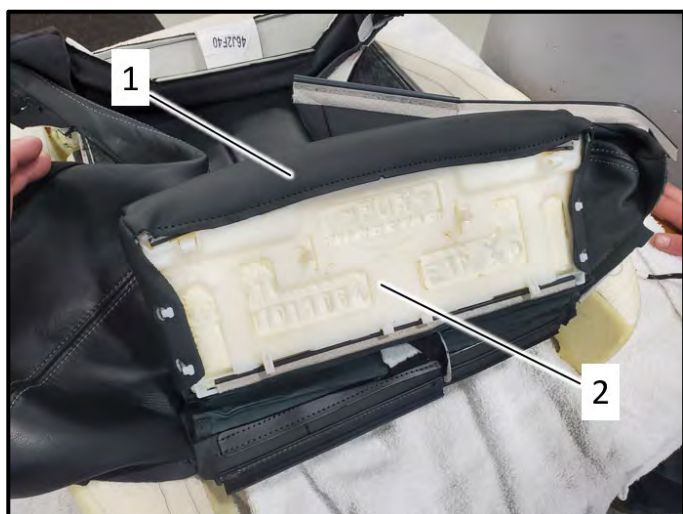
Separating seat cover and cushion (SPORT/SUPER-SPORT seats):

The seat covering <1> does not require removal from the seat depth adjuster cushion <2>.

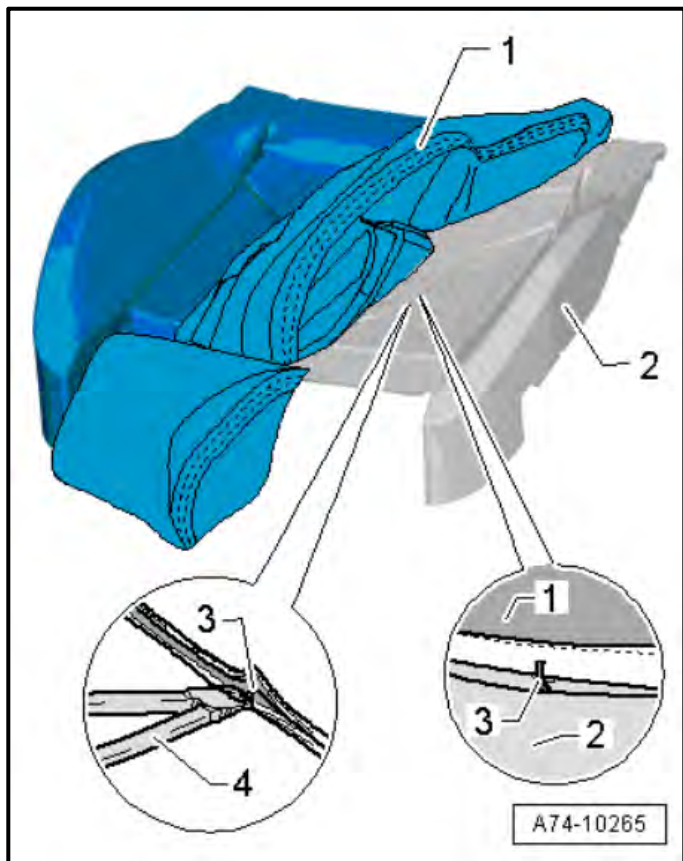
- Remove cover <1> from the cushion <2> and cut upholstery clips <3> using pliers <4>.

The seat cover will have approximately 24 upholstery clips installed. While cutting these clips, some fragments may remain attached to the seat cover and cushion. **ALL** fragments of the old clips **MUST** be removed from the seat cover and cushion prior to reassembling the seat.

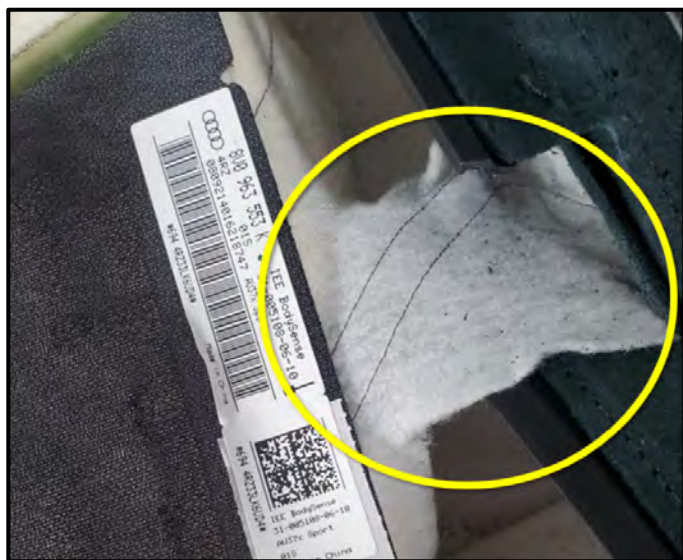
Ensure the seat heating element bridge <circle> is not twisted or damaged.

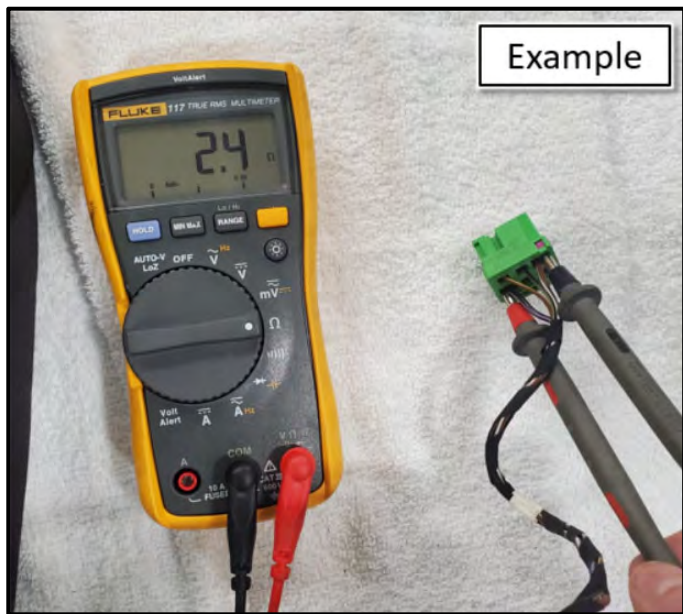
Before removing the sensor mat from the seat cushion, verify the resistance of the seat heater element (if equipped):

- Check and record the resistance between pins 3 and 4 of the T6j connector.
- Checking the resistance prior to removing the PODS sensor mat confirms the integrity of the seat heater element.
- If the seat heating element is found damaged (open circuit or high resistance) prior to replacing the PODS sensor mat, the customer must be informed.

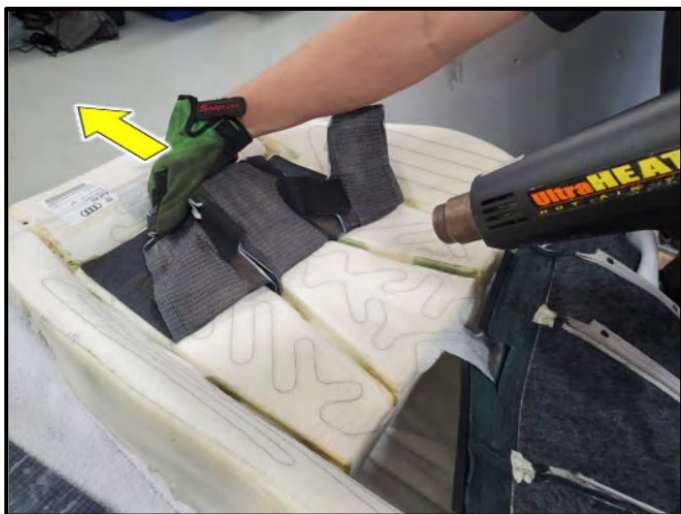
Removing PODS Sensor Mat:

Sport/Supersport seat shown. Procedure for standard seat is similar.

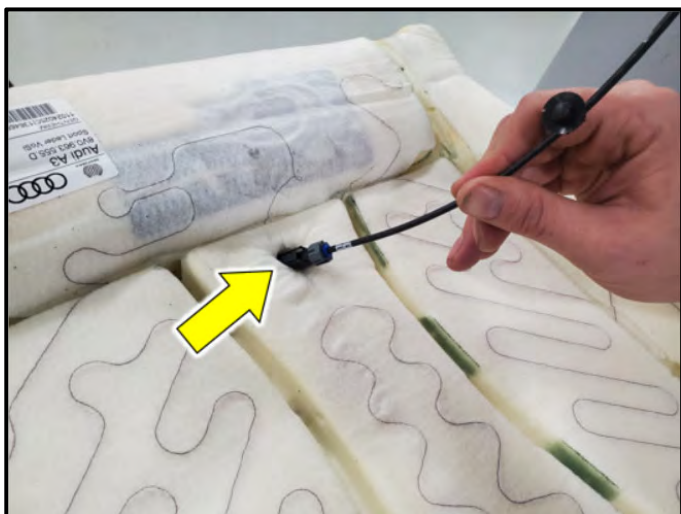
Installing PODS Sensor Mat:

- Carefully insert wiring harness through hole <arrow> in the seat cushion.

Sport/Supersport seat shown. Procedure for standard seat is similar.

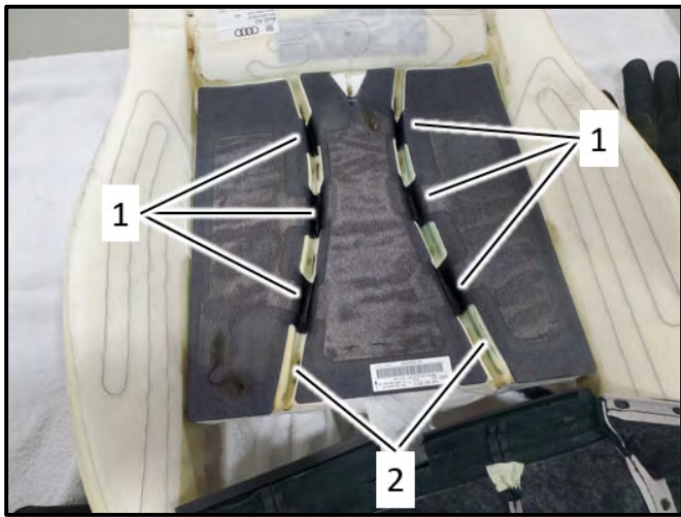
- Remove the protective backing from only one section of the PODS mat at a time.
- Adhere only one section of the PODS mat to the seat cushion at a time.
- Ensure there are no wrinkles or large air pockets between the PODS sensor mat and the seat cushion.
- Sport/Supersport seats - adhere the center section first before adhering each side section.
- Ensure each “bridge section” <1> is pressed evenly into the valleys <2> of the seat cushion.

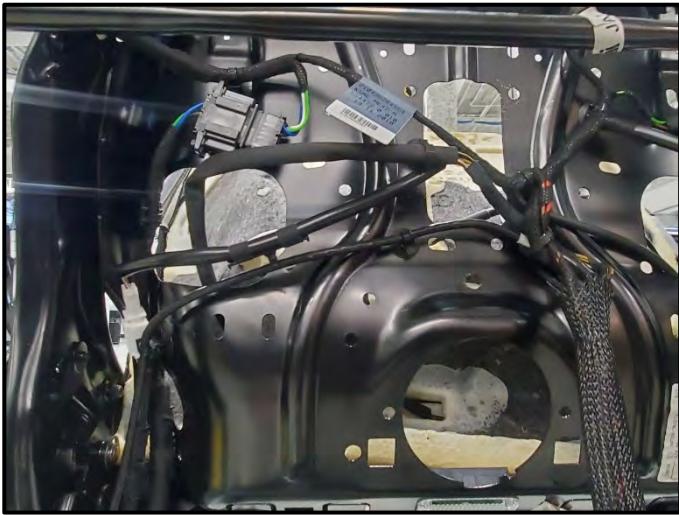
Secure PODS sensor mat harness (versions with storage compartment):

- Install wiring harness clips into seat pan as shown <arrows>.

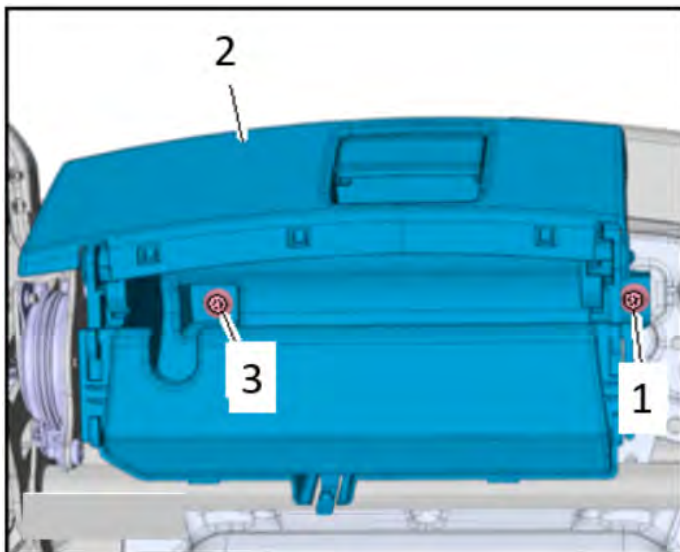
Reassemble seat trim and adjustment components:

- Installation is the reverse order of removal.
- Connect and secure seat adjustment electrical connectors.
- Torque fasteners for seat trim bracket to 7.5 Nm.

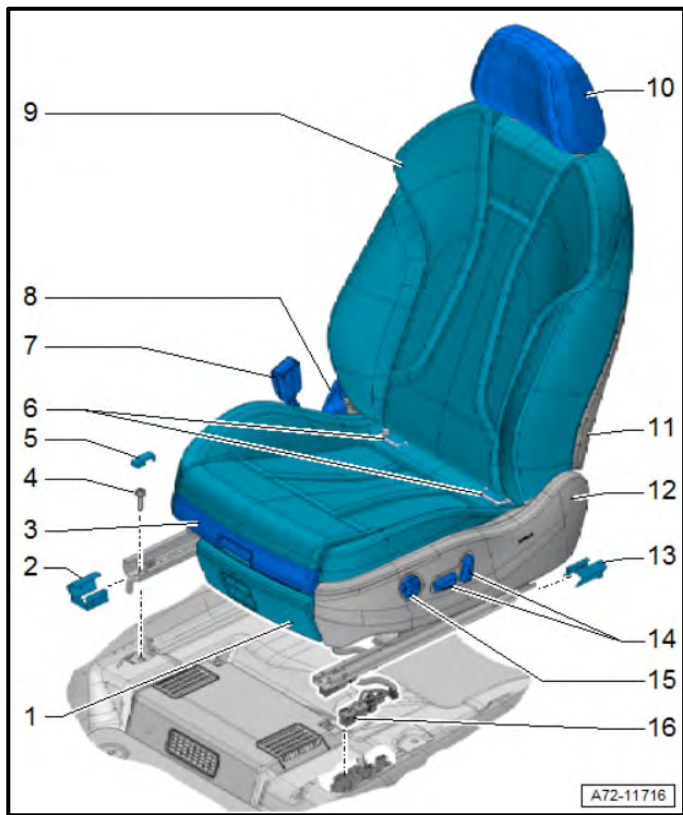
The number of connectors present in the connector station will vary based on vehicle equipment.

- Reinstall seat rail end covers in the reverse order of removal.
- Torque seat bolts to 40 Nm.

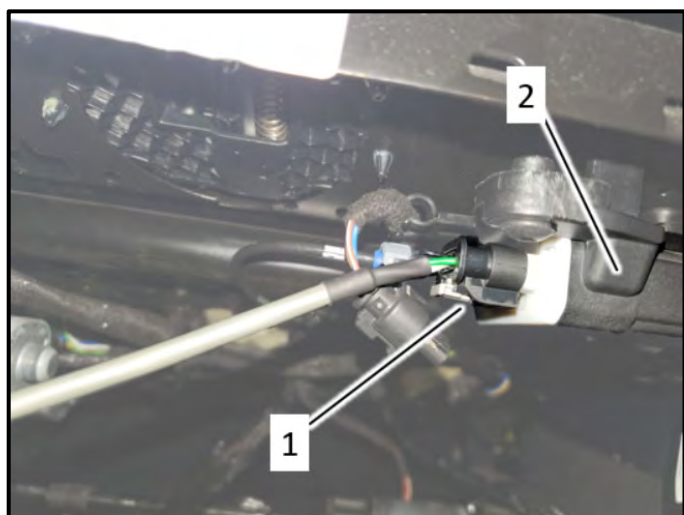
- Connect Programmer connector <1> to PODS ECU <2>.

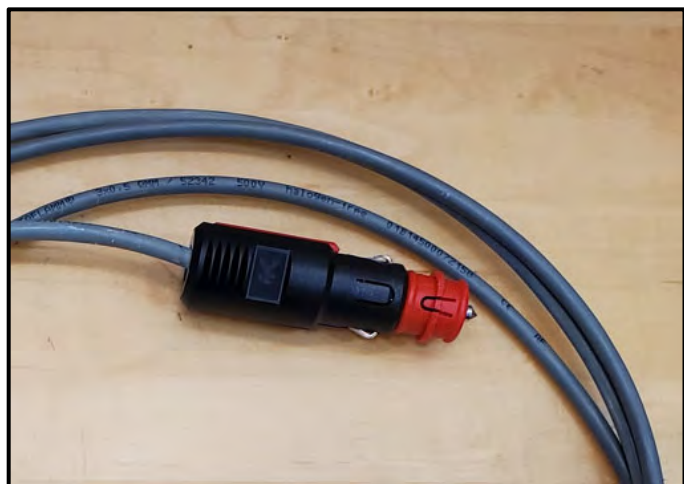
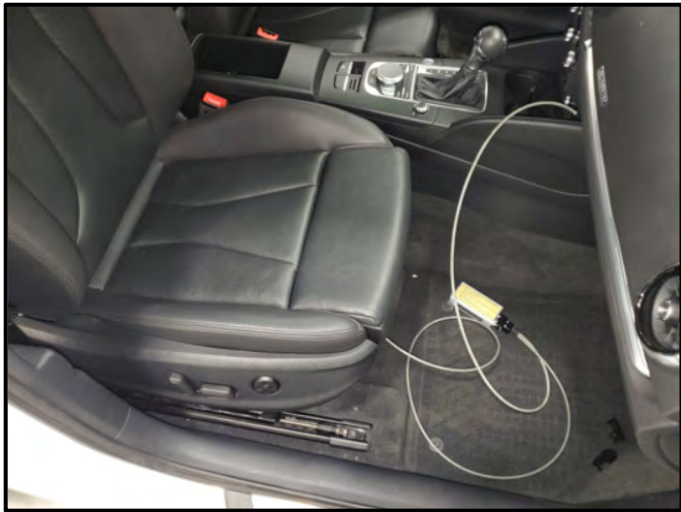
- Plug programmer into a 12V power source.

To ensure there is no interruption in the 12V power supply, an external 12V power source (locally sourced) is the preferred method of powering the PODS Programmer. Using the vehicle's 12V power source increases the risk of PODS programming failures.

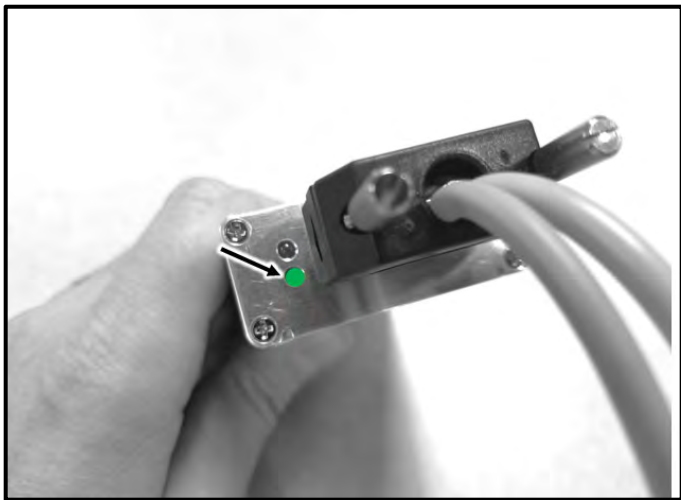
- Lights <arrows> will flash alternately.

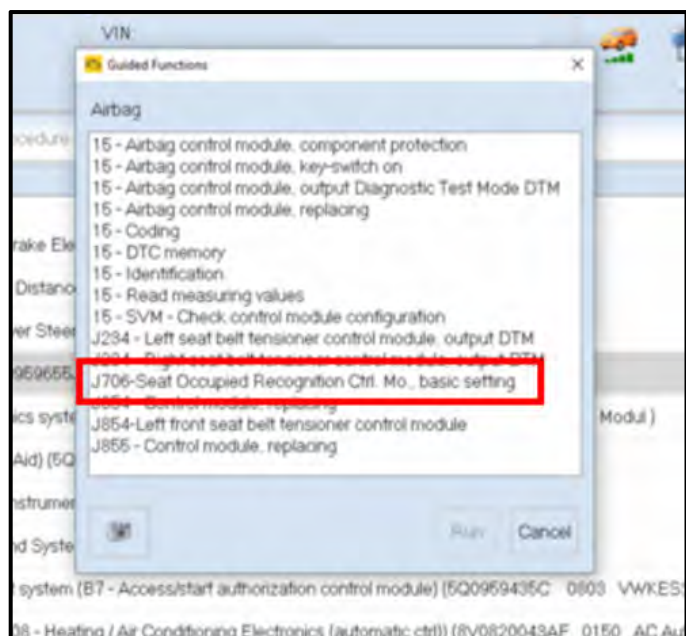
- Switch the ignition ON.
- Connect the VAS tester to the vehicle.
- Using ODIS, perform a complete GFF scan of the vehicle.
- Select the Guided Functions menu for 0015 - Airbag Control Module.
- Perform the test plan “J706 – Seat Occupied Recognition Ctrl. Mo., basic setting”.
- Follow the on screen prompts.
- Exit GFF.
