Safety Recall

Code: 69BY

Subject Passenger Occupant Detection System (PODS)

REVISION SUMMARY Updated PODS programming and troubleshooting steps

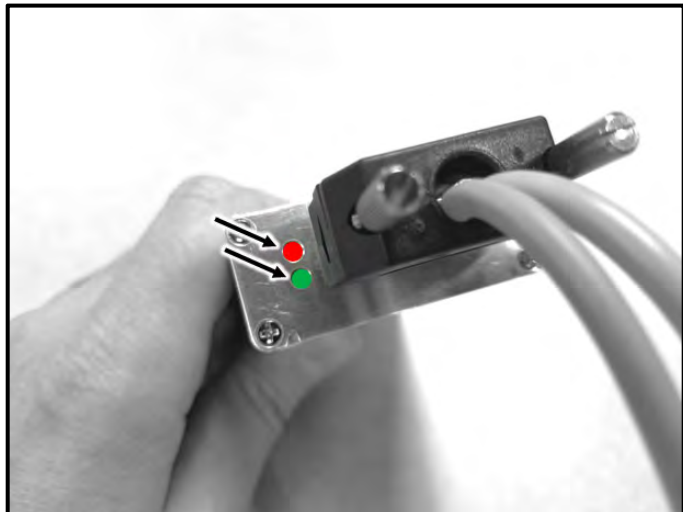
- If the start-up procedure fails, the red and green lights will flash simultaneously.
- This means the maximum number of stored records has been reached.
- If this situation is encountered, create an Audi Technical Assistance WEB ticket and wait for further direction.

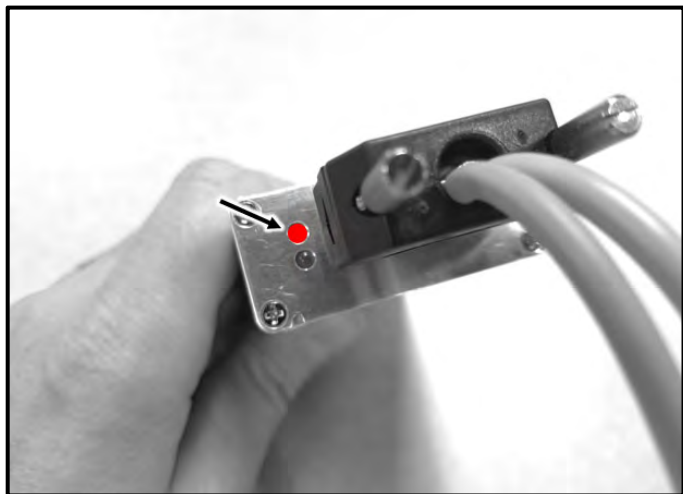
- If the programming has failed the red light will flash and one of the following may have occurred:

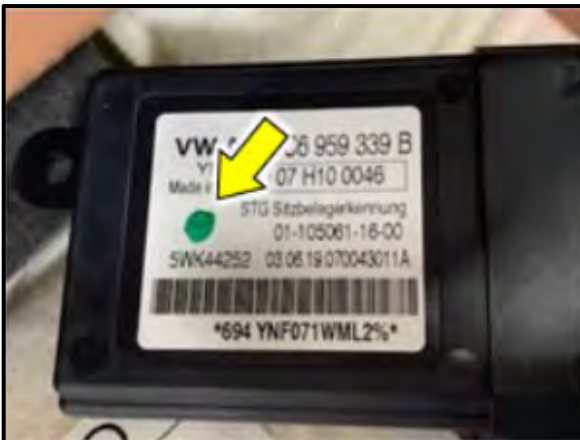
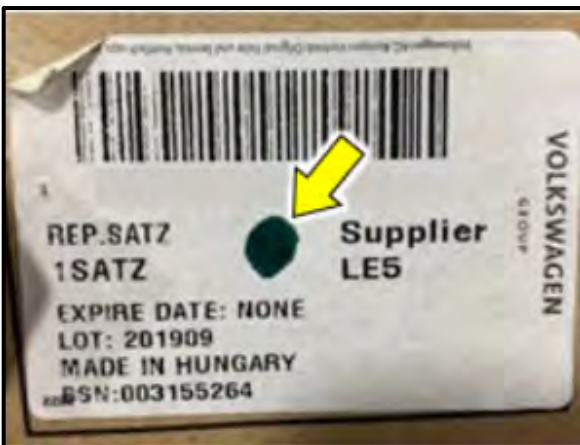
- U.S. dealers: Contact Audi Warranty for authorization.
 - Canadian dealers: Create an ATA WEB ticket.
- When installing a new PODS repair kit (Service Part from ETKA, not the campaign parts), ensure the new part has a green mark (marker or sticker) on the packaging and the PODS control module.
