INSTRUCTION TO SERVICE

ITS: 59212		April 12, 2021
SECTION:	219-Engine	
WRITTEN BY:	Dana Carver	
SUBJECT:	Updating Siemens Software, Vansco and CM0711 Programs	
ISSUE:	Watchdog faults on the inverters cause them to shut down without warning	
SUMMARY:	Vansco, CM0711 and Siemens software update

Ref. NHTSA Recall No.	Ref. Transport Canada Recall No.
21V-244	2021-206

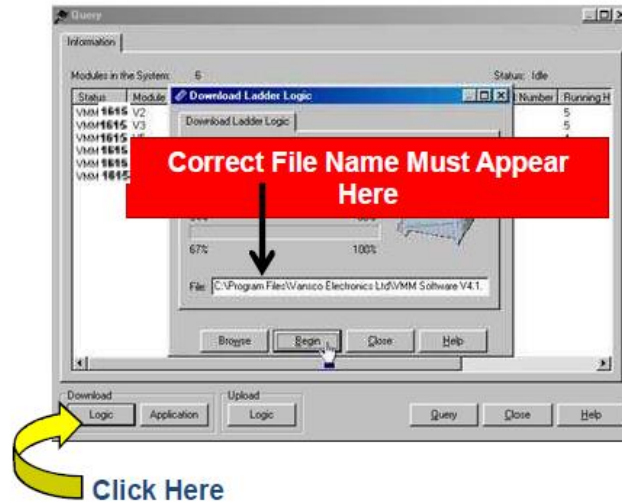
7. Select Download Logic.
8. Ensure the correct file name and revision appear in the File window.

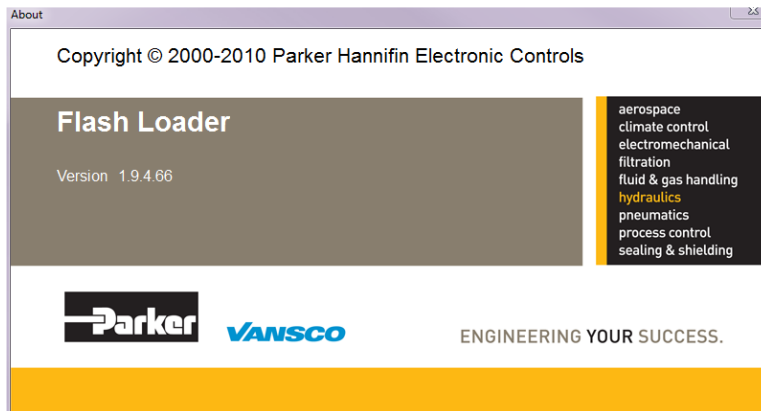
Figure 2: Flashloader version

12. Ensure VMM 7100 or later is installed because it should have Flash Loader v1.9 or newer on it.
 - a. To open flash loader open the VMM software and click Applications → click FlashLoader. See figure 1.
 - b. To check the version is v1.9 or later, click Help → click About. See figure 2.

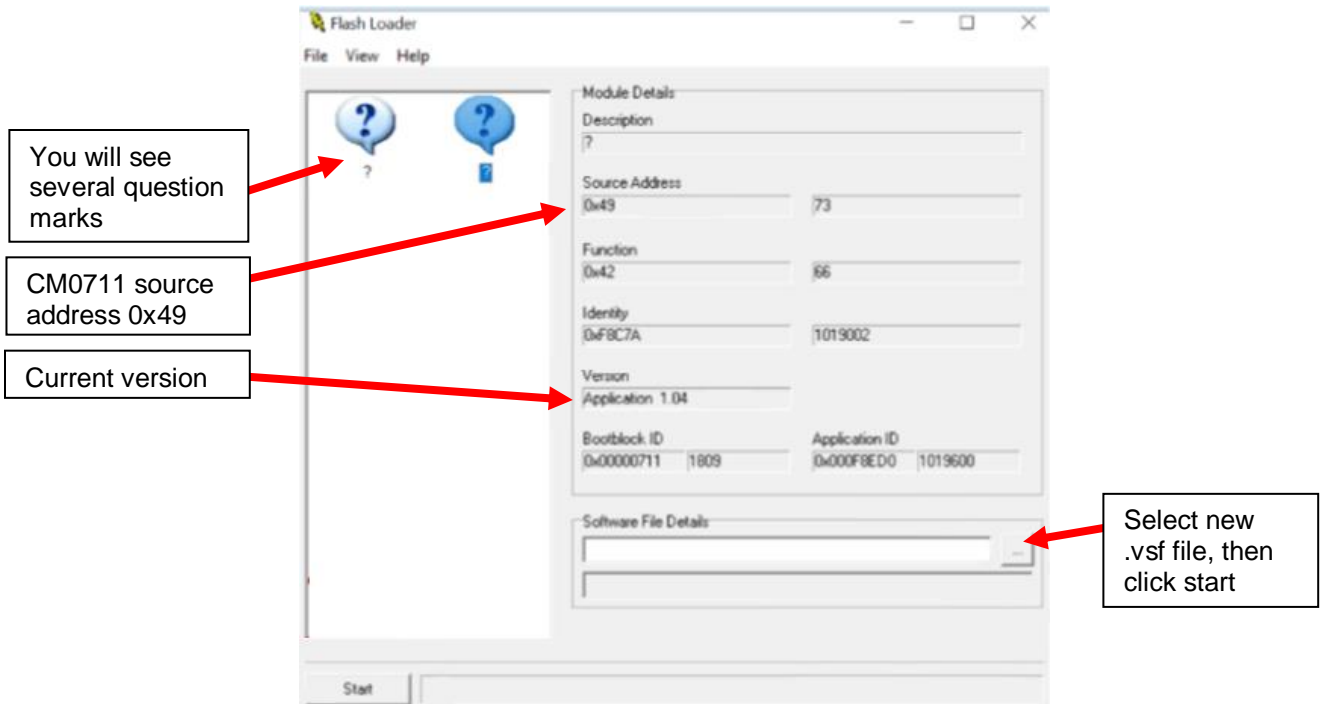
Figure 3: CM0711 source address and current version

16. With the NEXIQ connected, in FlashLoader go to File → RP1210 Settings and make sure NEXIQ USB LINK J1939 Channel 1 is selected. Check this if you are having trouble getting connected.
17. You will see several question marks and other devices on the left-hand side, find source address 0x49, this is the CM0711 (see figure 3).
 - a. The version shows what is currently loaded in the CM0711. Take a screenshot of what is currently loaded.
 - b. Select the new .vsf file you received and click start (It will take 1-2 minutes to download the program).

18. After downloading finishes, follow the same process in step 5 and find source address 0x49. The Version # should now be updated to the program you just loaded. The following example in figure 4 is for loading 1019607_NFIL_Electric_Bus_V5.00.vsf. It is also important to notice that it is V5.00 Build 0.

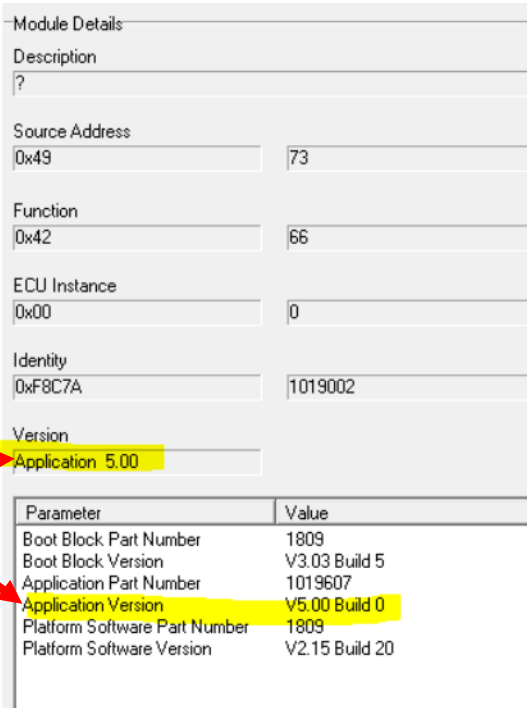
Figure 4: CM0711 source address and updated version

Updated application:
version V5.00
Build 0

Module Details	
Description	?
Source Address	0x49 73
Function	0x42 66
ECU Instance	0x00 0
Identity	0xF8C7A 1019002
Version	Application 5.00
Parameter	Value
Boot Block Part Number	1809
Boot Block Version	V3.03 Build 5
Application Part Number	1019607
Application Version	V5.00 Build 0
Platform Software Part Number	1809
Platform Software Version	V2.15 Build 20

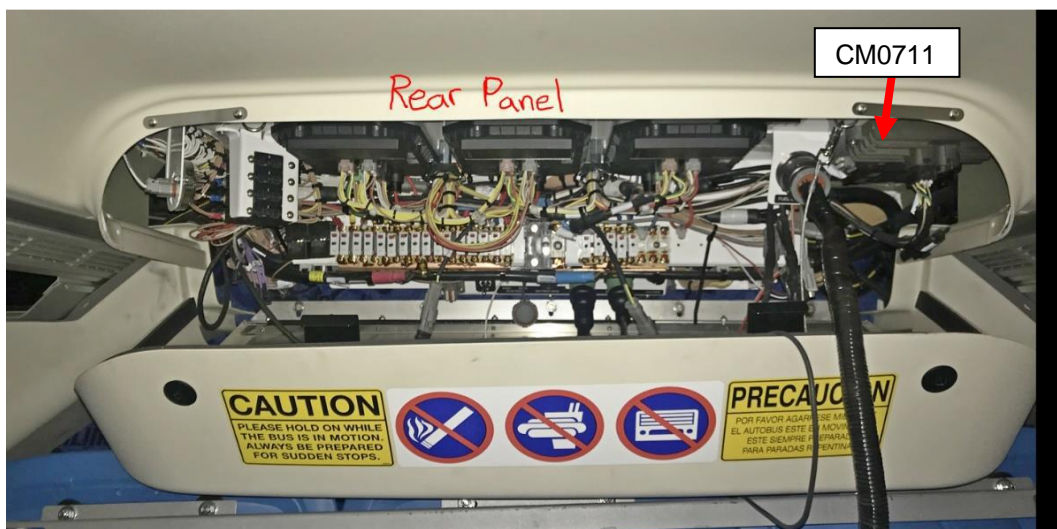
Figure 5: Rear panel and CM0711 module location

19. Turn the master-run switch OFF for at least 20 seconds. It takes at least 7 seconds for the CM0711 to power off after turning off the master-run switch, but 20 seconds is recommended to be safe.
20. Put the bus back into Day Run (not EV mode).
21. Open the rear panel and make sure the light on the CM0711 is flashing green and then orange. This indicates the CM0711 is operating.

NOTE: If the CM0711 light is off or steady red, it is bricked and will need to be sent back to NPD. Unfortunately, the bus will be undrivable without a function CM0711 so please contact NPD as soon as possible.

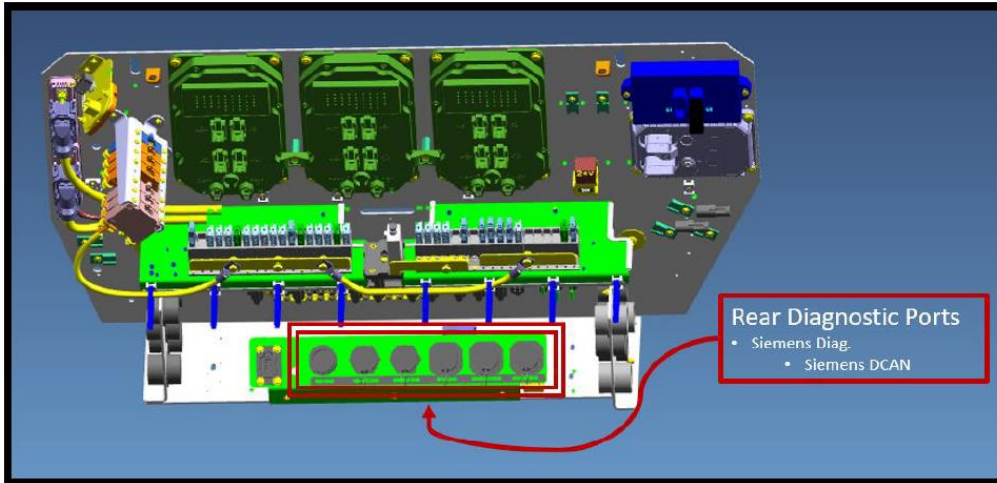
- 1.1 Use the Siemens Diag in the Rear Panel (see diagram below) to connect the computer containing the software to the system.

Image 1. CAD image showing location of Siemens diagnostic ports

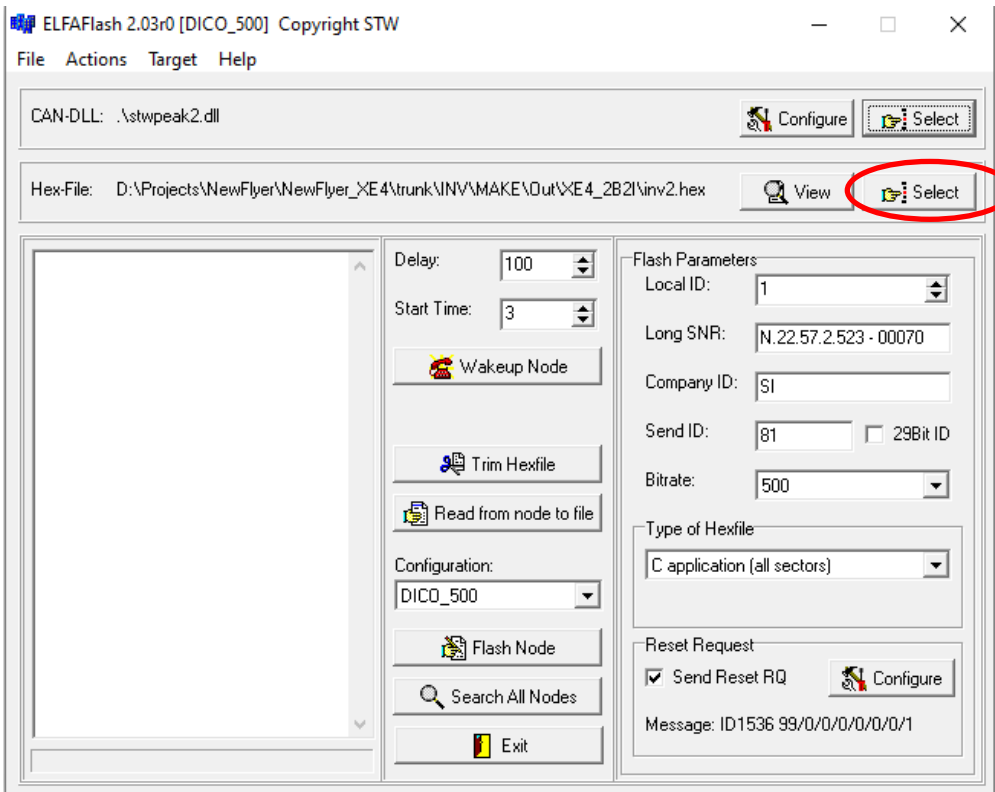
1.4 From the tool choose **Select** in *Hex-File menu*

Image 3. Image showing ELFA flash tool window

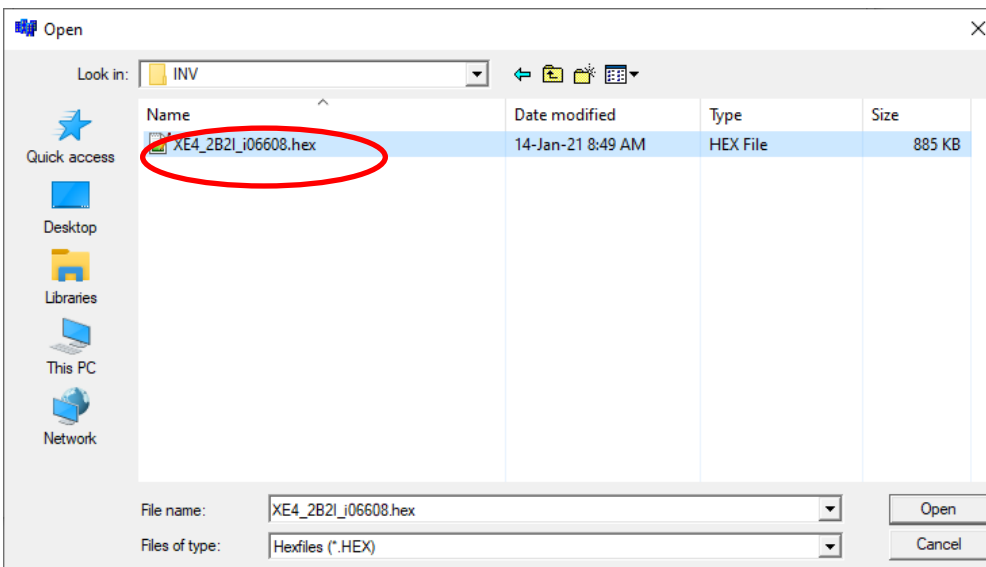
1.5 Navigate to the folder where SW package is located *ReleasePack*→*Software*→*INV*.
Click the .hex file to open

Image 4. Image showing .hex file for an XE40 configuration

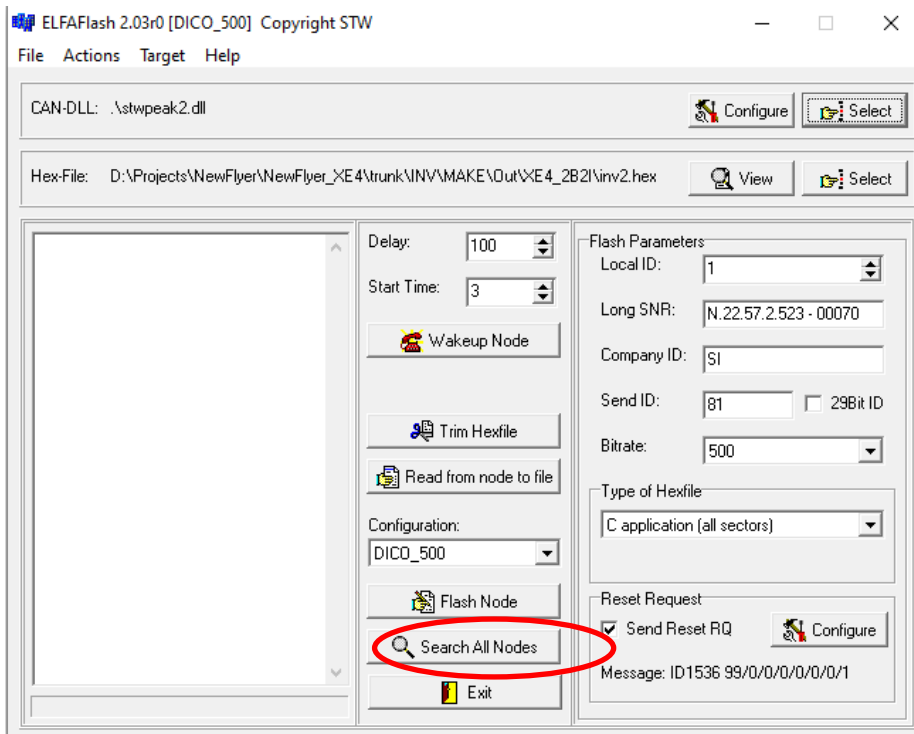
- 1.6 Switch OFF Key Start (KL15) for all components and wait approximately 30 seconds
- 1.7 Select **Search All Nodes** and switch ON Key Start (KL.15)

Image 5. Image showing “Search All Node” selection on Flash tool window

Important Note 1: Force the HVIL flag inactive to ensure that the PLC program does not shut off communication prior to searching all nodes (step 1.7 in Appendix A).

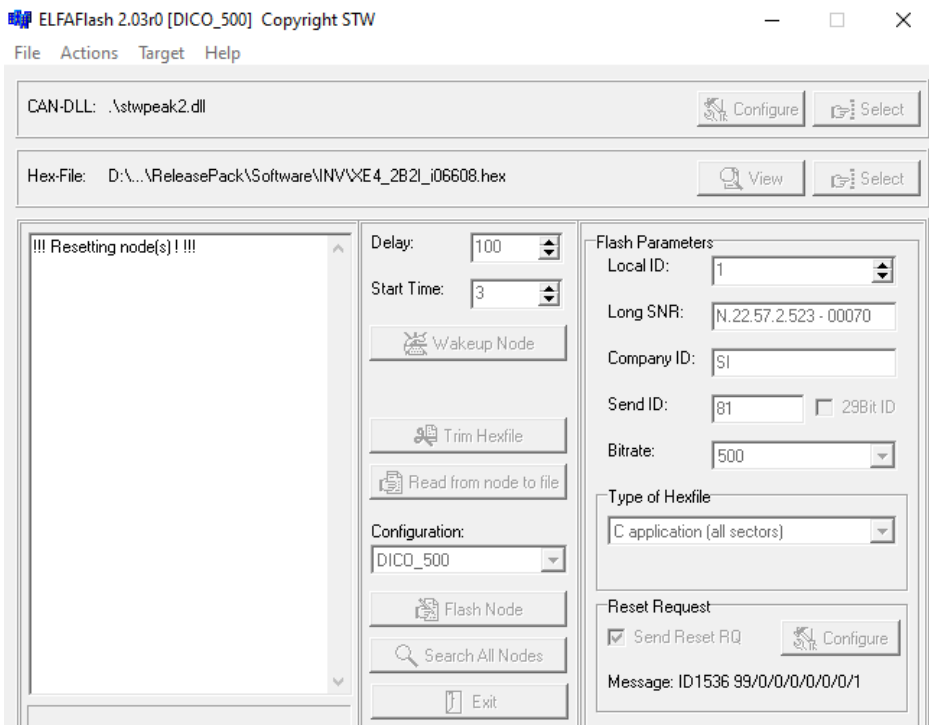
The process of Resetting node(s) will appear like the image below

Image 6. Image showing Resetting node(s) message on Flash tool.

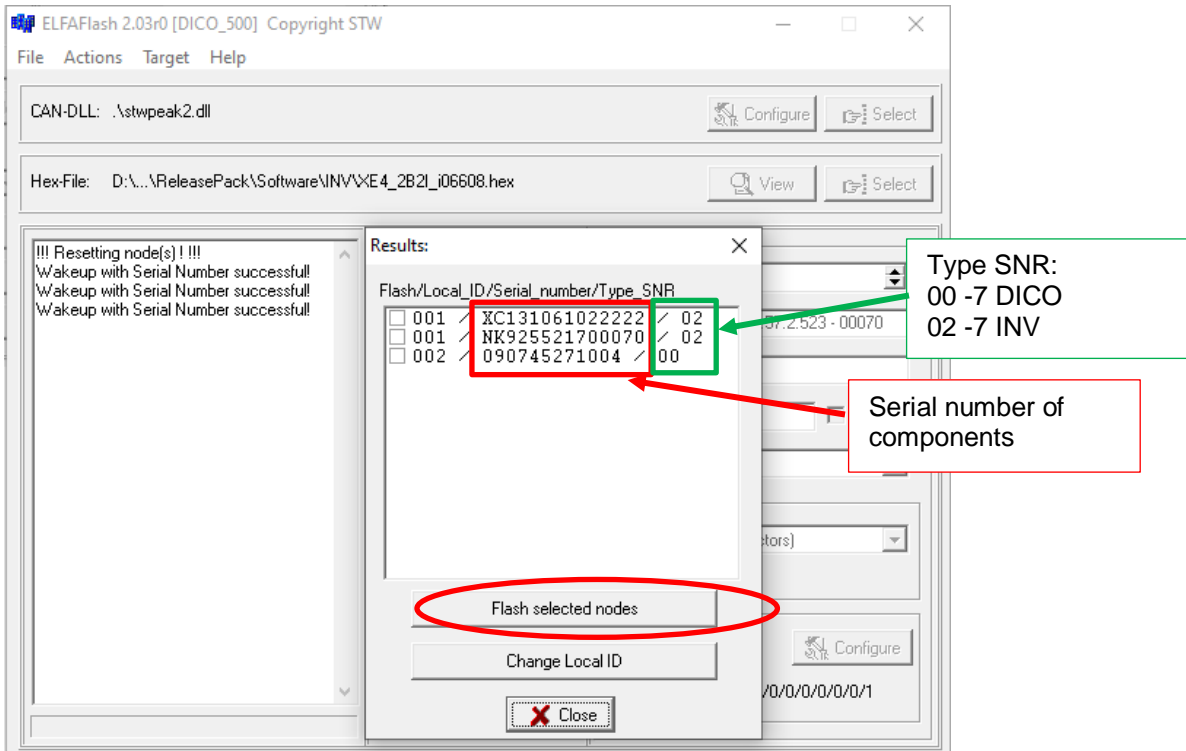
After successful wakeup, choose the correct Inverter serial number and then click **Flash selected nodes**.

Image 7. Image showing example of a system containing two Inverters and one DICO

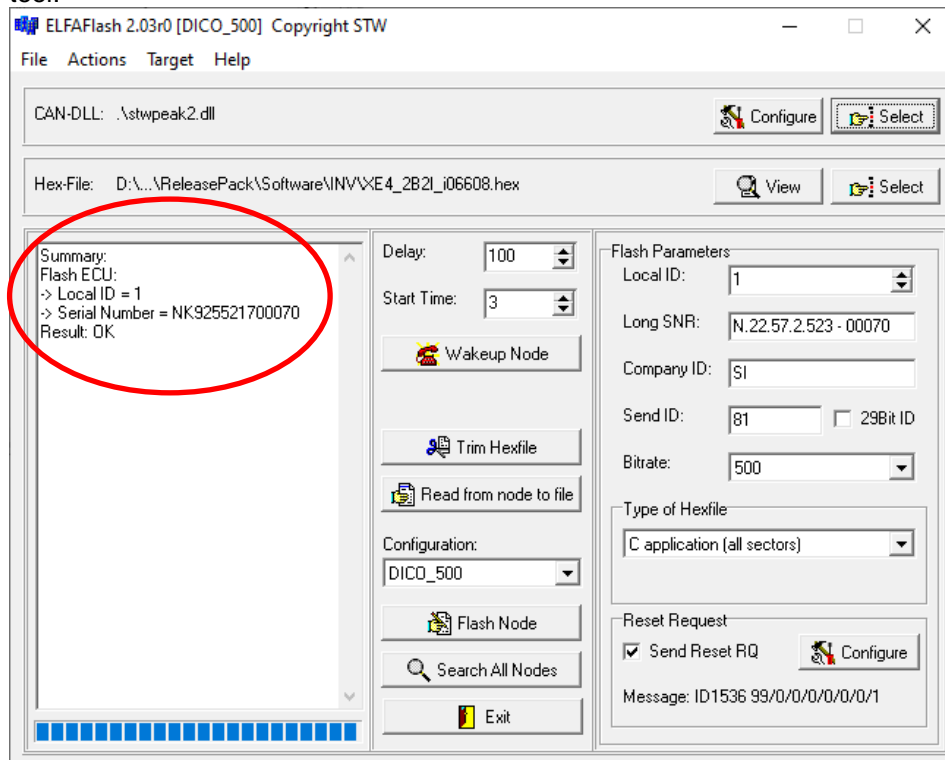
The Inverter with the serial number which has been flashed will show up like the picture below. Close ELFA flash tool.

Image 10. Image showing ELFA flash tool window with serial number of the inverter that has been flashed

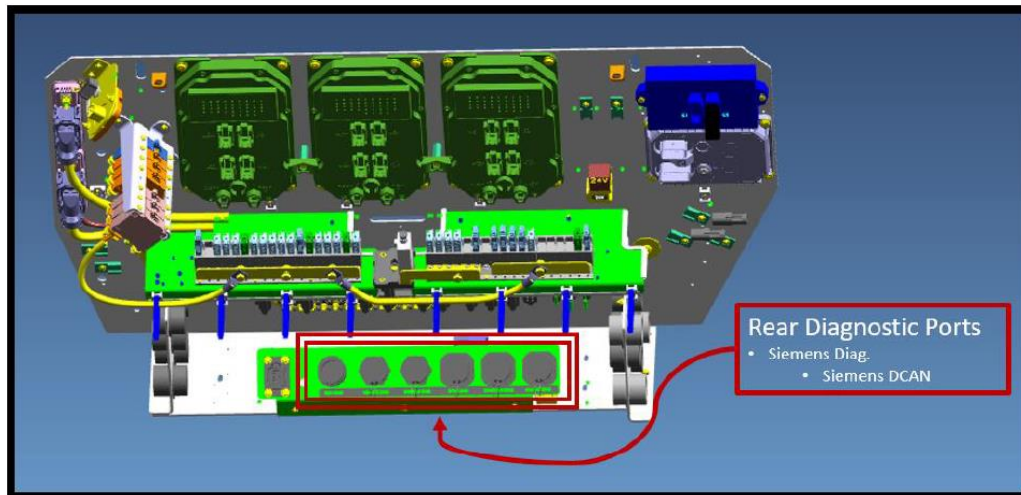
1. Key off (restart) the vehicle
2. Test drive the vehicle for 20-30 minutes
3. Pull off to a safe area, stop the vehicle, and turn off bus
4. Connect to the vehicle via PCAN-USB tool (see image below for location of diagnostic port). Open Siadis Expert

Image 11. CAD image showing location of Siemens diagnostic ports
