GROUP	MODEL
Safety Recall Campaign	2020-2021MY Soul (SK3) and 2021MY Seltos (SP2) w/2.0L Nu MPI engine
NUMBER	DATE
SC209 (Rev 2, 06/24/2021)	June 2021

ENGINE VIBRATION INSPECTION AND REPLACEMENT (SC209)

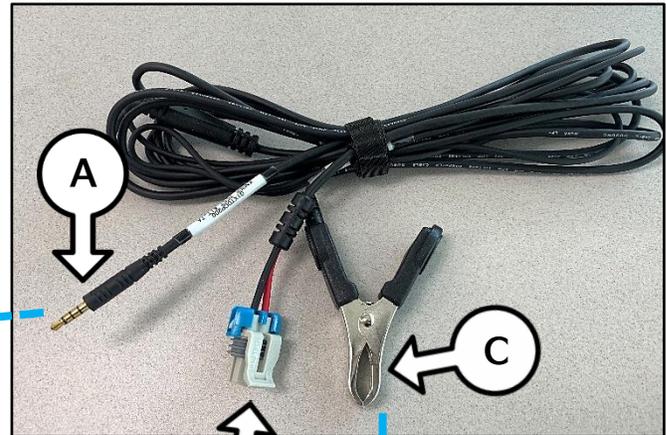
Refer to note(s) on pages 8-9.

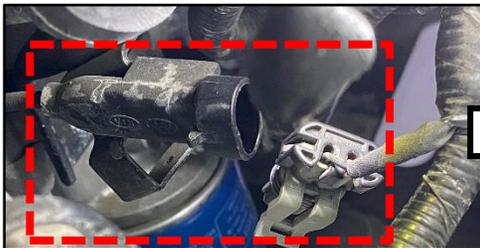
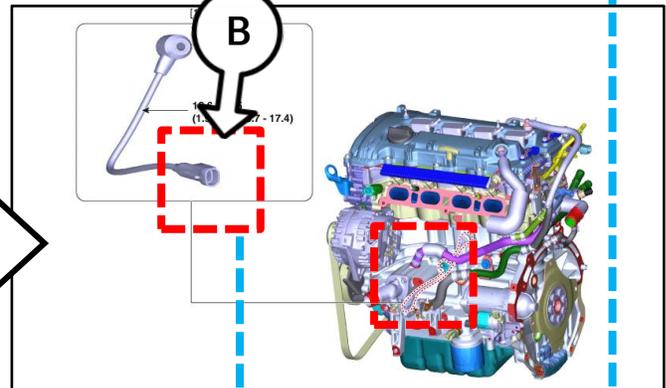
- 2b. Connect the knocking sensing connector (B) of engine vibration inspection harness to the knock sensor connector on the vehicle.

- 2c. Connect the clamp (C) to the battery (-) terminal.

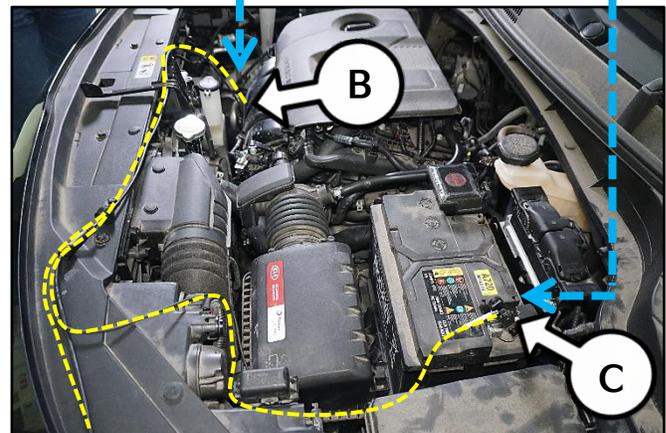
IMPORTANT

If the vibration inspection harness is placed over the engine components, external vibration may negatively affect to the inspection result. Route the wiring around the engine (yellow outline) shown in the photo.

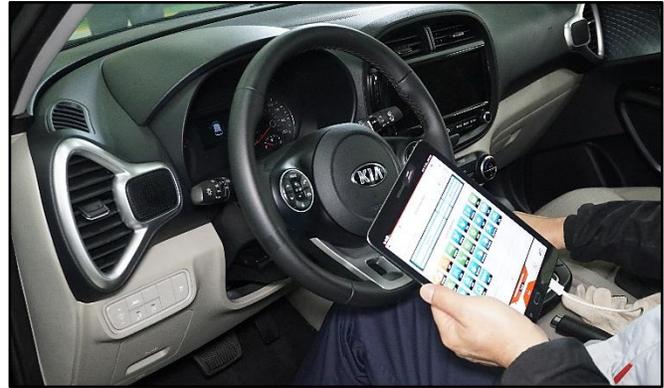
3. Connect the VCI to the vehicle's OBD2 port and confirm the Bluetooth pairing condition between KDS and VCI.

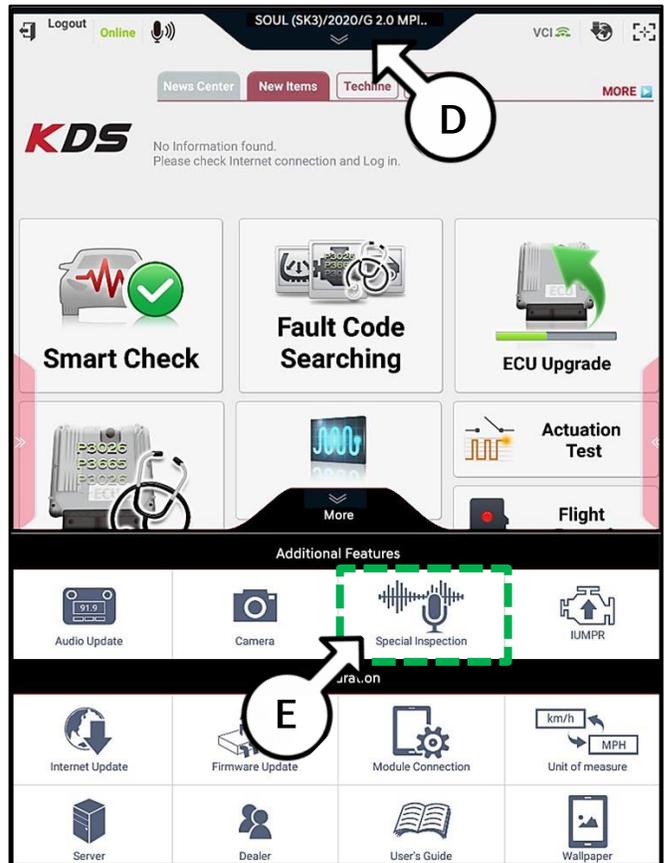
- 4a. Match the vehicle model (D) on the top of KDS screen.

- 4b. Turn the ignition to 'ON'.

- 4c. Select 'Special Inspection' mode (E).

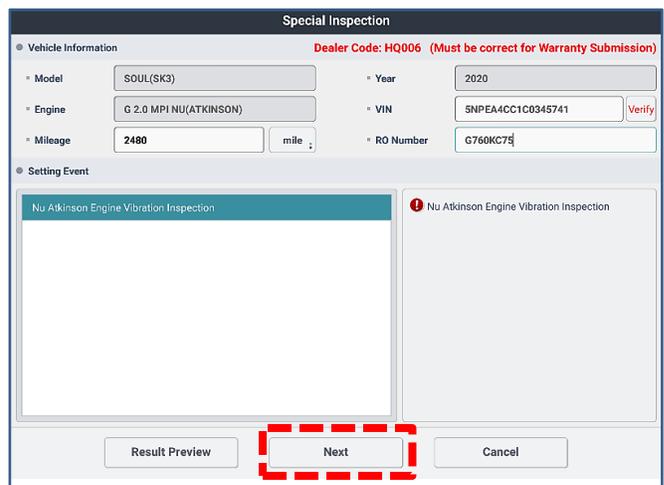
- 5a. Enter the vehicle information (Mileage, RO#). The VIN is recognized automatically.

Select 'Nu Atkinson Engine Vibration Inspection'. And then select 'Next'.

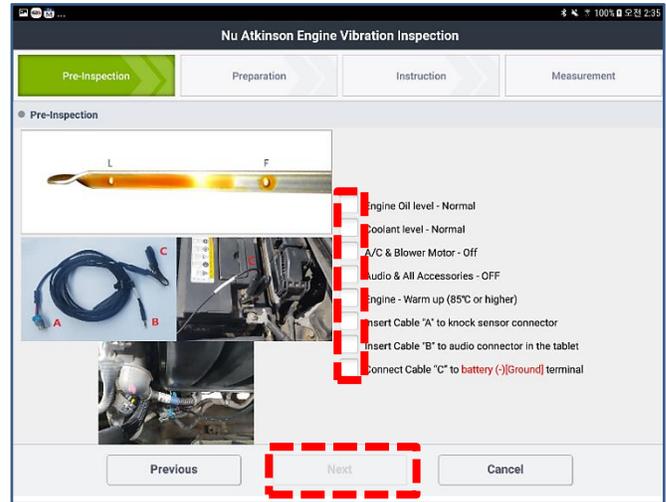
6. Confirm all "Pre-Inspection" conditions by selecting the check boxes.

Once conditions are checked off, select 'Next'.

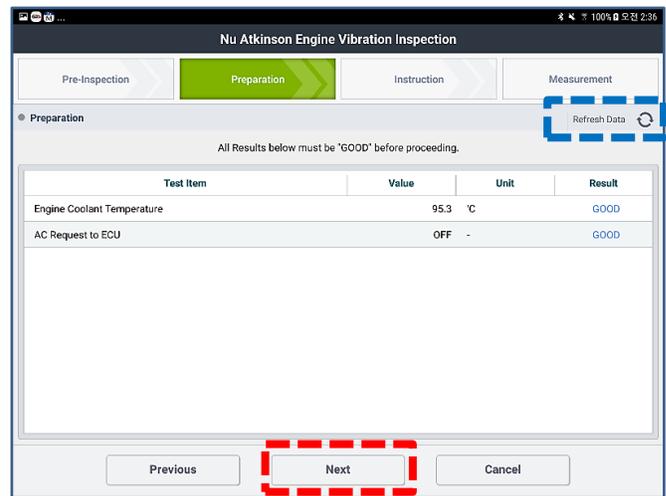
7. The program will automatically check the engine sensor data.

Once activated, select 'Next' as all conditions are now complete.

If the conditions are not met, a 'NOT GOOD' message will display. Confirm the requirements are met, then select 'Refresh Data'.

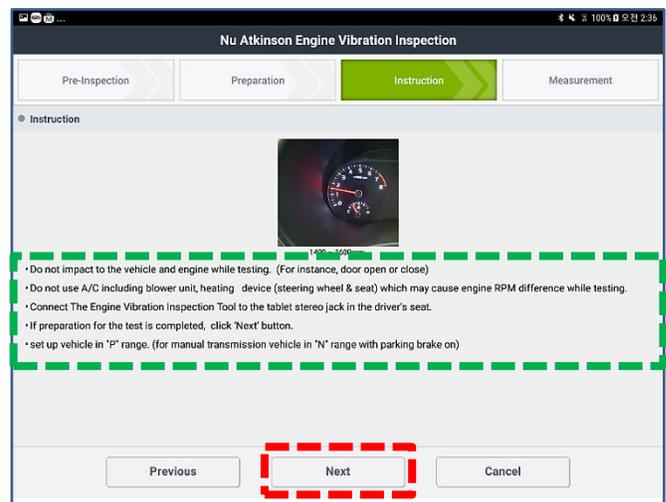
- 8a. Read and follow the instruction displayed to recognize the measuring process.

- 8b. Select 'Next'.

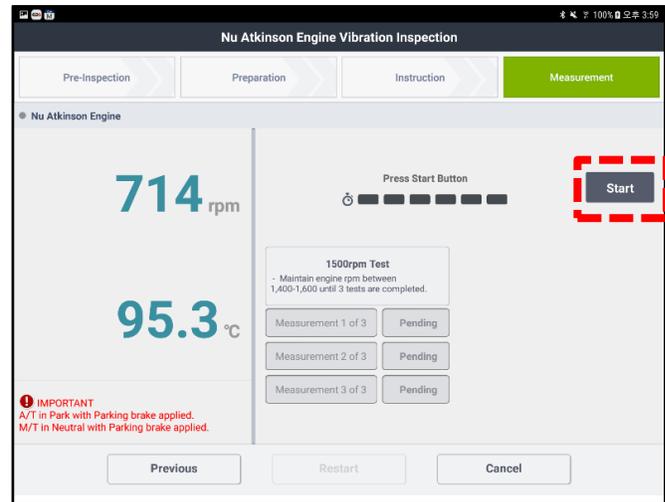
9. In the "Measurement" stage, select the 'Start' while engine is idling.

The program will test the knock sensor reading for 5 seconds to check internal system and confirm it is working normally.

Celsius 95.3° = 203.54° Fahrenheit

NOTE: If the measured vibration test is too low or abnormally higher than the set value, a pop-up message will display to check the audio jack input (microphone) or knock sensor connector.

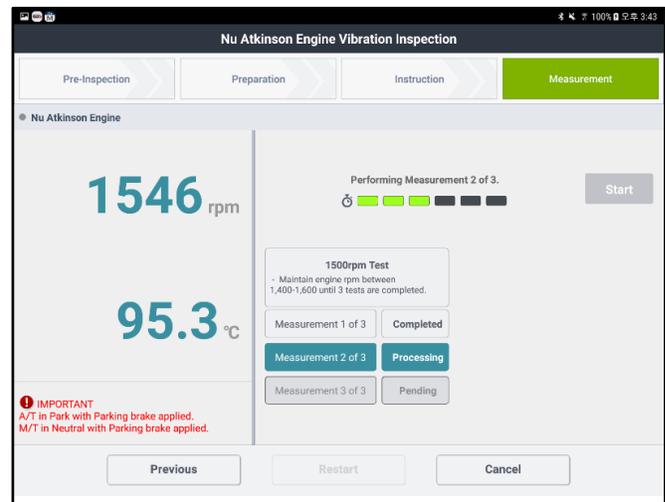
10. By lightly pressing down the accelerator pedal, keep the 'rpm' value between 1400 and 1600 rpms. A total of three (3), 15 sec. tests are required.

NOTE: If the rpm value is above the required range, the color of rpm value displayed will change to a red color and the time counter will reset.

Celsius 95.3° = 203.54° Fahrenheit

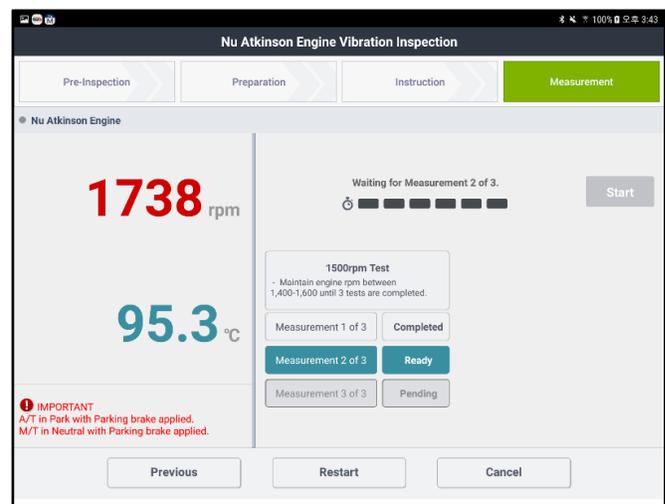
The successful measurements will display "Completed" on the screen.

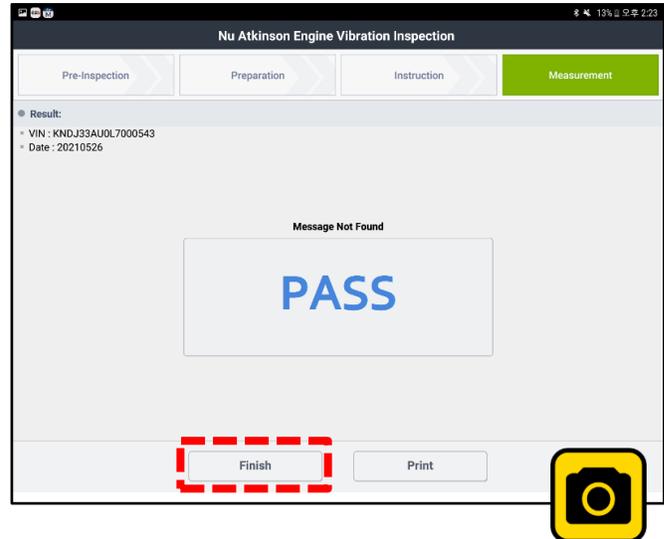
10a. **PASS:** If the measured engine vibration test has a normal condition, capture the screen image/screenshot for record keeping and attach to the warranty claim using Attachment Type - 'XX': Other. Select 'Finish'.

REQUIREMENT: Take one (1) clear image/screenshot of the test result (Pass, No Pass or Retest). (Attachment Type - 'XX': Other).

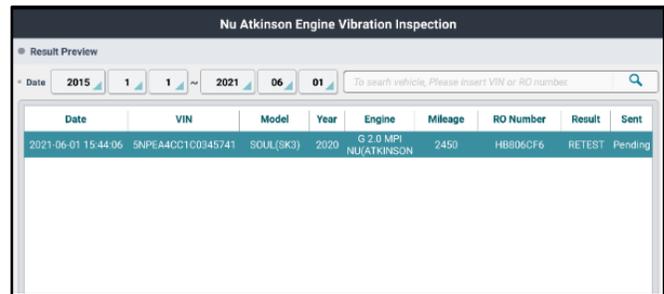
Note: All measured data value and transferring results are available by selecting 'Review Results' in the initial screen.

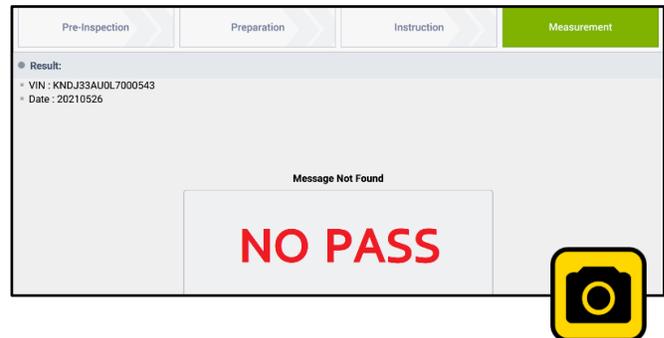
10b. **NO PASS:** If the measured engine vibration test is abnormal capture the screen image/screenshot for record keeping and attach to the warranty claim using Attachment Type - 'XX': Other. → **Open a Techline case online for further instructions.**

Select 'Finish' and replace the engine long block by referring to the "Engine Mechanical System → Engine And Transaxle Assembly → Repair procedures" chapter in the applicable Shop Manual on KGIS. Refer to page 7 information.

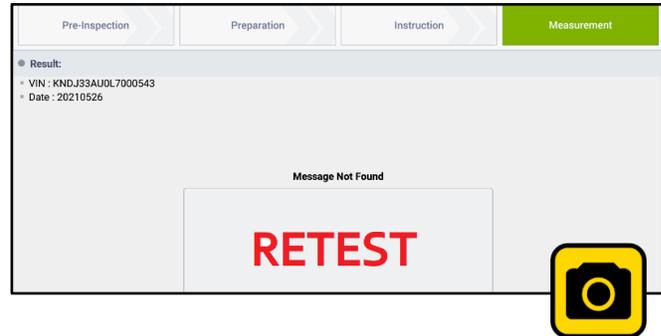
- 10c. **RETEST:** If there's an **error** on the measured engine vibration test, check the jack input (microphone) and knock sensor connection and perform measuring test again.

NOTE: If the results keep displaying 'RETEST' (more than 2 times), open a Techline case online for further instructions.
