GROUP	MODEL
Safety Recall Campaign	2020-2021MY Soul (SK3) and 2021MY Seltos (SP2) w/2.0L Nu MPI engine
NUMBER	DATE
SC209 (Rev 1, 06/14/2021)	June 2021

ENGINE VIBRATION INSPECTION AND REPLACEMENT (SC209)

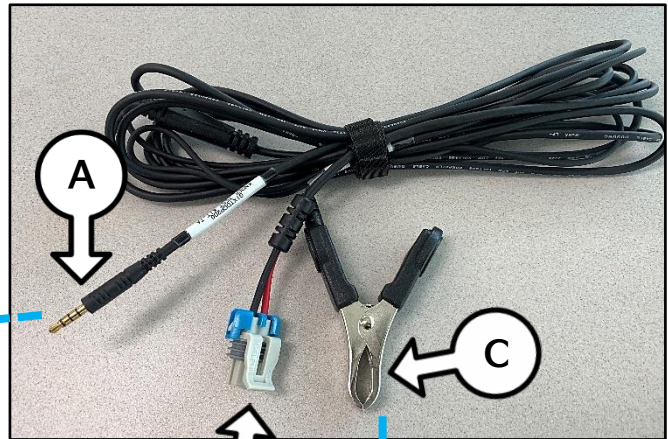
- 2a. Connect the engine vibration inspection harness audio jack (A) to KDS.

Samsung USB Type C – 3.5mm adapter may be required.
Model: EE-UC10JUWEGUS
DO NOT USE AFTERMARKET
Refer to note(s) on pages 8-9.

USB Type C to 3.5mm Headphone Jack Adapter (Model: EE-UC10JUWEGUS) used in the repair may be required when using a Samsung tablet not equipped with a 3.5mm headphone jack input. DO NOT AN USE AFTERMARKET ADAPTER, ONLY SAMSUNG ADAPTER IS APPROVED FOR TESTING USING KDS.

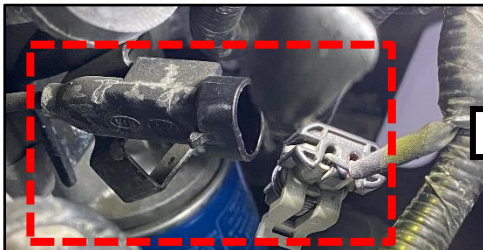
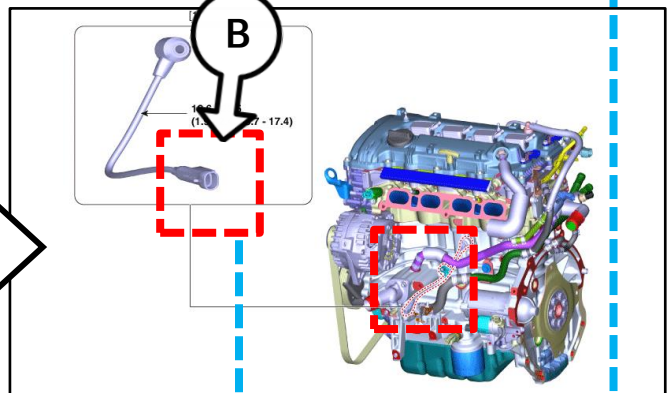
- 2b. Connect the knocking sensing connector (B) of engine vibration inspection harness to the knock sensor connector on the vehicle.

- 2c. Connect the clamp (C) to the battery (-) terminal.

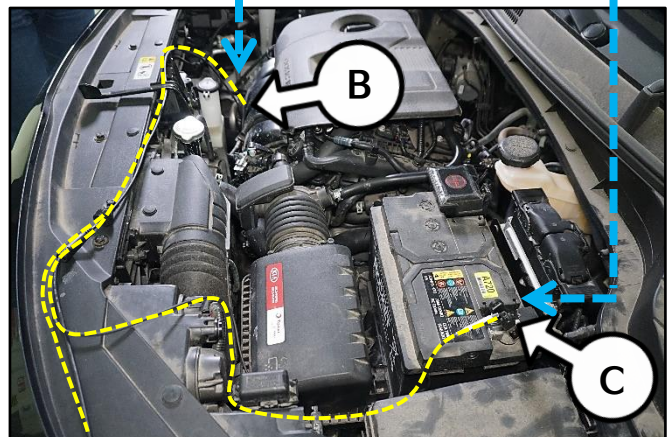
If the vibration inspection harness is placed over the engine components, external vibration may negatively affect to the inspection result. Route the wiring around the engine (yellow outline) shown in the photo.

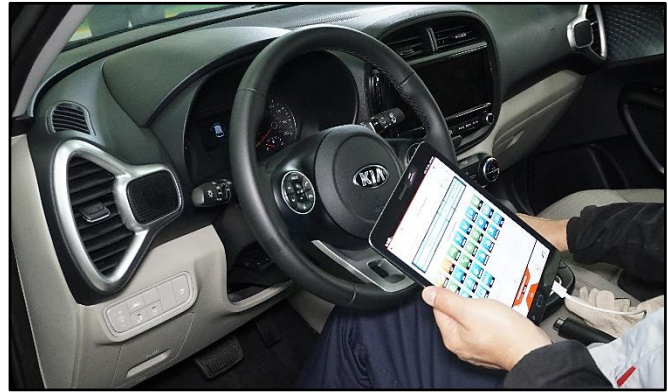
3. Connect the VCI to the vehicle's OBD2 port and confirm the Bluetooth pairing condition between KDS and VCI.

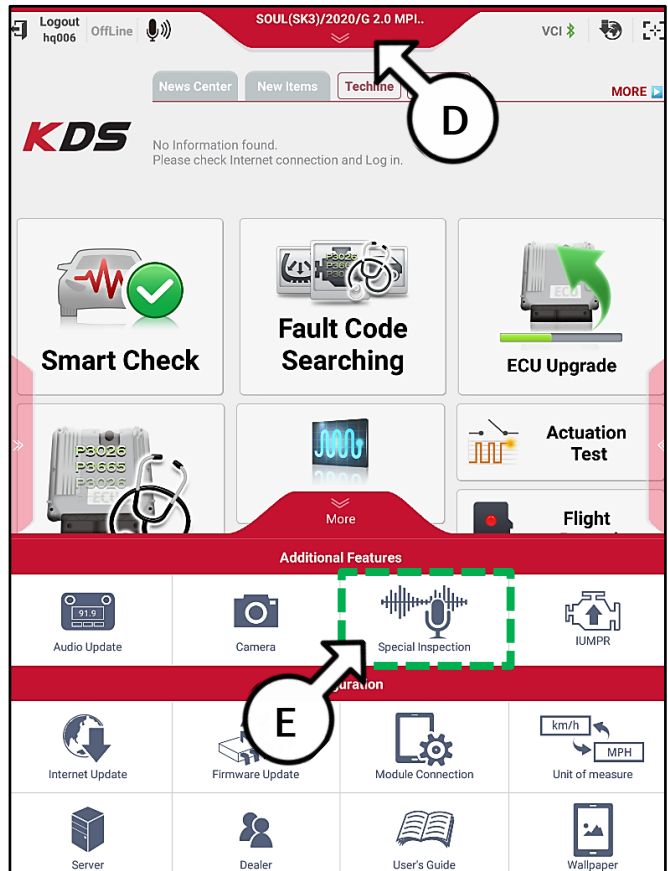
- 4a. Match the vehicle model (D) on the top of KDS screen.

- 4b. Turn the ignition to 'ON'.

- 4c. Select 'Special Inspection' mode (E).

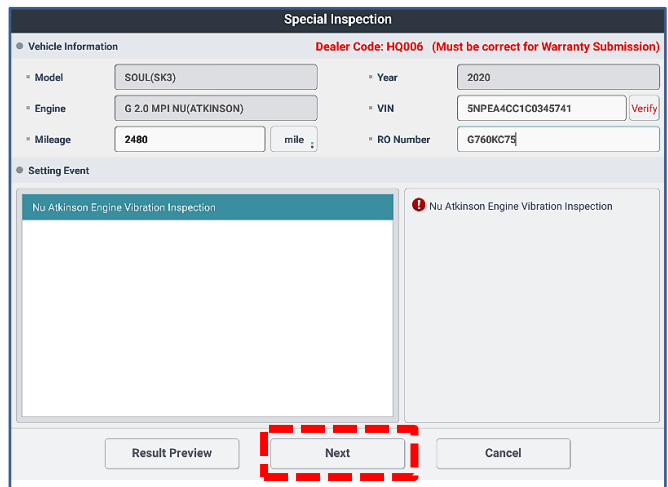
- 5a. Enter the vehicle information (Mileage, RO#). The VIN is recognized automatically.

Select 'Nu Atkinson Engine Vibration Inspection'. And then select 'Next'.

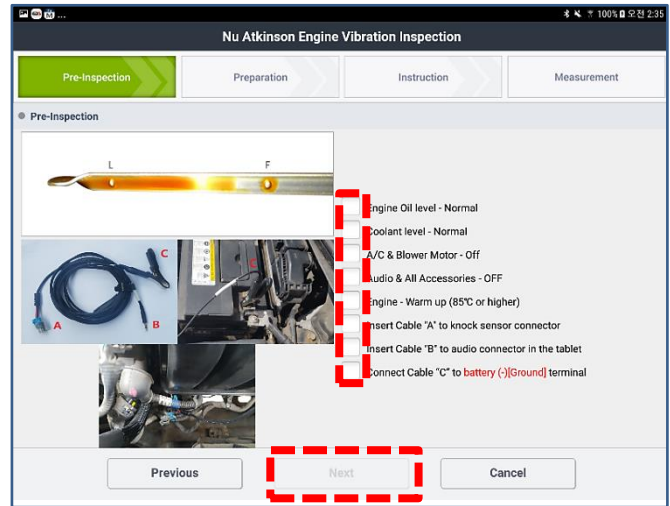
6. Confirm all "Pre-Inspection" conditions by selecting the check boxes.

Once conditions are checked off, select 'Next'.

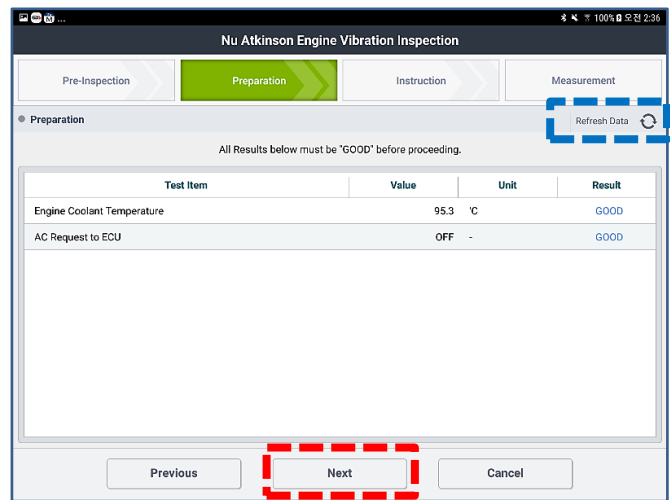
7. The program will automatically check the engine sensor data.

Once activated, select 'Next' as all conditions are now complete.

If the conditions are not met, a 'NOT GOOD' message will display. Confirm the requirements are met, then select 'Refresh Data'.

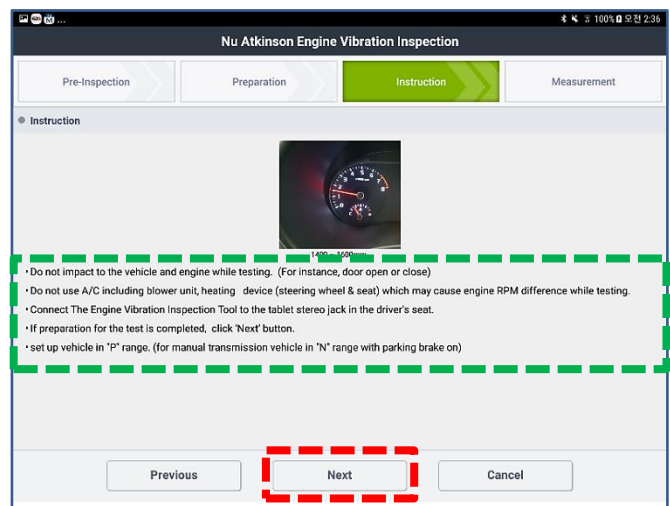
- 8a. Read and follow the instruction displayed to recognize the measuring process.

- 8b. Select 'Next'.

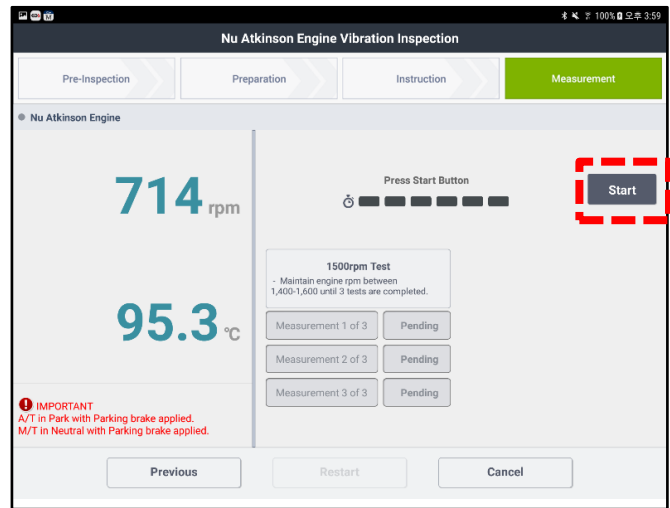
- In the "Measurement" stage, select the 'Start' while engine is idling.

The program will test the knock sensor reading for 5 seconds to check internal system and confirm it is working normally.

NOTE: If the measured vibration test is too low or abnormally higher than the set value, a pop-up message will display to check the audio jack input (microphone) or knock sensor connector.

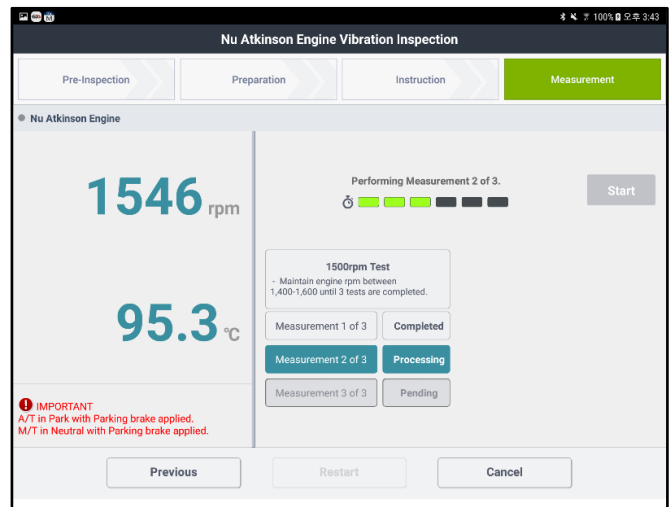
- By lightly pressing down the accelerator pedal, keep the 'rpm' value between 1400 and 1600 rpms. A total of three (3), 15 sec. tests are required.

NOTE: If the rpm value is above the required range, the color of rpm value displayed will change to a red color and the time counter will reset.

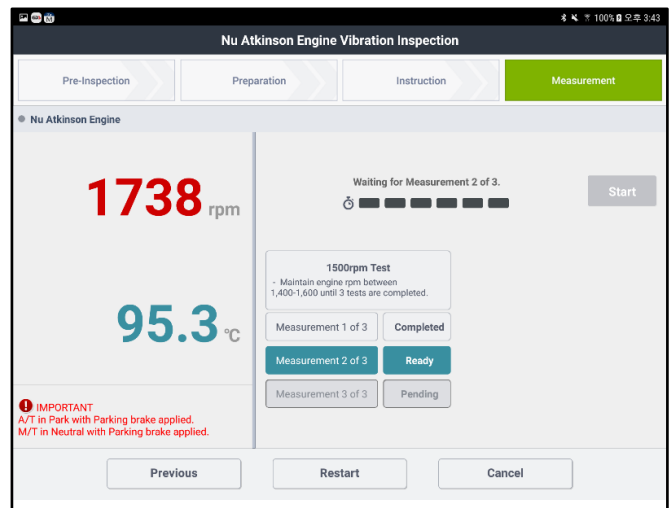
The successful measurements will display "Completed" on the screen.

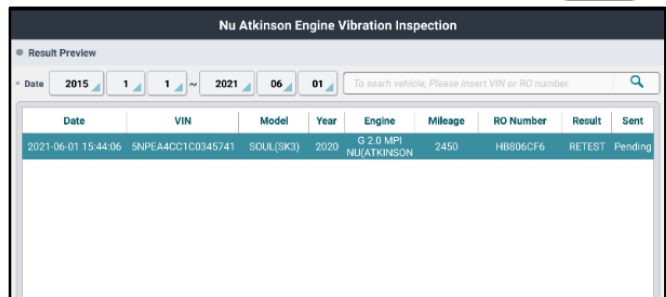
10a. **PASS:** If the measured engine vibration test has a normal condition, capture the screen image/screenshot for record keeping and attach to the warranty claim using Attachment Type - 'XX': Other. Select 'Finish'.

Note: All measured data value and transferring results are available by selecting 'Review Results' in the initial screen.

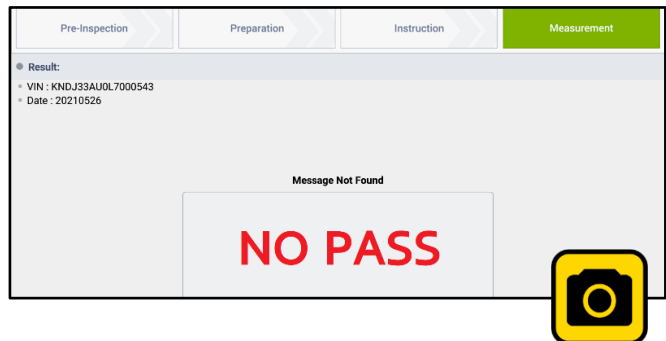
10b. **NO PASS:** If the measured engine vibration test is abnormal capture the screen image/screenshot for record keeping and attach to the warranty claim using Attachment Type - 'XX': Other. → **Open a Techline case online for further instructions.**

Select 'Finish' and replace the engine long block by referring to the "Engine Mechanical System → Engine And Transaxle Assembly → Repair procedures" chapter in the applicable Shop Manual on KGIS. Refer to page 7 information.
