GROUP	MODEL
Safety Recall Campaign	2020-2021MY Soul (SK3) 2021MY Seltos (SP2)
NUMBER	DATE
SC209A (Rev 1, 04/06/2022)	December 2021

ECM LOGIC IMPROVEMENT FOR PISTON RING NOISE SENSING SYSTEM (SC209A)

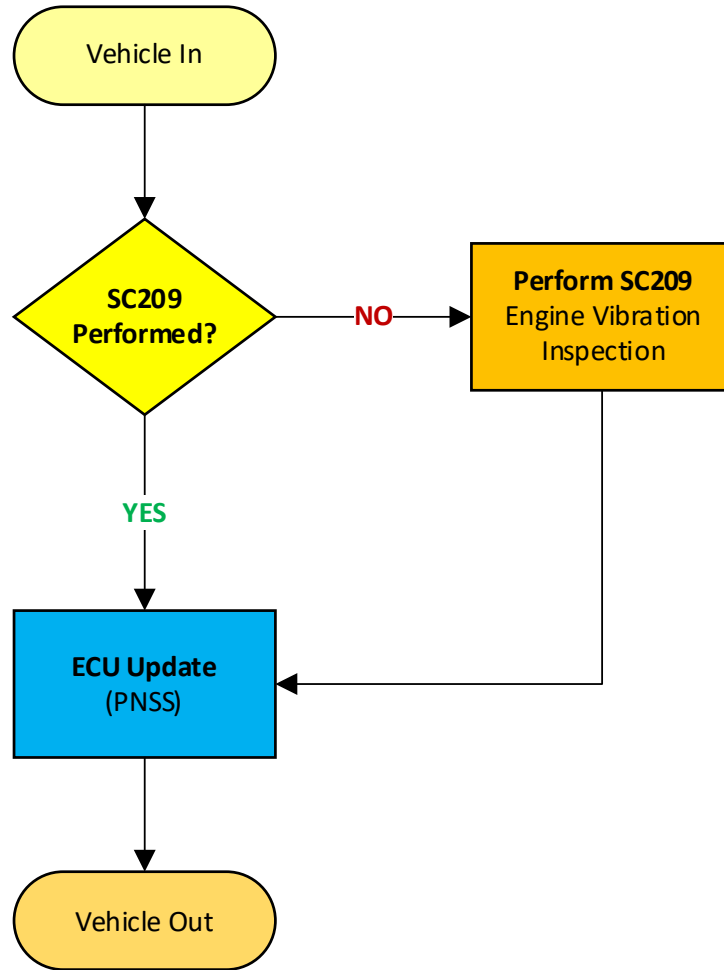
Flowchart:

NOTE: Piston Ring Noise Sensing Software (ECU Update, PNSS) enables DTC P1327/P132700 - Piston Noise Detection, in the event that the ECU detects Piston Ring Noise from the engine.

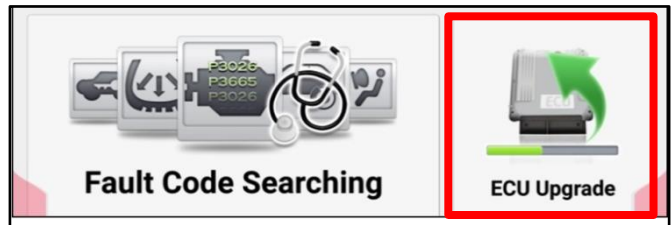
4. Select 'ECU Upgrade'.

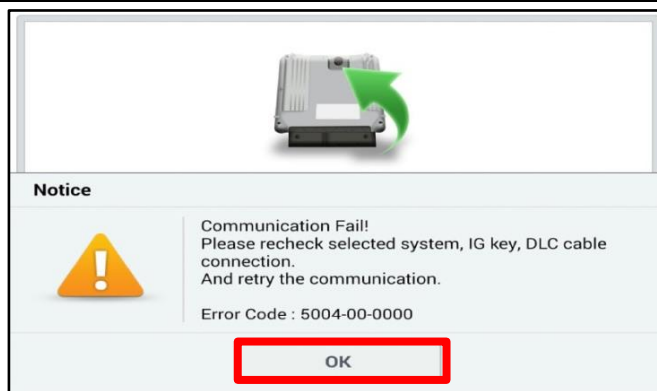
9. If a "Communication Fail" screen appears, verify that the VCI-II and KDS are communicating properly. Select 'OK' and restart the procedure from step 4.

If an error notice continues to appear or if the upgrade cannot be performed, DO NOT disconnect the KDS/VCI-II. Contact GIT America Help Desk at (888) 542-4371 or Techline.

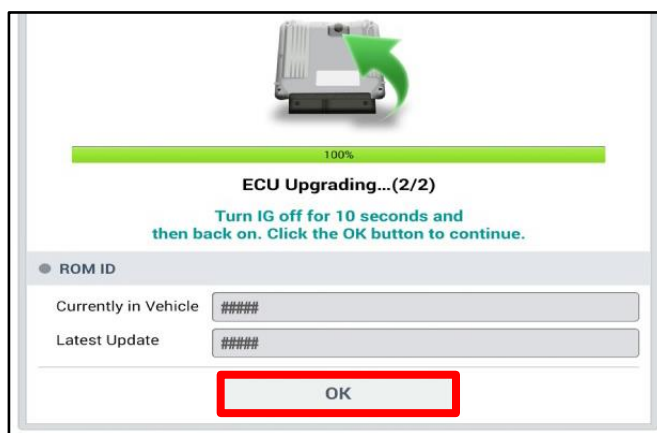
10. When instructed on the KDS, turn the ignition OFF for ten (10) seconds then back on. Select 'OK' to continue.

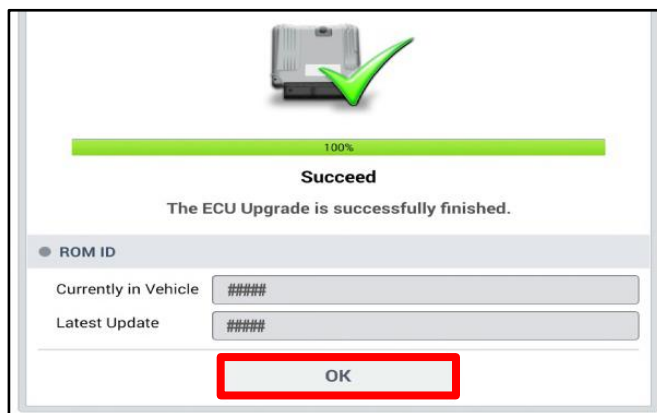
11. Once the upgrade is complete, select 'OK' to finalize the procedure.

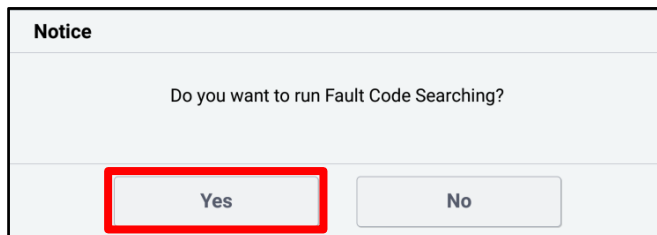
12. When prompted, select 'YES' to check for Diagnostic Trouble Codes (DTC) and erase any DTCs stored such as EPS, ESC, and TPMS that may have been set during the upgrade.
