L62X-R.02.21

Rear View Camera not available - Kombi update

**Model:**Huracán 4WD, Huracán 2WD, Huracán Performante,  
Huracán EVO**Model year:**

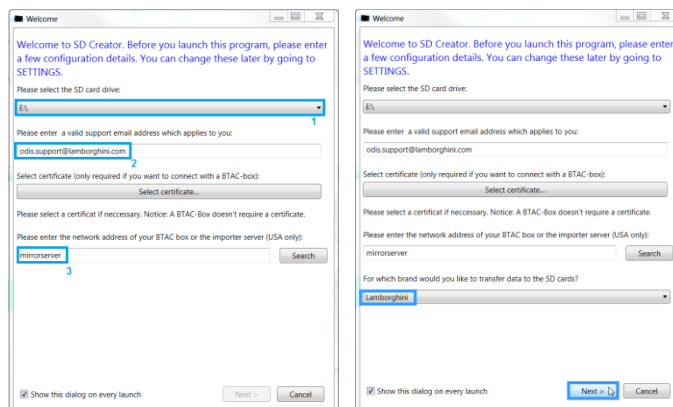
2. When the program starts, fill in the Windows screen fields as explained in the "BI-09.17\_[ENG]\_SD-Creator installation package procedures".

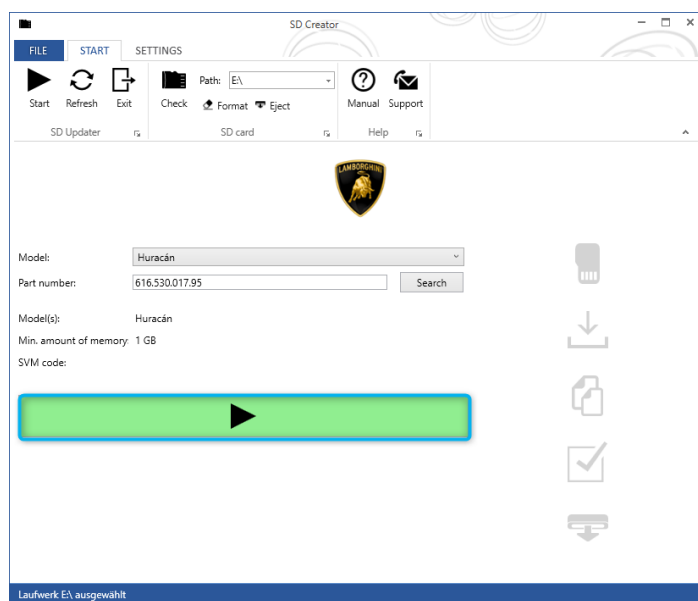
7. Follow the instructions to download the software. Click the Start Button,

, to start the software download process. The software will be automatically saved in the Micro SD card stick.

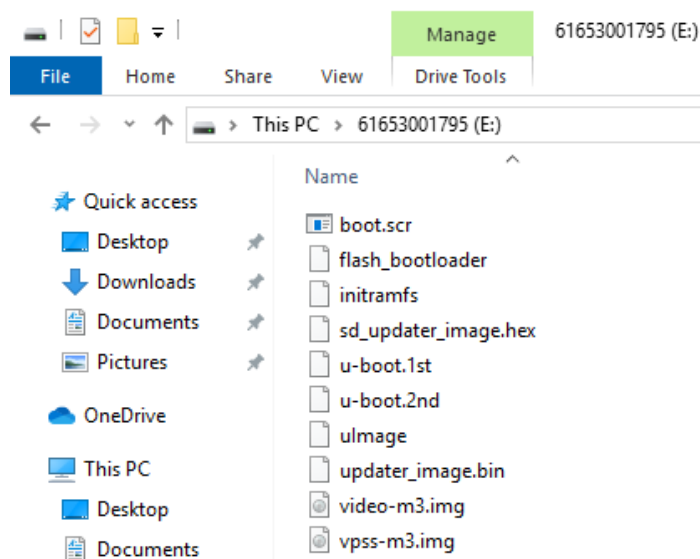
9. To verify the success of the operation, extract and reinsert the Micro SD card and make sure that the software required is present. The following image is an example concerning the folders created.

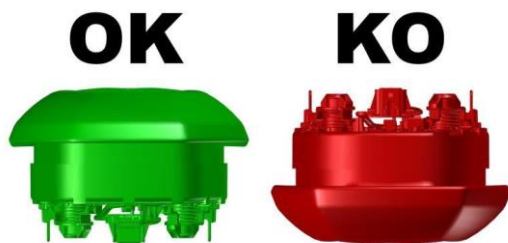
62x15\_0001368

12. Disconnect the connector then remove the airbag module.

Position the airbag as shown in the figure.

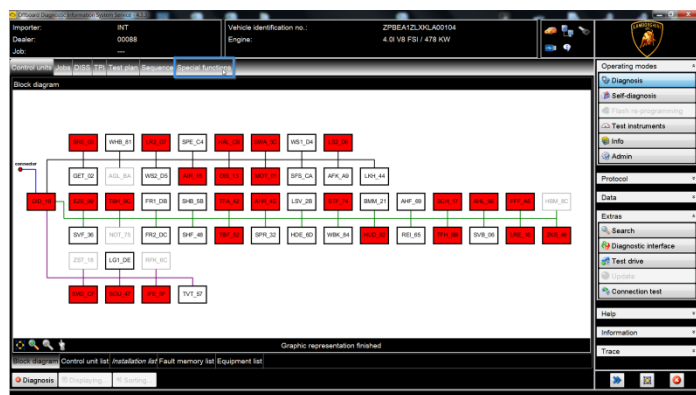
**21.** To start the procedure to execute an SVM code, select the "Special functions" card in ODIS.

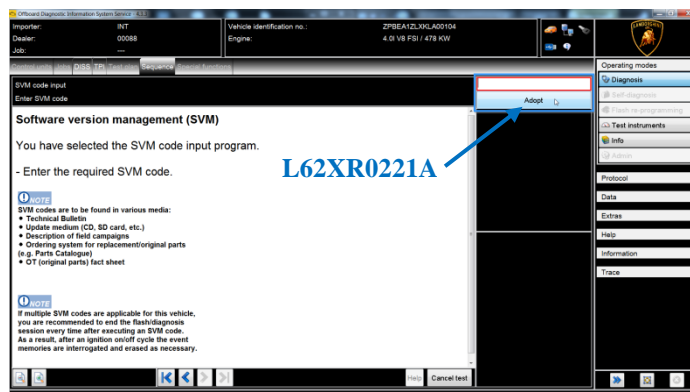
**23.** Enter the code "L62XR0221A" in the appropriate space at the top right and click "Adopt".

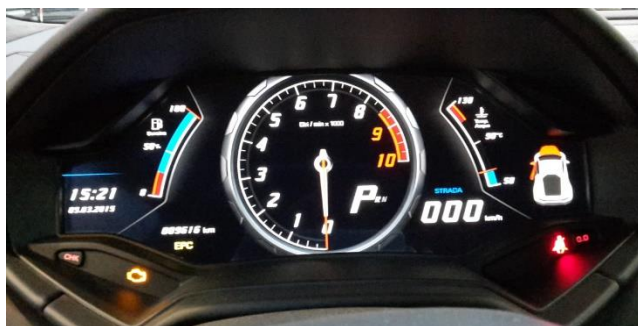
**30.** Wait for completion of the update, indicated by the yellow progress bar below the display as shown in the first image, until it disappears completely and the Instrument Cluster turns back on, as indicated in the second image.

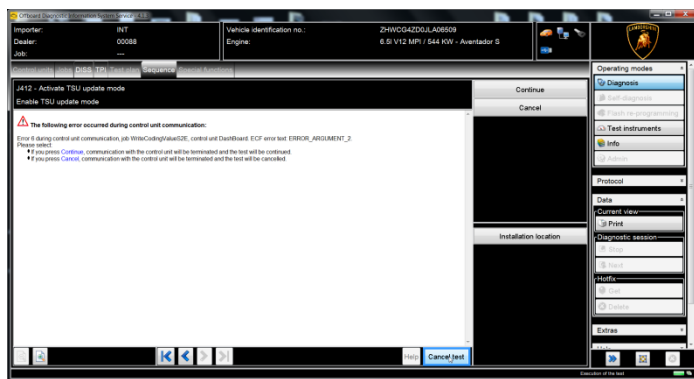
- i. If the following error screen is displayed, abort the guided function by clicking on "Cancel Test" and contact Technical Support.
