AMB5 - Re-programming Power Electronics (Stop Delivery/Recall Campaign)

Model Line: **Taycan (Y1A)**
Taycan Cross Turismo (Y1B)

Concerns: **Power electronics and engine electronics (DME)**

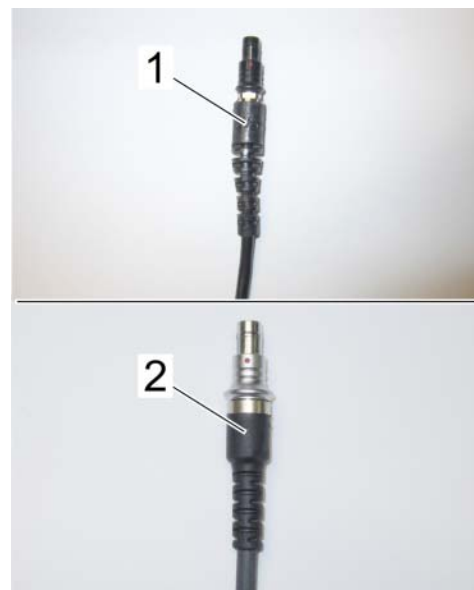
Use the **new** PIWIS Tester data cable to carry out the campaign. The difference between the old ⇒ *PIWIS Tester data cable -1-* and new ⇒ *PIWIS Tester data cable -2-* data cable is shown in the illustration.

If the connection between the vehicle and PIWIS Tester is interrupted, check the data cable for the PIWIS Tester for signs of damage. If the data cable is damaged, it **must** be **replaced**. To do this, follow the instructions in the PPN for "Returning faulty USB cable caps" (PPN portal > Dr Ing. h.c. Porsche AG > Aftersales > Workshop > PIWIS > Documents).

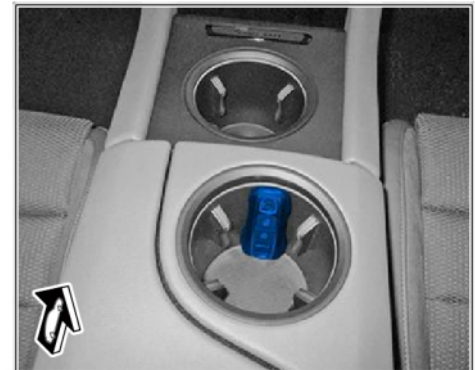
Emergency start tray

2 Position the **driver's key** with the back facing forward upright between the holding struts in the rear cupholder (**emergency start tray**) to guarantee a permanent radio link between the vehicle and remote control ⇒ *Emergency start tray*.

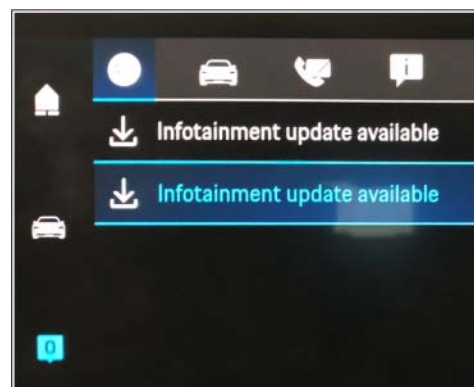
Infotainment update in central display

After carrying out the campaign, please inform customers that Infotainment updates are available via the central computer (PCM) and provide them with any help and support they need during installation ⇒ *Infotainment update in central display*.

These updates are only available if the customer has logged in on the vehicle using his/her main user credentials (Porsche ID). Several updates are available depending on equipment and these must be installed one after the other in steps. It can take several minutes to install these. New functions can only be used when all updates have been completed and the vehicle has established bus idle for at least 15 minutes.
