Dealer Service Instructions for:

# Safety Recall Y47 / NHTSA 21V-516

## Windshield Adhesion

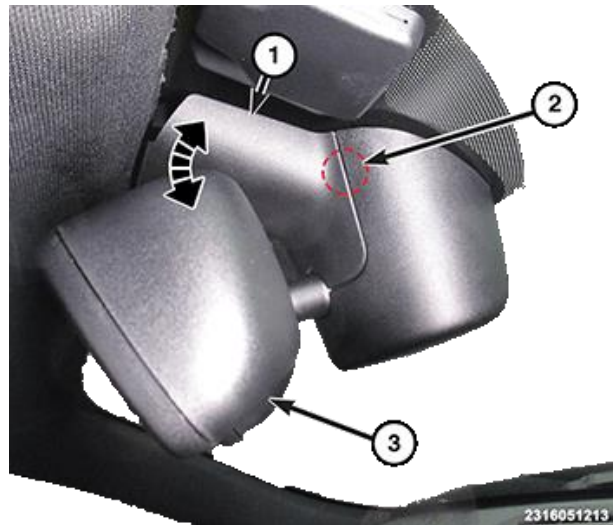
**Figure 1 – Upper Mirror Trim**

1. Partially lower the windows.
2. Disconnect and isolate the negative battery cable. If equipped with an Intelligent Battery Sensor (IBS), disconnect the IBS connector first before disconnecting the negative battery cable.
3. Using a small flat bladed tool, release the clips (2) on each side of the upper mirror trim (1) and rotate the upper mirror trim downward to remove (Figure 1). Challenger shown, Charger and 300 similar.

99. Insert the bottom of the upper mirror trim (1) and rotate upward to engage the tabs (2) (Challenger shown, Charger and 300 similar) (Figure 1).
100. Connect the negative battery cable. If equipped with an IBS, connect the IBS connector.

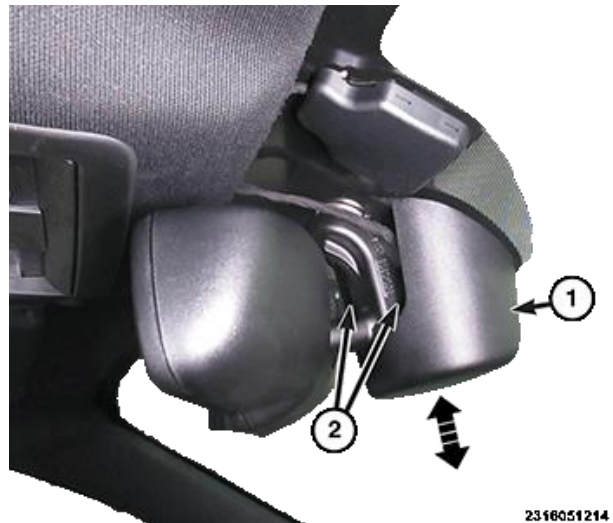
**Figure 2 – Lower Mirror Trim**

4. Using a small flat bladed tool, release the tabs (2) and lower the lower mirror trim and remove (Figure 2). Challenger shown, Charger and 300 similar.

97. Connect the wire harness connector (1) to the LRSM connector receptacle (6) (Figure 5).
98. Install the lower mirror trim (1) from the bottom. Make sure the tab(s) (2) engage fully (Challenger shown, Charger and 300 similar) (Figures 2 and 3).

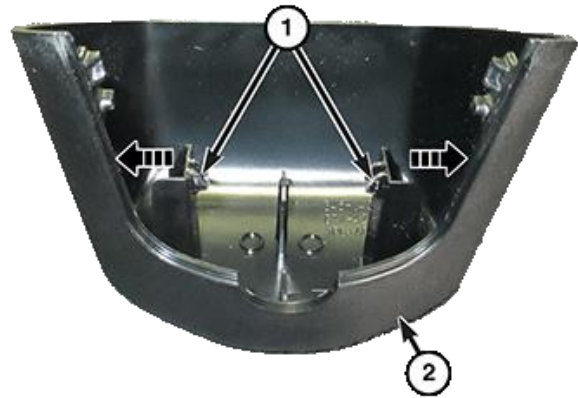
**Figure 3 – Lower Mirror Trim Tabs**

5. The lower mirror trim (2) is shown removed, pry tab(s) (1) outward to release (Figure 3).

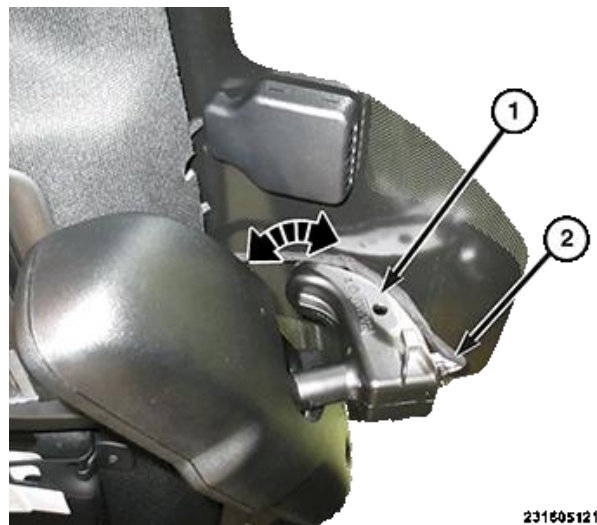
**Figure 4 – Harness Connector**

6. Disconnect the wire harness connector (2) from the mirror (Figure 4). Challenger shown, Charger and 300 similar.

10. Grasp the mirror (1) by the base and rotate it clockwise approximately 90 degrees and remove (Figure 4). Challenger shown, Charger and 300 similar.

70. Close the hood.
71. Seat the tether (1) by sliding it into the A-pillar trim panel (3) (Figure 9).
72. Place the A-pillar trim panel in position to the instrument panel and push downward (Figure 8).
73. Push at the top of the A-pillar trim panel (1) and attach it to the body (Figure 8).
74. Place the rear view mirror (1) onto the mirror button (Challenger shown, Charger and 300 similar) (Figure 4).

75. Grasp the mirror by the base and rotate it approximately 90 degrees counter-clockwise until the mirror locks into place. DO NOT touch the lens (Figure 4).

80. Install the forward facing camera, if equipped (Charger and 300) (Figure 6).
81. Connect the wire harness connector (2) (Figure 4).

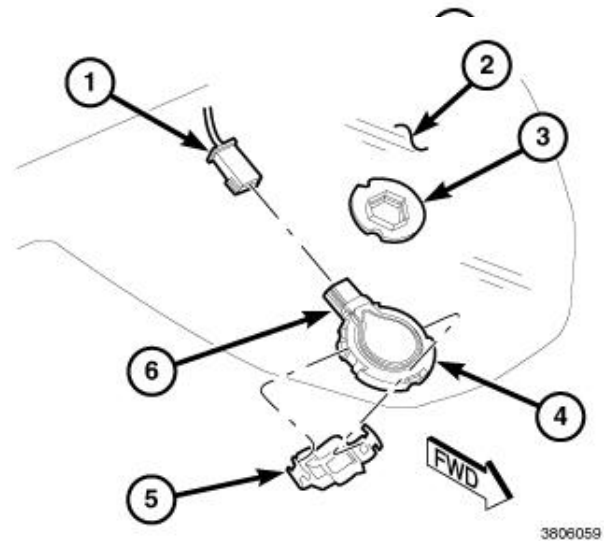
**Figure 5 – Harness Connector**

7. Disconnect the wire harness connector (1) from the connector receptacle for the Light Rain Sensor Module (LRSM) (6), using care not to dislodge the sensor from the glass, if equipped (Figure 5).

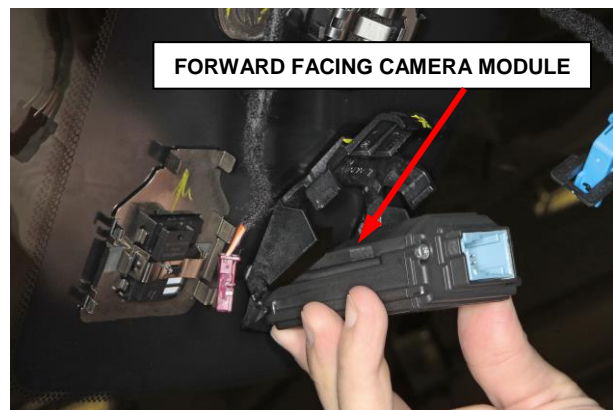
**Figure 6 – Forward Facing Camera Module**

8. Remove the forward facing camera, if equipped (Charger and 300) (Figure 6).

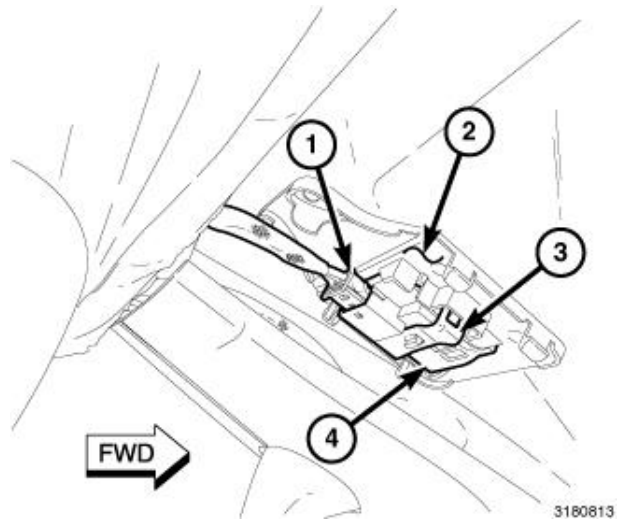
**Figure 7 – Humidity Sensor**

**NOTE: Use care when removing the humidity sensor. The humidity sensor bracket cannot be serviced separately from the windshield. If the sensor bracket becomes damaged, the windshield will need to be replaced.**

9. Disconnect the wire harness connector (1) from the humidity sensor, if equipped (Figure 7).

76. Is the original windshield being reused?
  - Yes, see step 79.
  - No, see step 77.
77. When installing a new windshield, transfer the humidity sensor from the original windshield. Using a small screwdriver or similar tool, carefully disengage the metal retaining clip (3) from the sensor bracket (2) and remove the humidity sensor (4) and the clip as an assembly (Figure 7).
78. Carefully engage the metal retaining clip (3) to the sensor bracket (2) and install the humidity sensor (4) and the clip as an assembly on the new windshield (Figure 7).
79. Connect the wire harness connector (1) to the humidity sensor (Figure 7).

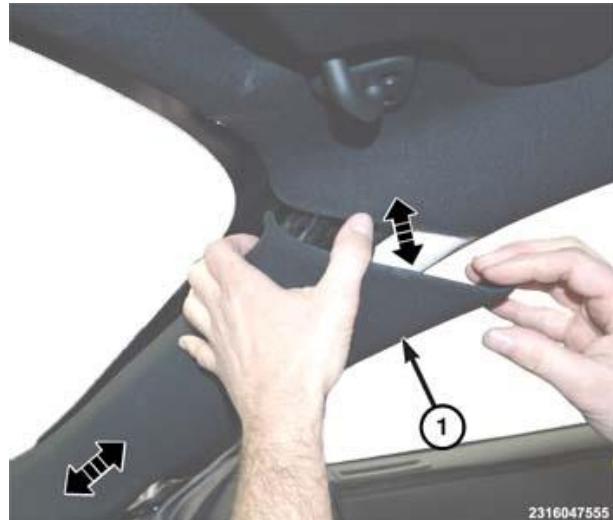
**Figure 8 – A-pillar Trim**

11. By hand, pull at the top of the A-pillar trim panel (1) and release it from the body. Do not remove the A-pillar trim (Figure 8).
12. Pull the A-pillar trim panel upward to separate it from the instrument panel.

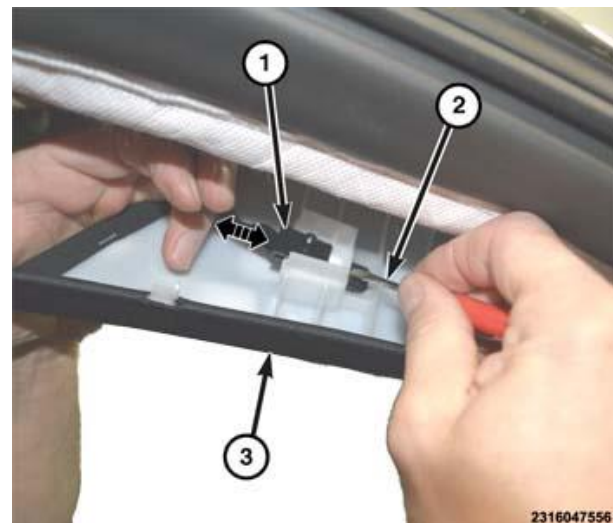
**Figure 9 – A-pillar Trim Tether**

13. Using a flat bladed tool (2), press the tab to disengage the tether (1) and slide it out of A-pillar trim panel (3) (Figure 9).
14. Open the hood.

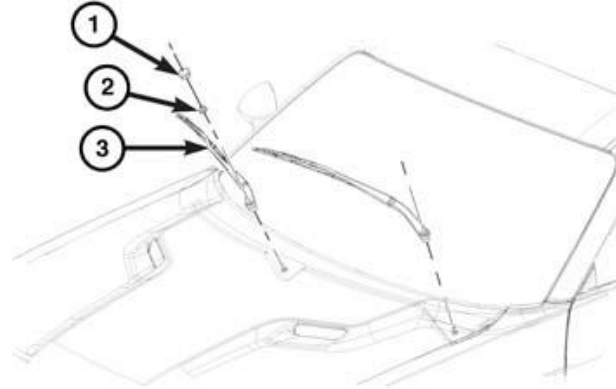
**Figure 10 – Wiper Arms**

15. Lift the wiper arm and blade (3) to its over-center position to hold the wiper blade from the glass and relieve the spring tension on the wiper arm to pivot shaft connection (Figure 10).

16. Carefully pry the plastic nut cap (1) from the nut (2) on the pivot end of the wiper arm (Figure 10).

17. Remove the nut (2) that secures the wiper arm to the wiper pivot shaft (Figure 10).

65. The wiper arm and blade (3) must be indexed to the pivot shaft with the wiper motor in the park position to be properly installed. Loosely position the wiper arm pivot end onto the wiper pivot shaft so that the wiper blade is aligned with the appropriate wiper alignment line, which is a mark located just below the upper margin of the lower windshield blackout area (Figure 10).

66. Once the wiper blade is aligned, push the pivot end of the arm down firmly and evenly over the pivot shaft until it is fully engaged.
67. Install and tighten the nut (2) that secures the wiper arm to the pivot shaft. Tighten the nut to 24 N·m (18 ft. lbs.) (Figure 10).

69. Install the plastic nut cap (1) onto the wiper arm mounting nut (Figure 10).

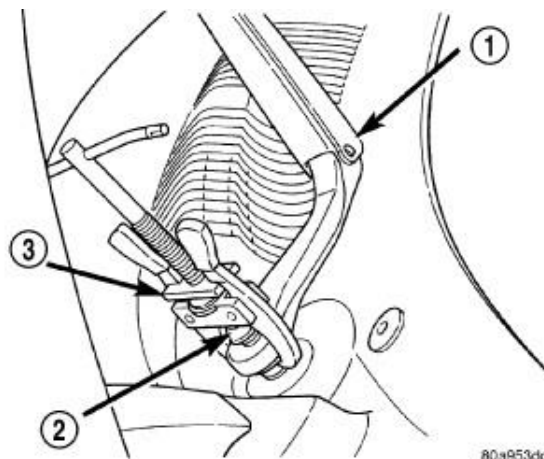
**Figure 11 – Battery Terminal Puller**

18. If necessary, use a suitable battery terminal puller (3) to disengage the wiper arm (1) from the wiper pivot shaft (2) (Figure 11).

19. Remove the wiper arm pivot end from the wiper pivot shaft.

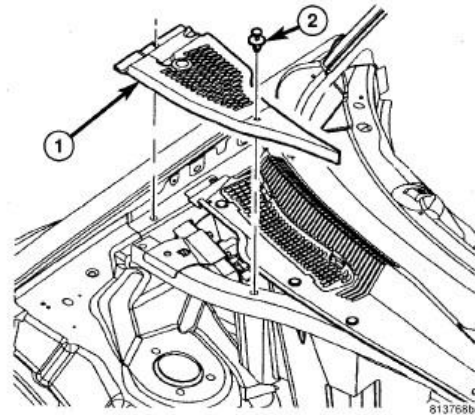
**Figure 12 – Cowl Top Panel**

20. Remove the cowl panel cover fastener and the cowl top panel (Challenger) (Figure 12).

62. Install the barbed fasteners (2) to the corner on each side of the cowl panel cover to the fender (Challenger) (Figure 14).
63. Rotate the seal 90 degrees to cover cowl panel fastener (Challenger) (Figure 13).
64. Install the cowl panel cover fastener and the right side seal (Challenger) (Figure 12).

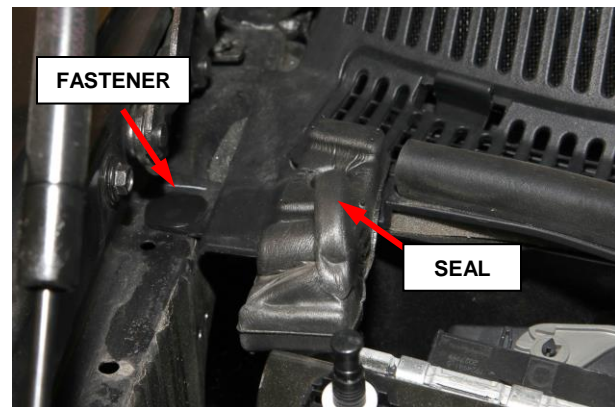
**Figure 13 – Cowl Panel Fastener and Seal**

21. Rotate the seal 90 degrees to access cowl panel fastener (Challenger) (Figure 13).

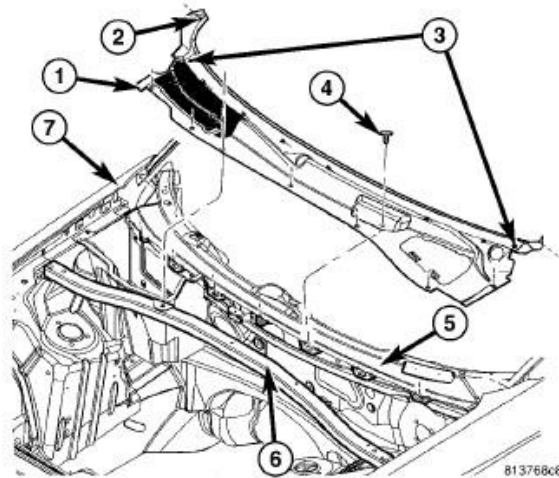
**Figure 14 – Cowl Panel Cover Fasteners (Challenger)**

22. Remove the barbed fasteners (2) from the corner on each side of the cowl panel cover to the fender (Challenger) (Figure 14).

24. Disengage the two 1/4-turn fasteners (3) that secure the cowl panel cover (1) to the dash panel (5) (Challenger) (Figure 14).
25. Remove the fir tree fasteners (4) (quantity of eight on Challenger, nine on Charger and 300) that secure the cowl panel cover (1) to the dash panel (5) (Figure 14).
26. Release the retaining clips and remove the cowl top panel (1) (Figure 14).

57. Open the hood. Position the cowl cover panel (1) and engage the retainer clips (Figure 14).
58. Install the fir tree fasteners (4) (quantity of eight on Challenger, nine on Charger and 300) that secure the cowl panel cover (1) to the dash panel (5) (Figure 14).
59. Secure the two 1/4-turn fasteners (3) that secure the cowl panel cover (1) to the dash panel (5) (Challenger) (Figure 14).
60. Install the fasteners (2) in the corners on each side (Charger and 300) (Figure 15).
61. Install the fasteners from the corners on each side of the cowl panel cover to the fender (Charger and 300) (Figure 15).

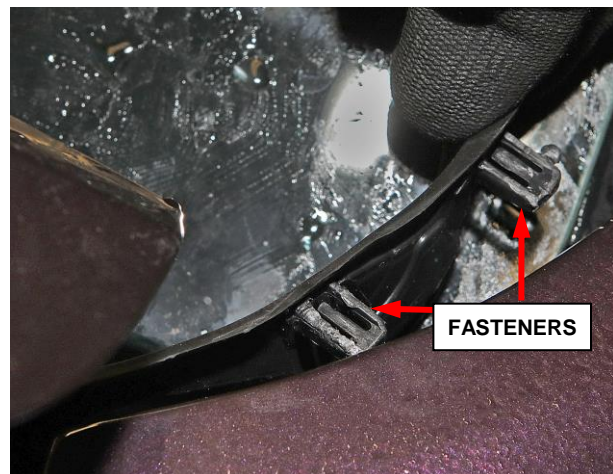
**Figure 15 – Cowl Panel Cover Fasteners (Charger and 300)**

23. Remove the fasteners from the corners on each side of the cowl panel cover to the fender (Charger and 300) (Figure 15).

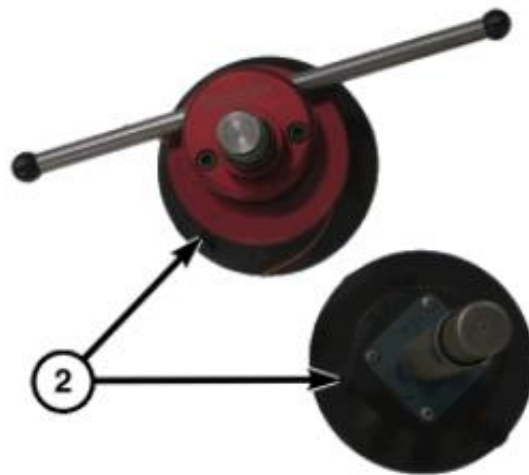
**Figure 16 – Rotating Wire Windshield Removal Tool**

**CAUTION:** To reduce the chances of windshield breakage, the use of a rotating wire windshield removal tool is required (Figure 16).

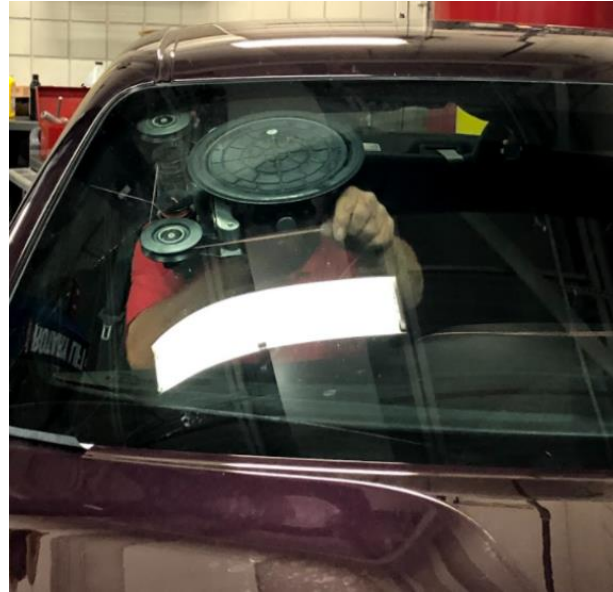
**Figure 17 – Rotating Wire Removal System**

27. Close the hood. With a grease pencil or tape, mark the location of the windshield to the body. Using a rotating wire glass extraction tool or equivalent, cut and separate the urethane adhesive securing the windshield to the windshield fence. Make sure that the wire is under the lace molding (Figure 17).

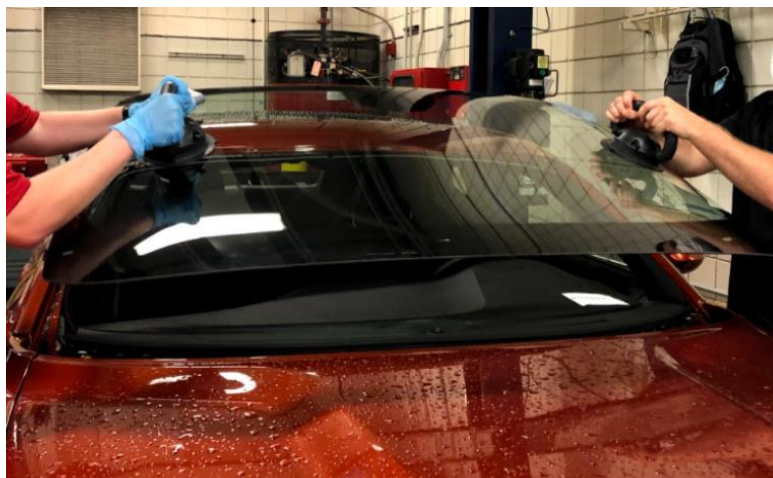
**Figure 18 – Windshield Removal**

28. Using appropriate tools, carefully remove the windshield from the vehicle (Figure 18).

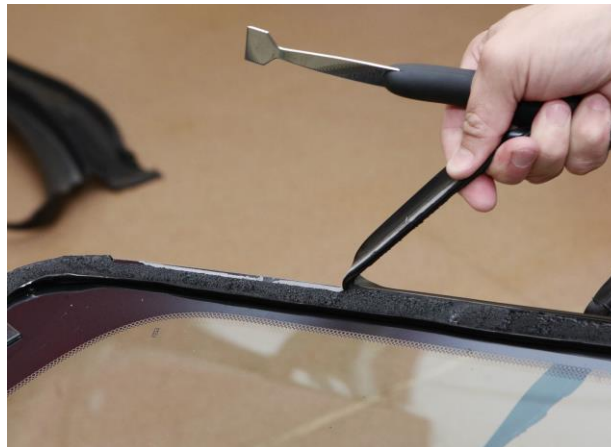
**Figure 19 – Remove Old Lace Molding**

30. Remove the lace molding from the edge of the windshield. Usually it will pull right off, but if it is embedded too deeply in the urethane, the use of a razor cutting tool may be helpful (Figure 19).

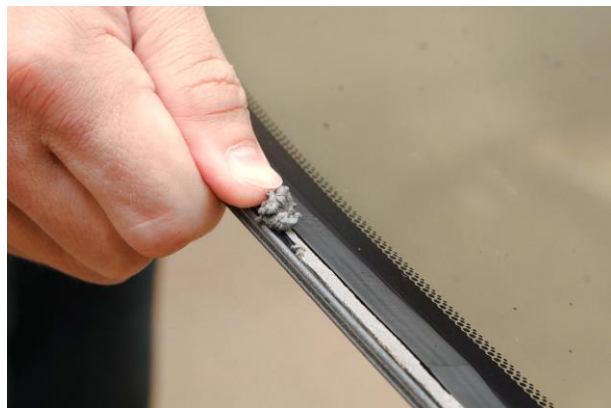
**Figure 20 – Remove Lace Molding Adhesive**

31. Remove any remaining adhesive from the old lace molding (Figure 20).

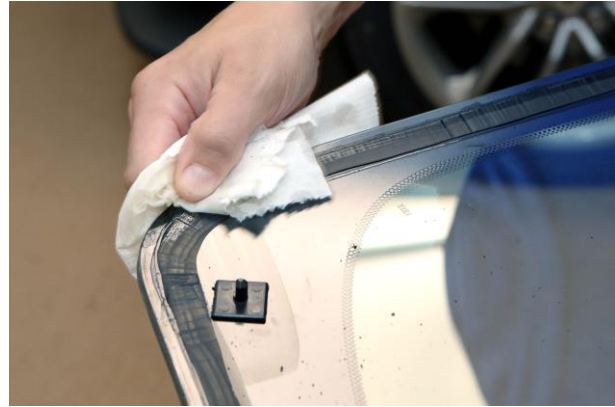
**Figure 21 – Remove Lace Molding Adhesive Residue**

- 32. Clean the edge of the glass where the lace molding adheres with isopropyl alcohol (Figure 21).

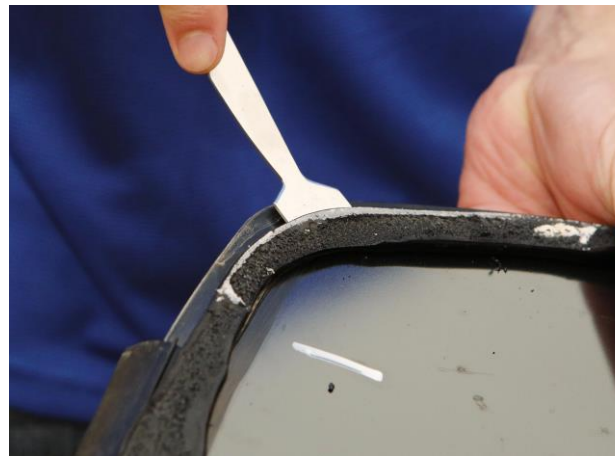
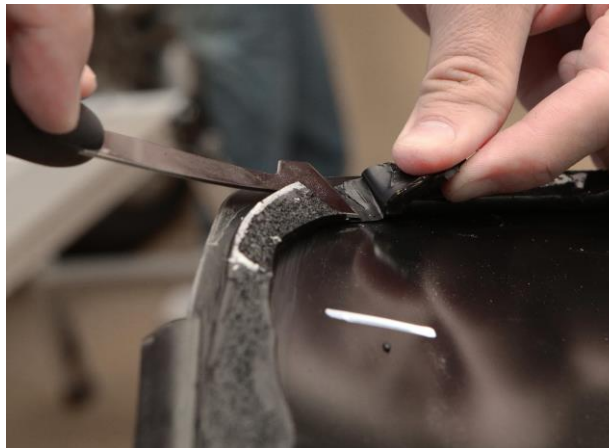
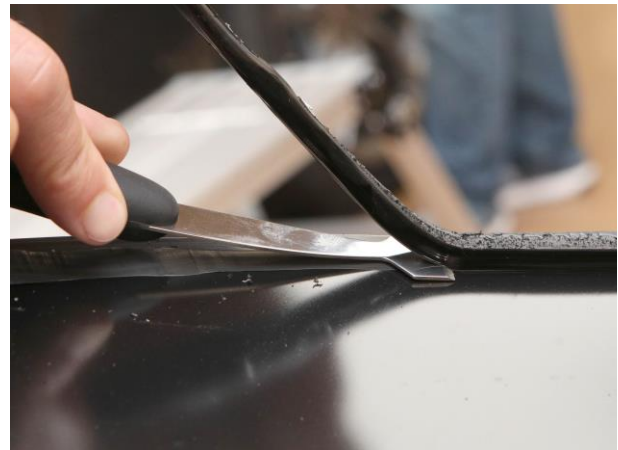
- 33. Remove the original urethane, leaving 1mm of thickness on the glass surface using a razor cutting tool. It is easiest to start the removal at a corner of the windshield (Figures 22-24).

**Figure 22 – Windshield Preparation**

**Figure 23 – Windshield Preparation**

**Figure 24 – Windshield Preparation**

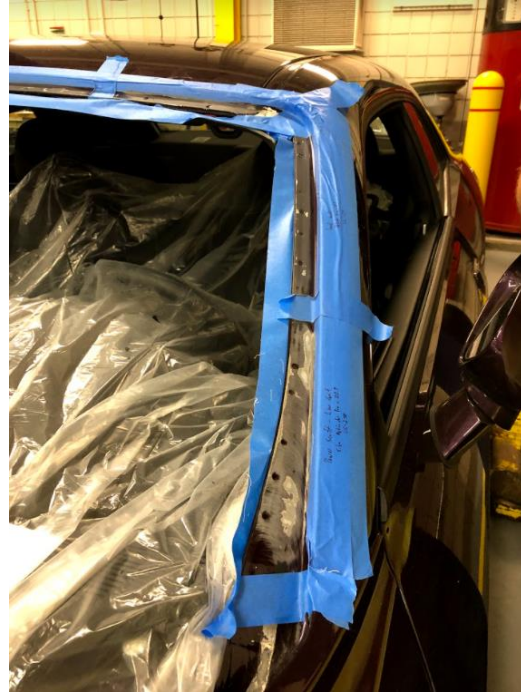
**Figure 25 – Protect Adjacent Surfaces**

34. Place tape over the VIN tag. Cover the dash pad, interior, and the edge of the headliner, and tape off the windshield fence on the body surrounding the urethane bead (Figure 25).

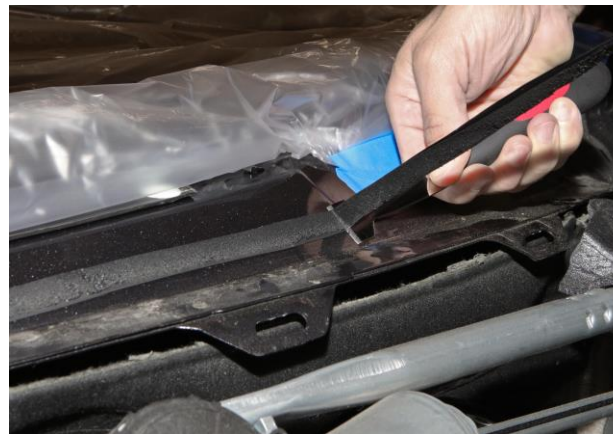
**Figure 26 – Windshield Preparation**

35. Starting in a convenient spot, use a razor knife to cut across the urethane bead down to, but not through, the painted surface. Lift the cut edge of the bead with a scraper, and pull the urethane bead from the body by hand. If the bead breaks, begin again with procedure above until all of the urethane is removed from the body (Figure 26).

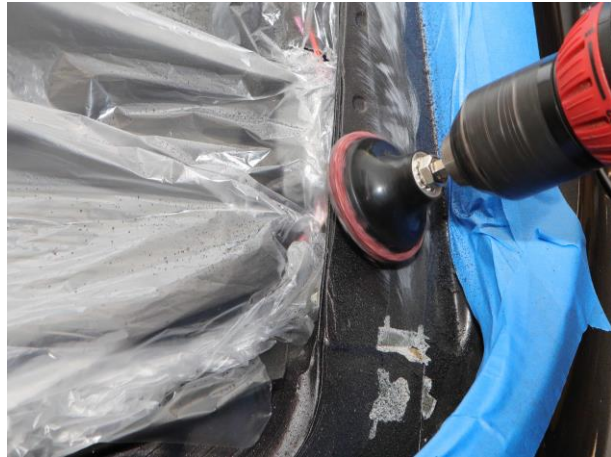
**Figure 27 – Windshield Preparation**

- 36. Remove any damaged adhesive backed spacers.
- 37. Use a 180-240 grit ScotchBrite 3M Roloc disk to remove any remaining urethane that could not be removed in step 36 (Figure 27).

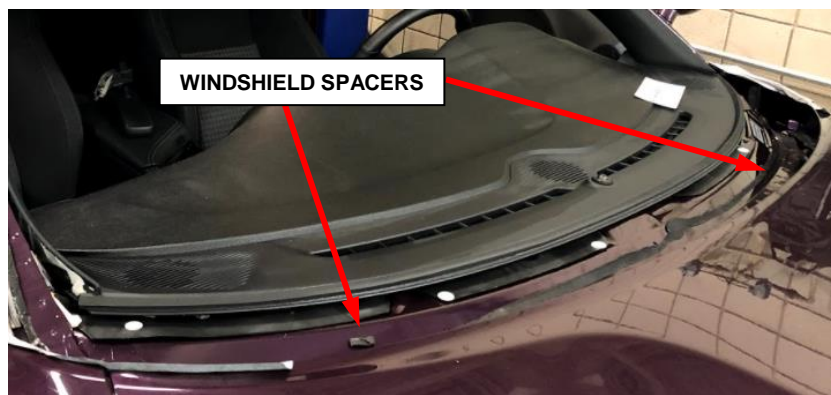
**Figure 28 – Windshield Spacers**

- 38. Using 180 grit sandpaper, scuff the windshield flange. Do not remove the clear coat or paint. This will provide a better bite for the new bead of urethane. Do not sand the other fence surfaces, but only those that will receive a bead of urethane.
- 39. Clean the windshield flange of loose debris.
- 40. Install new spacers as required (Challenger shown, Charger and 300 similar) (Figure 28).

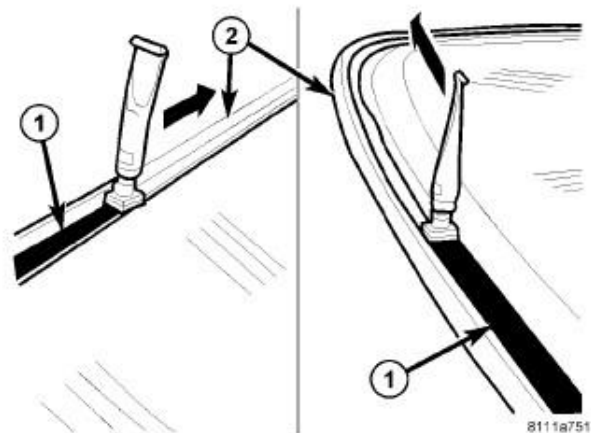
**Figure 29 – Primer**

43. If installing a NEW windshield, using a single step primer like Sika Primer 207, Betaprime 5504g, or equivalent, apply glass primer 25 mm (1 in) wide (1) around the perimeter of the windshield (2) and 5 mm (0.2 in) from the edge of the glass. Allow at least three minutes drying time (Figure 29).

44. Using a flashlight, verify that the primer is completely and evenly installed along the perimeter of the windshield.
45. Re-prime any area that is not fully and evenly primed.

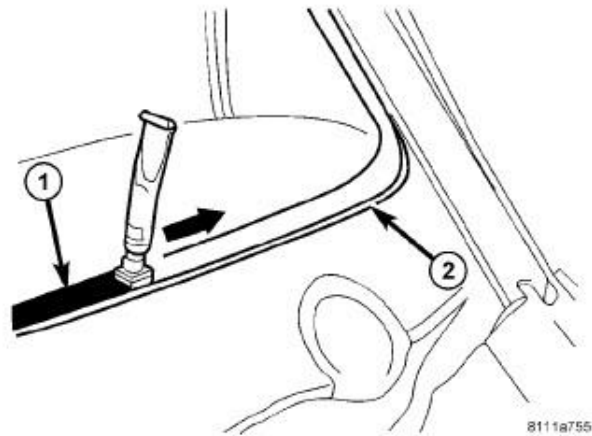
**Figure 30 – Pinch Weld Primer**

**NOTE: Sika Primer 207 requires Sika Aktivator Pro and Betaprime 5504g requires two coats of product when used on the metal body flange.**

47. Using a single step primer like Sika Primer 207, Betaprime 5504g or equivalent, apply pinch weld primer to the entire bonding flange (1) around the windshield fence (2). Allow at least three minutes drying time (Figure 30).

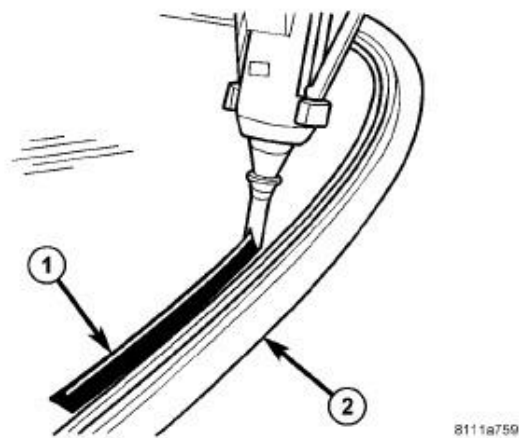
**Figure 31 – Urethane Bead**

51. Using Sikatack Mach 30, (Sikatack Safe 30 if Safelite is performing the installation), Betaseal Xpress 30, or equivalent, apply approximately a 7 mm (0.275 in) wide by 13mm (0.511 in) high bead of adhesive (1) with a triangular nozzle approximately 6 mm (0.230 in) from the edge of the glass starting at the bottom center of the windshield (Figure 31).

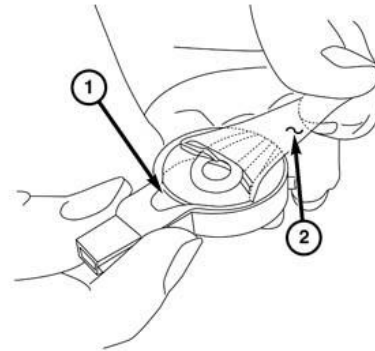
**Figure 32 – Membrane Removal**

84. Carefully peel away the old silicone gelatin adhesive membrane pad (2) from the windshield (optics) side of the LRSM (1) (Figure 32).

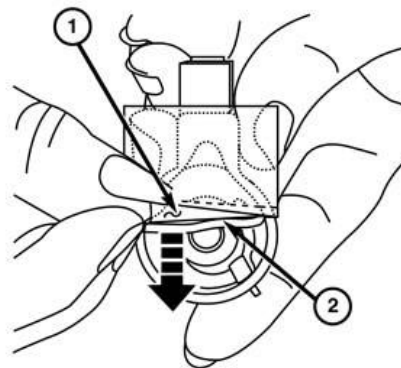
**Figure 33 – Membrane Installation**

87. Looking through the transparent protective film (1), align and center the replacement pad (2) over the windshield (optics) side of the LRSM. Then use a slow, smooth and deliberate motion to roll the pad on the windshield (optics) side of the LRSM (Figure 33).

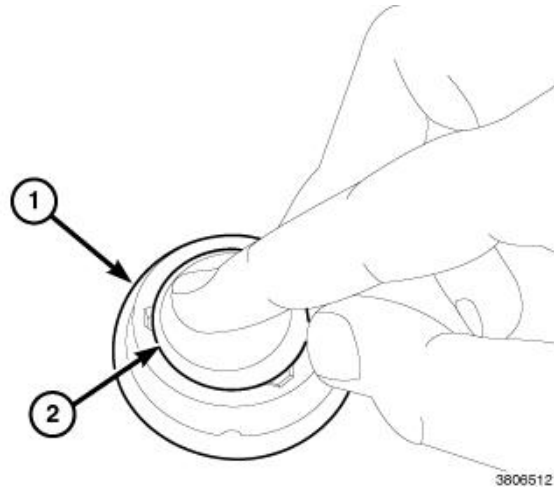
**Figure 34 – Handling LRSM**

89. To avoid contamination or damage of the replacement pad, do not remove the transparent protective film until just before installing the LRSM to the windshield.
90. Grasp the LRSM (2) by the connector receptacle between your thumb and middle finger. Place your index finger on the back of the LRSM at the point opposite the connector receptacle (Figure 34).
91. Align the LRSM with the mounting bracket (1) bonded onto the inside of the windshield glass near the inside rear view mirror mounting button (Figure 34).

92. Slowly insert the LRSM into the mounting bracket at a slight angle so that the edge of the module nearest the tip of your index finger makes the initial contact with the windshield glass (Figure 34).
93. Using a slow, deliberate motion and light pressure, draw your index finger across the back of the LRSM toward the connector receptacle until the SilGel adhesive membrane pad is in full contact with the windshield glass.
94. Engage one side of the spring steel retaining strap (5) into the groove on one side of the LRSM mounting bracket (4) on the inside of the windshield glass (2) (Figure 5).
95. Depress the opposite side of the retaining strap over the LRSM firmly and evenly until it fully engages the groove of the mounting bracket with an audible click.
