GROUP	MODEL
FMVSS Noncompliance Recall Campaign	2022MY Telluride (ON) w/3.5" LCD Cluster Screen
NUMBER	DATE
SC215	July 2021

LCD CLUSTER LOGIC IMPROVEMENT (SC215)

This bulletin provides the procedure to improve the logic of the Cluster (CLU) on some 2022MY Telluride (ON) vehicles equipped with the 3.5" LCD Cluster, produced from May 26, 2021 through July 16, 2021. Due to an instrument cluster's software error and under certain starting conditions, the LCD screen will remain blank, resulting in the driver's inability to see the odometer. As a result, the subject vehicles fail to comply with the visibility requirement of Federal Motor Vehicles Safety Standard (FMVSS) 101, "Controls and Display". This condition does not affect the functionality of the vehicle's underlying systems or dedicated telltale/warning lamps. In order to improve the cluster operation, apply the improved software logic to the 'Cluster' system using the KDS ECU Upgrade function as described in this bulletin. For confirmation that the latest reflash has been applied to a vehicle you are working on, verify the ROM ID using the table on page 3 of this bulletin. Before conducting the procedure, verify the vehicle is

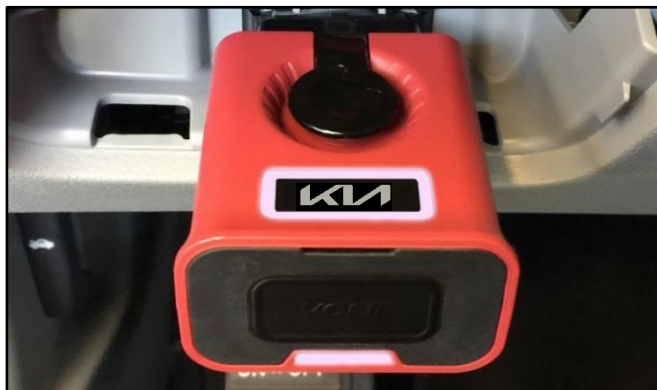
1. Connect the VCI-II to the OBD-II connector, located under the driver's side of the instrument panel.

The ECU upgrade function on KDS operates wirelessly. It is not necessary to perform the upgrade via USB cable.

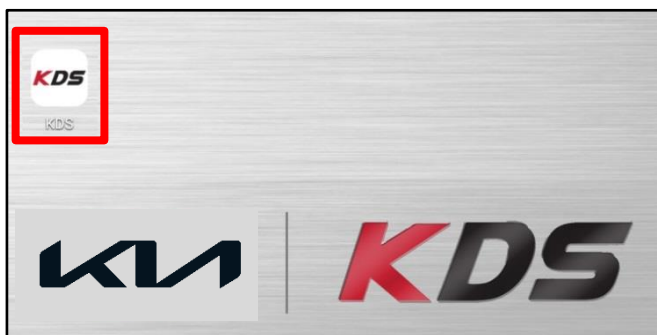
2. With the ignition ON, turn ON the KDS tablet. Select 'KDS' from the home screen.

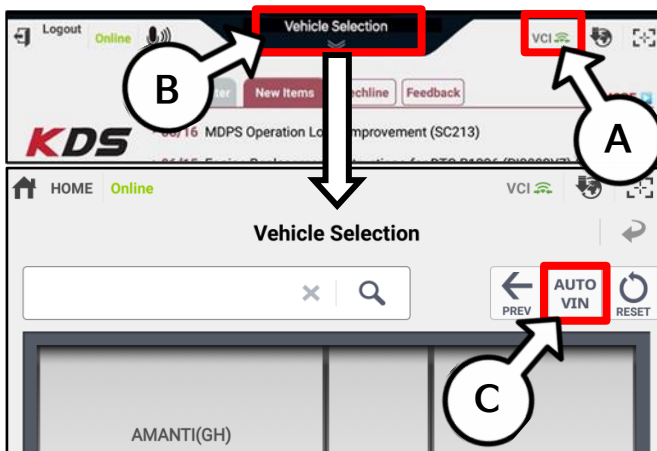
3. Confirm communication with VCI (A) and then configure the vehicle (B) using the 'AUTO VIN' (C) feature.
