Safety Recall

Code: 24HH

Subject Engine Control Unit (ECU) Software

Release Date October 21, 2021

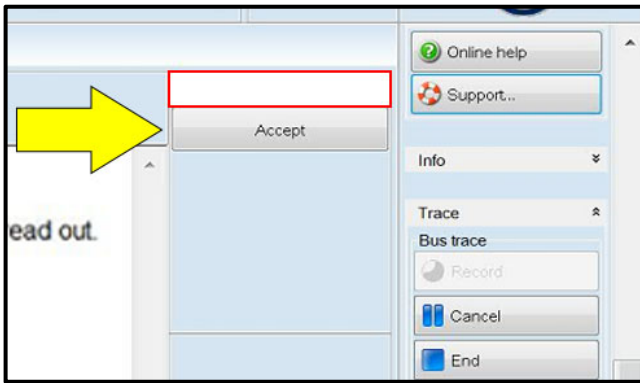
- Enter the corrective action code (SVM code) as listed below.

SVM code
4759

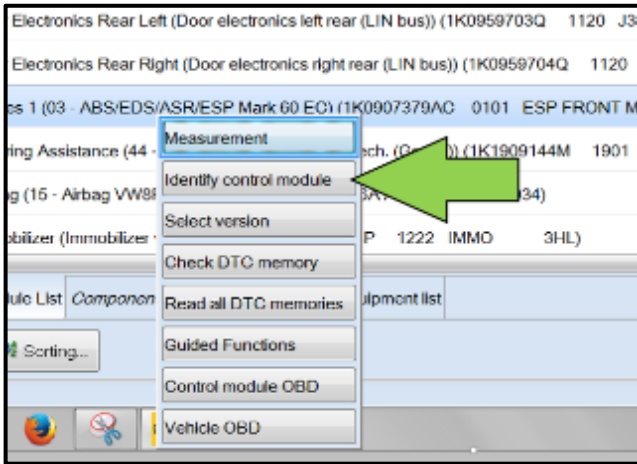
- After the software update is completed and before sending the GFF Log Online:
 - Select the “Control Module” tab.
 - Scroll down and right click on the module that was updated (0001).
 - Select “Identify Control Module” <arrow>.
