# Safety Recall

## N212345945 High Voltage Battery May Melt or Burn (GM Owned Vehicles)

Release Date: June 2023

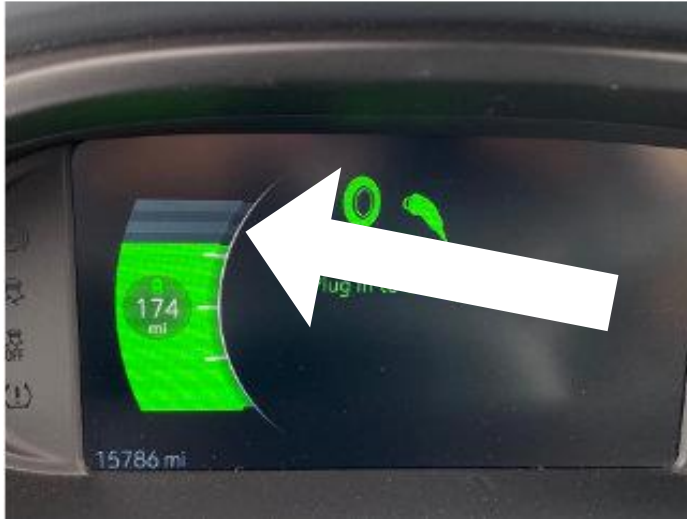
5924268

**Important:** Verify the vehicle SOC is less than 80%. This can be determined by looking at the bars on the power level indicator. If four or more empty bars (not showing green) are displayed, the SOC is at an acceptable level. If the power level indicator shows an SOC of greater than 80% The SOC must be adjusted before proceeding with the recalibration.

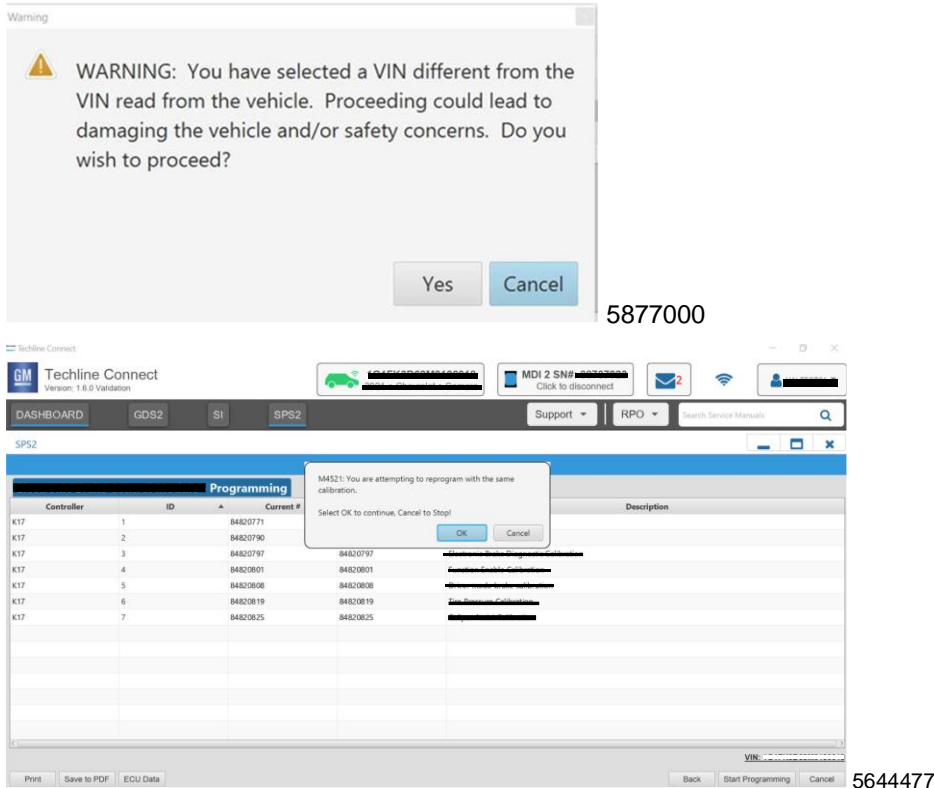
**Important:** If the vehicle VIN DOES NOT match, the message below will be shown.
