# Safety Recall

## N212345945 High Voltage Battery May Melt or Burn (GM Owned Vehicles)

**Release Date:** June 2024

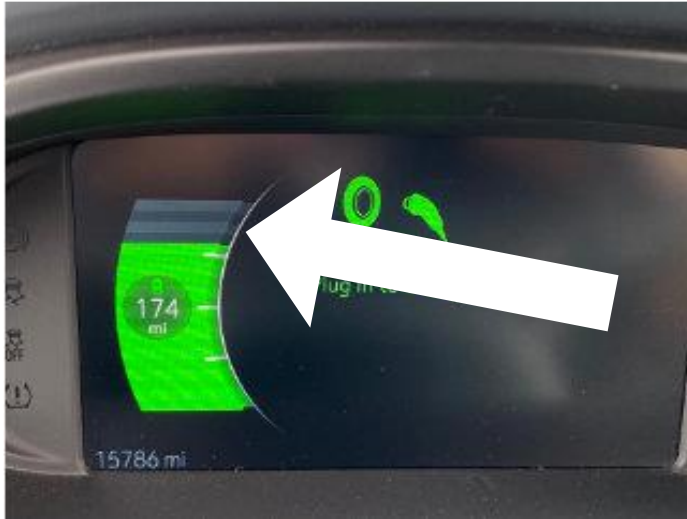
5924268

**Important:** Verify the vehicle SOC is less than 80%. This can be determined by looking at the bars on the power level indicator. If four or more empty bars (not showing green) are displayed, the SOC is at an acceptable level. If the power level indicator shows an SOC of greater than 80% The SOC must be adjusted before proceeding with the recalibration.
