GROUP	MODEL
Safety Recall Campaign	2015-2017MY Sedona (YP)
NUMBER	DATE
SC217	November 2021

# SMART JUNCTION BOX SOFTWARE UPGRADE FOR TURN SIGNAL OPERATION IMPROVEMENT (SC217)

This bulletin provides the procedure to improve the logic of the Smart Junction Box (SJB) on certain 2015-2017MY Sedona (YP) vehicles, produced from July 21, 2014 through June 10, 2016. The Smart Junction Box (SJB) interprets the signal from the multifunction switch to determine the intended turn signal direction. The SJB software logic may not properly interpret the signals received from the multifunction switch in certain circumstances. As a result, the turn signal may intermittently activate in the opposite direction of what was intended by the driver, thereby increasing the risk of a crash.

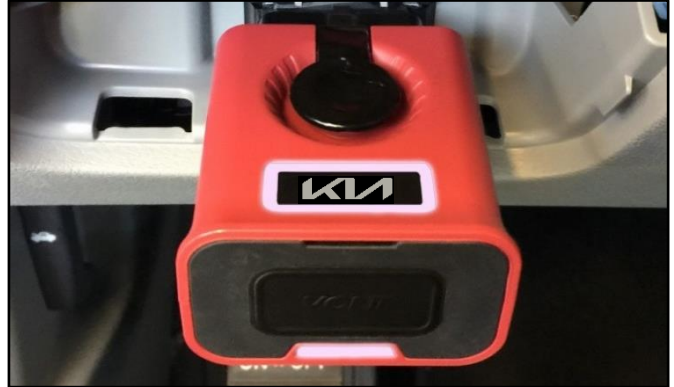
The ECU upgrade function on KDS operates wirelessly. It is not necessary to perform the upgrade via USB cable.

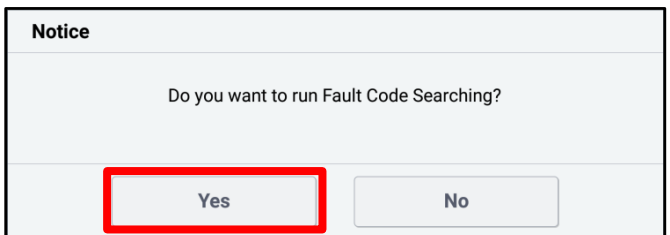
- When prompted, select 'YES' to check for Diagnostic Trouble Codes (DTC) and erase any DTCs stored such as EPS, ESC, and TPMS that may have been set during the upgrade.
